CHURCH OF ST EUSTACE
IBBERTON, DORSET

MONUMENTS & ROYAL ARMS

CONDITION ASSESSMENT
&
CONSERVATION RECOMMENDATIONS

JANUARY 2026

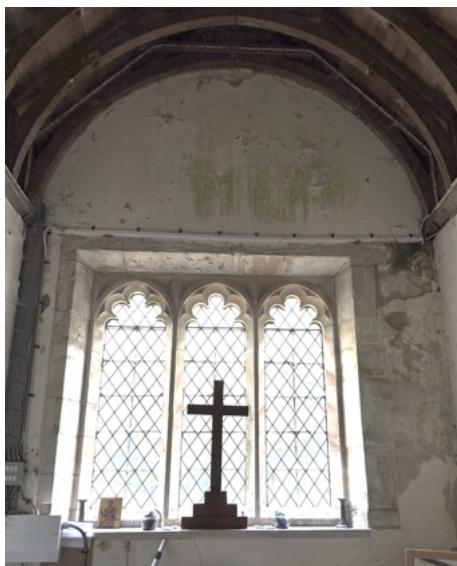
Figure 17 ~ Interior view of the North Chapel showing damp on the east elevation.

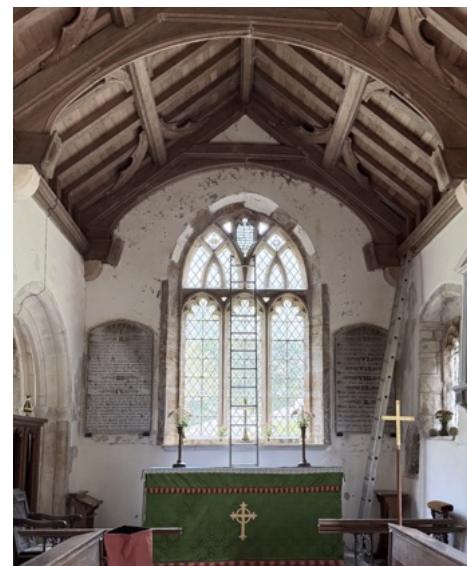
Figure 20 ~ Interior view of the Chancel wall around the Decalogues showing damp.

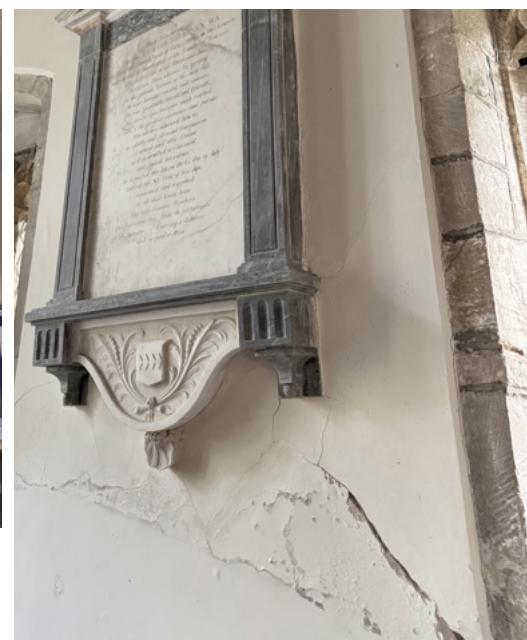
Figure 18 ~ View of the cracks in the wall around monument 6, on south elevation of Chancel.

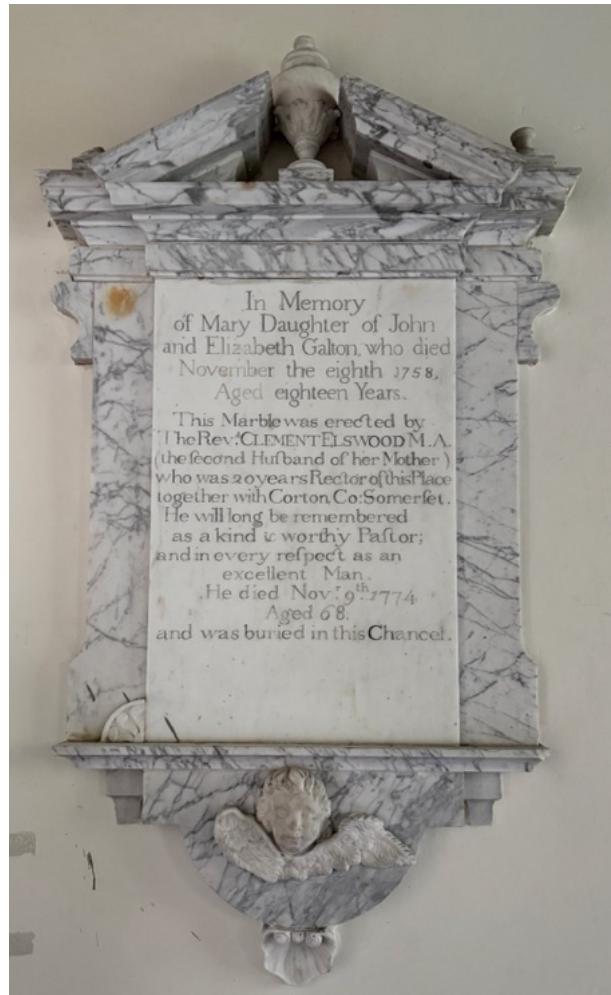
Figure 21 ~ Monument 001 to Mary Galton and the Revd. Clement Elswood M.A

The monument has suffered in the past. Despite losses and iron stains the upper sections, from inscription panel up, appear sound, however the lower apron bearing the winged cherub head shows signs of movement separating from the wall. Several details are cracked and there is evidence of iron stains.

LOSSES ~ Left / dexter marble finial is missing, having cracked at its narrowest section of the base. The right / sinister finial is also missing its top which looks to have been fixed with a dowel. The moulding of a cherub at the base of the monument has a hairline crack, possibly due to a corroding fixing. A circular corner detail is missing from the lower right / sinister of the monument.

STAINING AND SOILING ~ Surface is soiled with splatters of cement and paint. A ferrous stain on the top left / dexter of the marble surround from a corroding fixing.

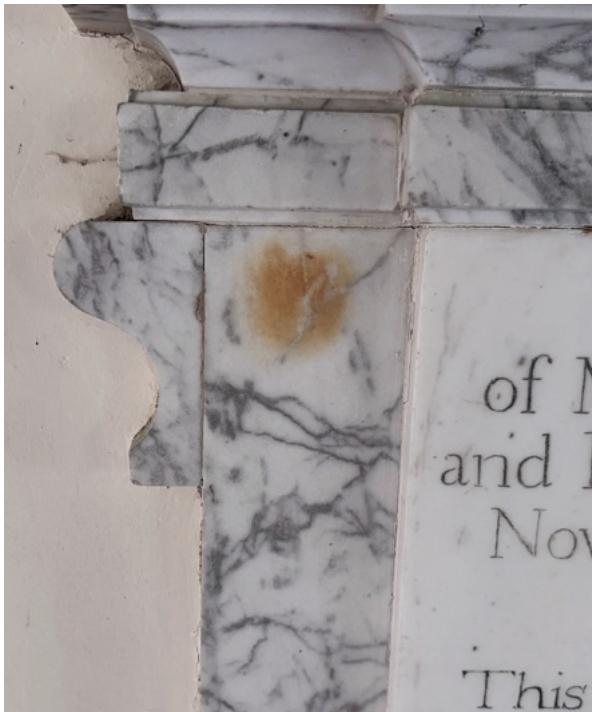
Figure 22 ~ Detail of iron stain on surround of the dexter of monument 001.

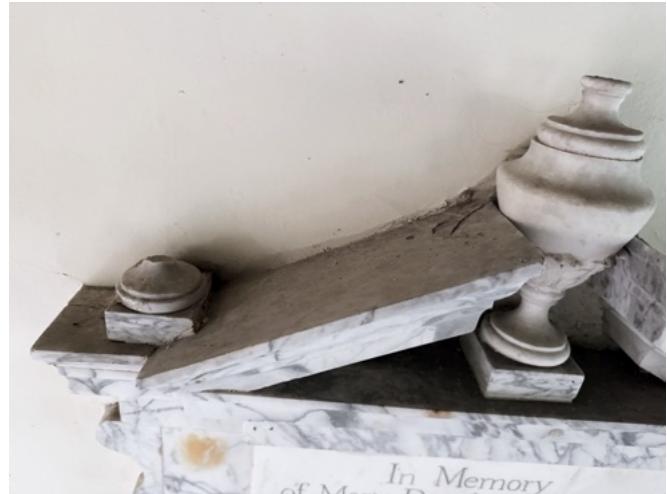
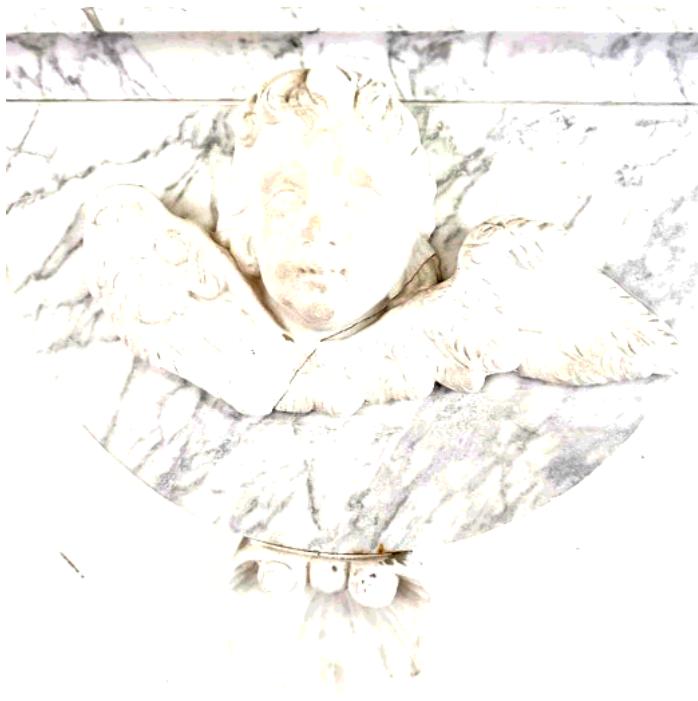
FIXINGS ~ Ferrous fixings corroding and causing staining and possible future loss. This is the likely cause of the lower movement and crack behind the cherub and apron.

Figure 24 ~ Detail of crack between cherub wings, detail of monument 1.

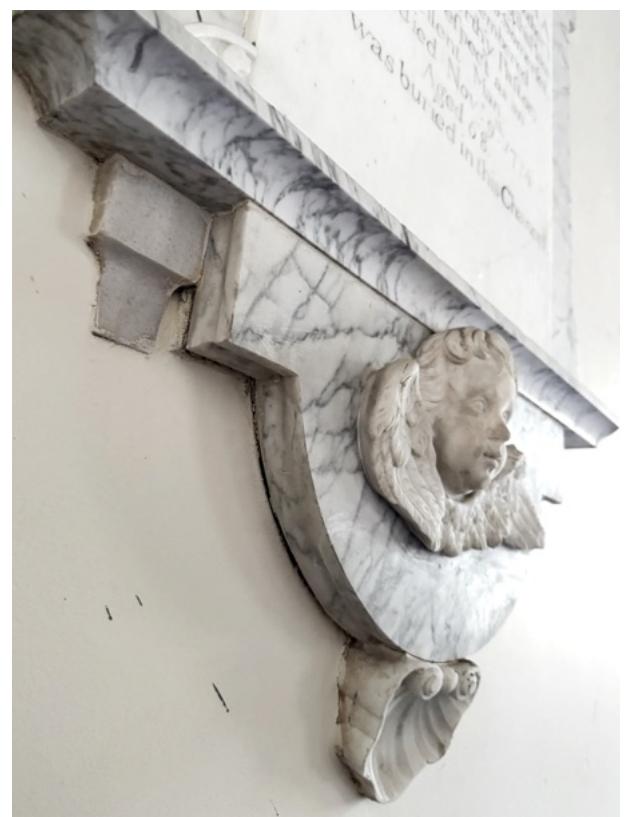
Figure 25 ~ Detail of separation of monument 1 from the wall.

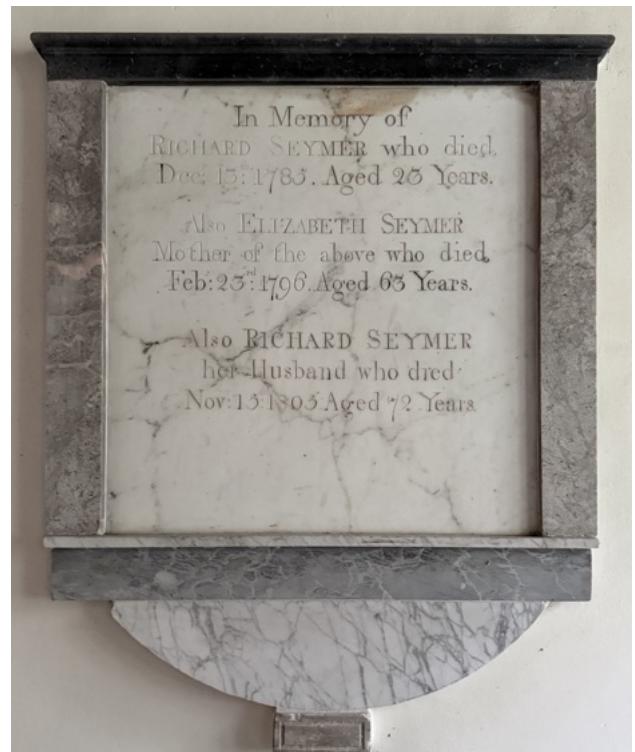
Figure 26 ~ Monument 3 to Richard, Elizabeth and Richard Seymour.

STAINING AND SOILING ~ Surface is soiled. Ferrous stain on the white marble inscription tablet, below the black mantle.

PAST REPAIRS AND FILLS ~ Upper left / dexter moulding has been repaired. See note above.

POLYCHROMY & LEGIBILITY ~ The lettering is very faded across the entirety of the monument.

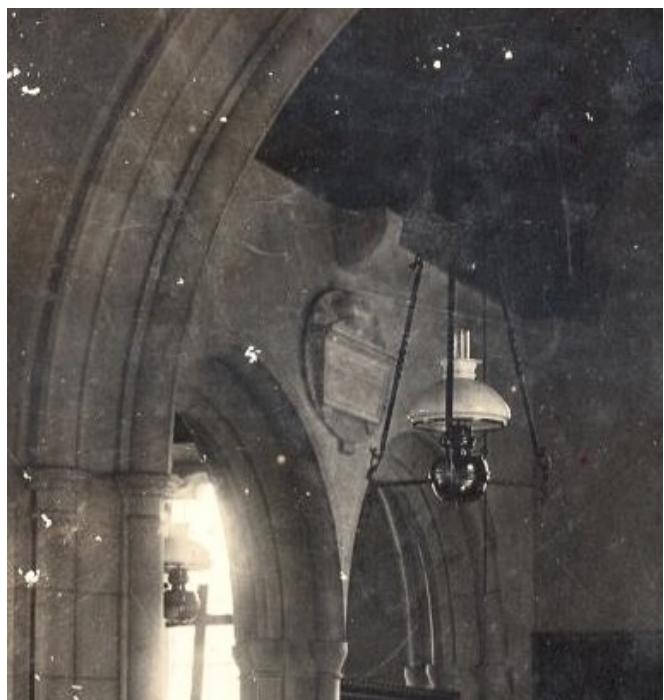
Figure 29 ~ View of Monument 004 to Joseph D'Aubeny. Note the oval impression of the former monument on the surrounding wall and the ferrous fixings.

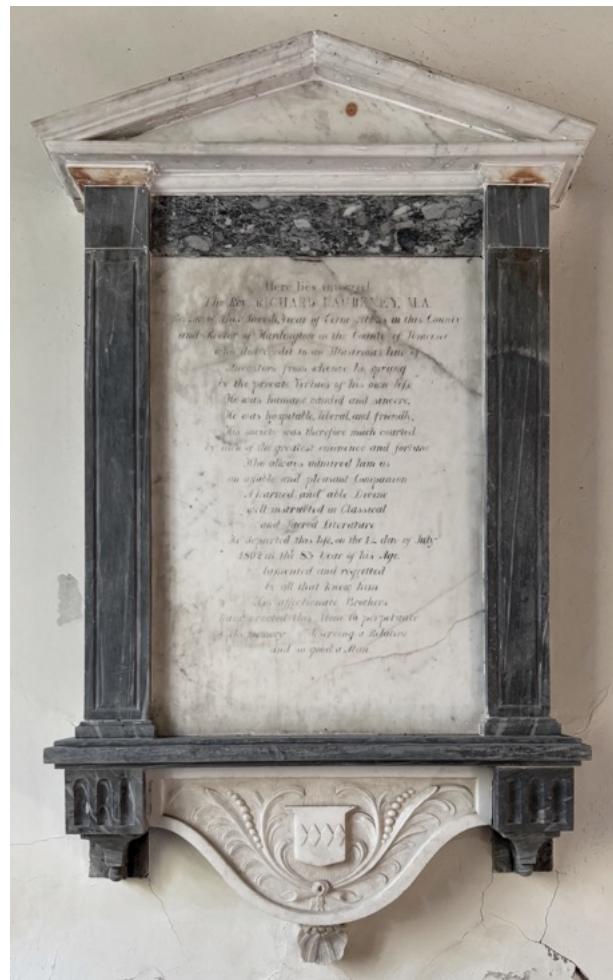
Figure 30 ~ Monument 5
to Rev. Richard Daubeny.

The surrounding wall has a pronounced lean outwards and extensive cracking. Although the angle of the lean is clearly historic, the stability has not been assessed, and the movement/cracking may be ongoing. The monument is separating from the wall at low level, with a fine crack around the perimeter at high level.

STAINING AND SOILING ~ Surface is soiled and iron staining is evident, most noticeably at high level above the pilasters and within the pediment.

FIXINGS ~ The fixings are likely to have corroded and be contributing to the movement at low level leading to the instability of the monument and the staining. However, the stability of the wall may also be a contributory factor.

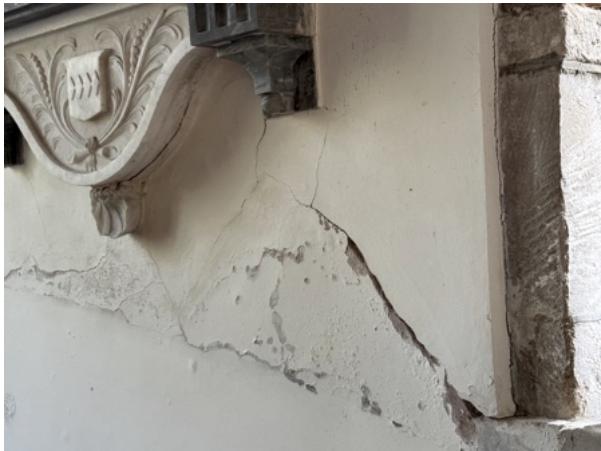
Figure 31 ~ Detail of cracks in the wall around monument 5.

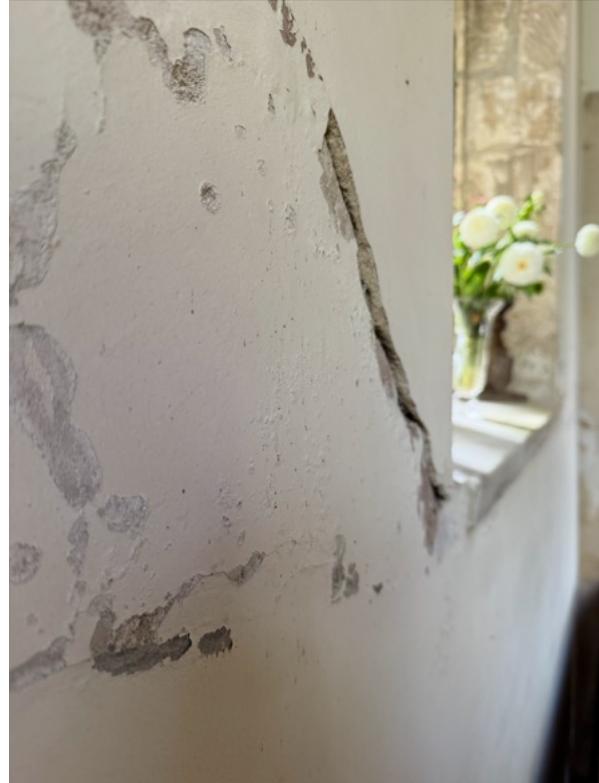
Figure 32 ~ Detail of south elevation beneath the monument, illustrating extensive cracking and movement of wall.

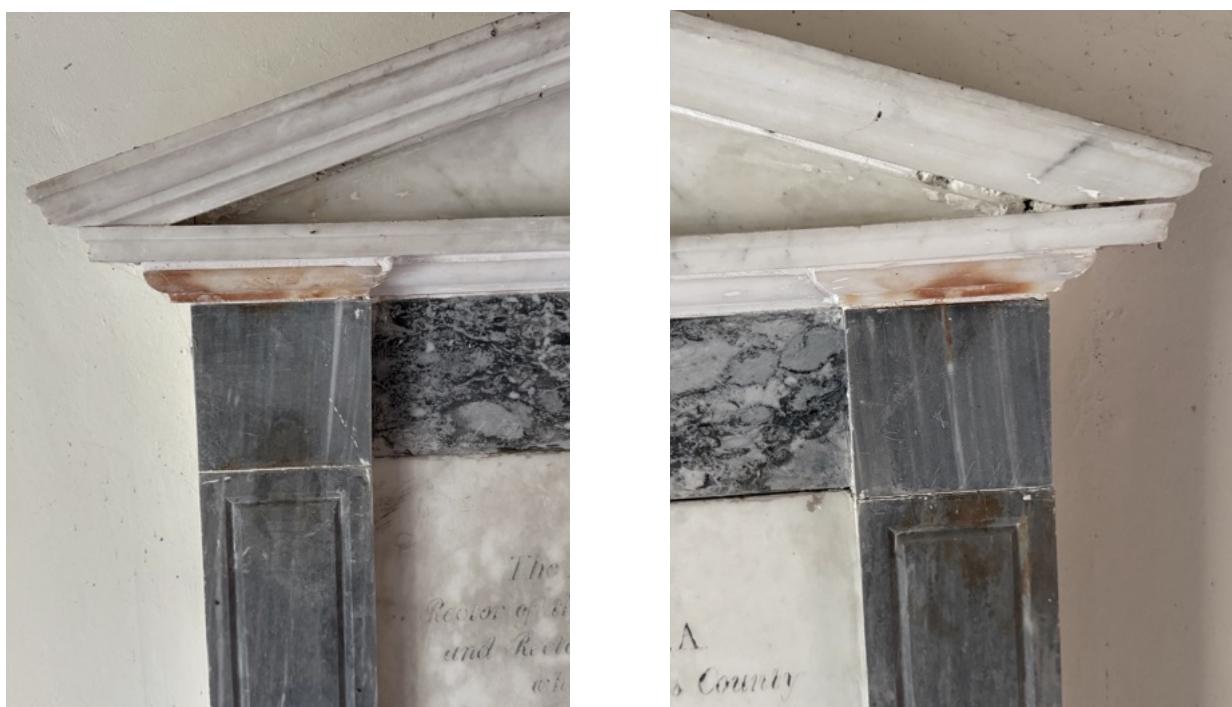
Figure 33 ~ Details of ferrous staining on both sides of the moulding supporting the pediment of monument 5, from corroding iron fixings behind.

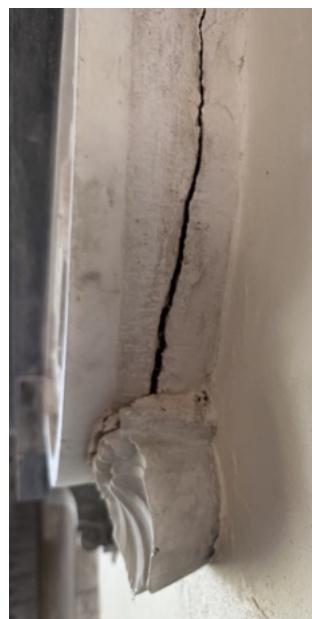
Figure 35 ~ Detail of crack around the lower side of the apron to monument 5.

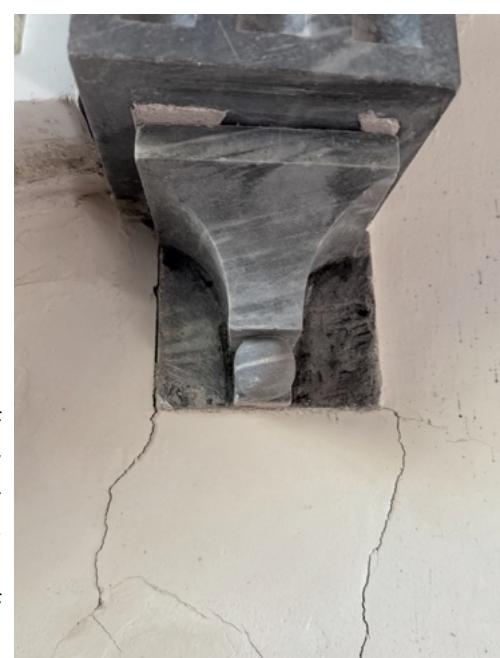
Figure 34 ~ Detail of cracks in the wall, directly below the right / sinister of monument 5. Note dislodged corbel indicating degree of movement.

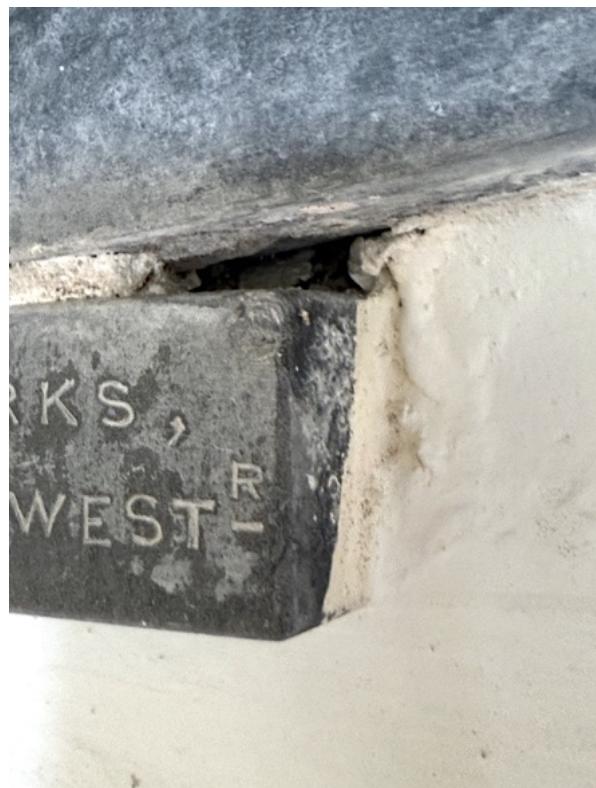
STAINING AND SOILING ~ Surface is soiled, surface of the black surround is bloomed.

Figure 37 ~ Detail bloomed black surface and minor loss of mortar around the manufacturer's inscription below monument 6.

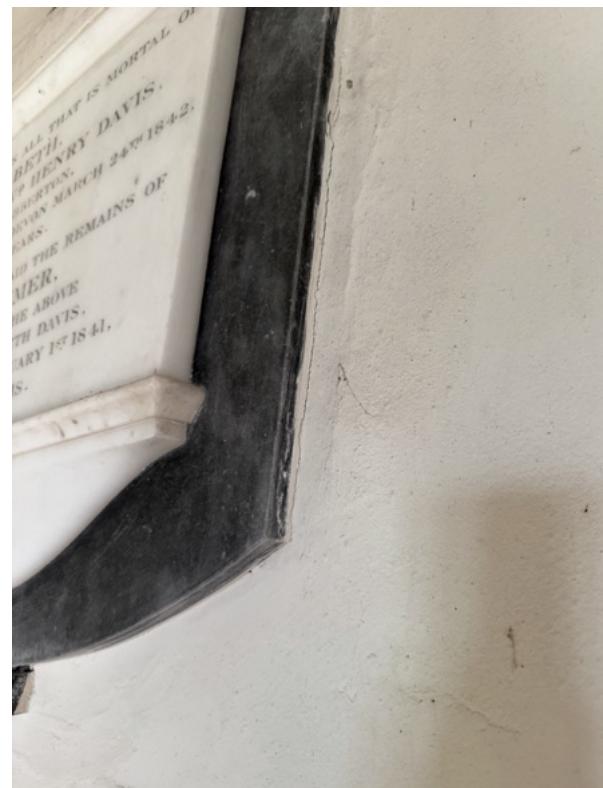
Minor crack to perimeter joint with wall.

Figure 38 ~ Detail of minor crack around the perimeter of monument 6 on the sinister side.

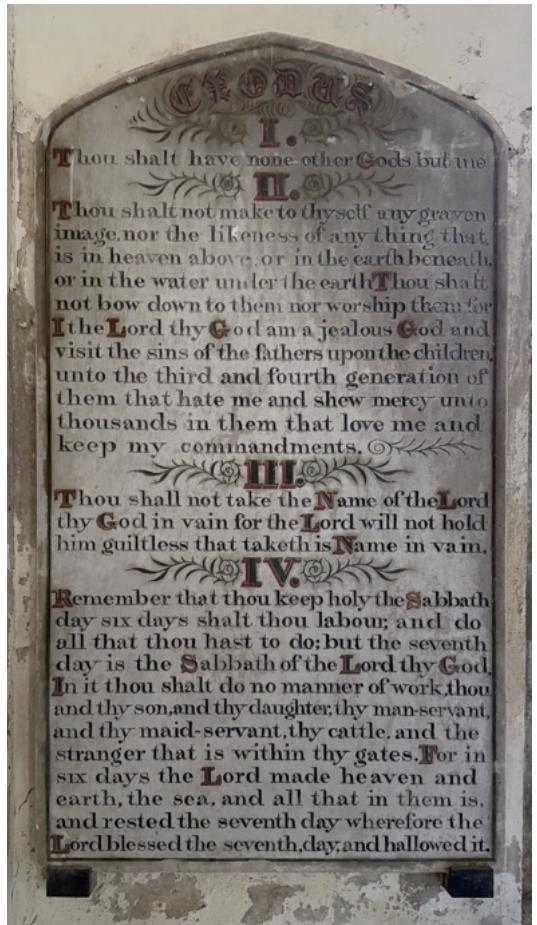
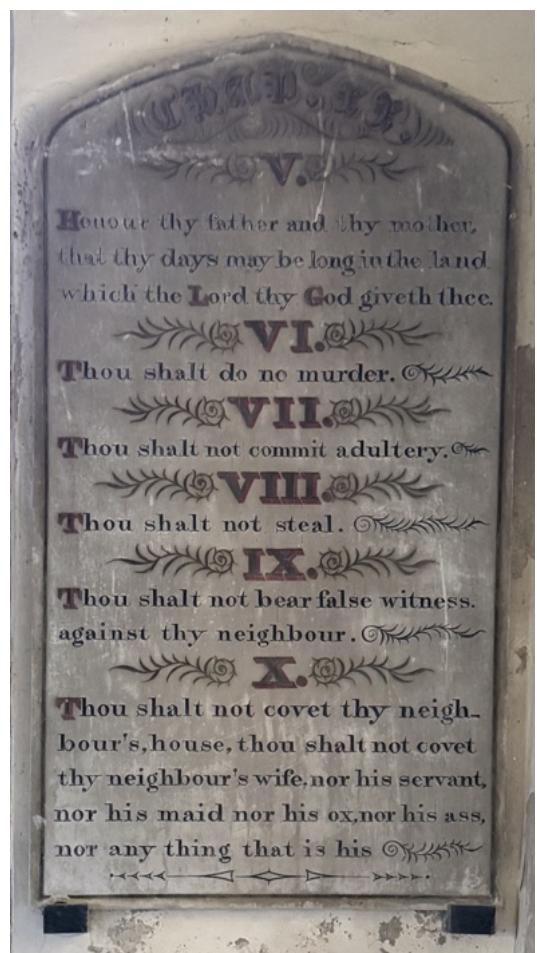
Figure 40 ~ Decalogue 2 (008).

The decalogues are structurally stable and secure to the wall, however the painted surfaces are in a fragile and vulnerable condition, displaying on-going loss of detail.

STAINING AND SOILING ~ Surface is heavily soiled with a dusty appearance. The white background is now grey throughout and dark grey in areas. The decalogues are set against a wall which has been suffering from damp for an extended period.

POLYCHROMY & LEGIBILITY ~ The polychromy lettering is discoloured from soiling and is in a very friable state. The painted border is worn in the top right / sinister of decalogue 1 and the background is in a poor state with extensive losses across both 1 and 2.

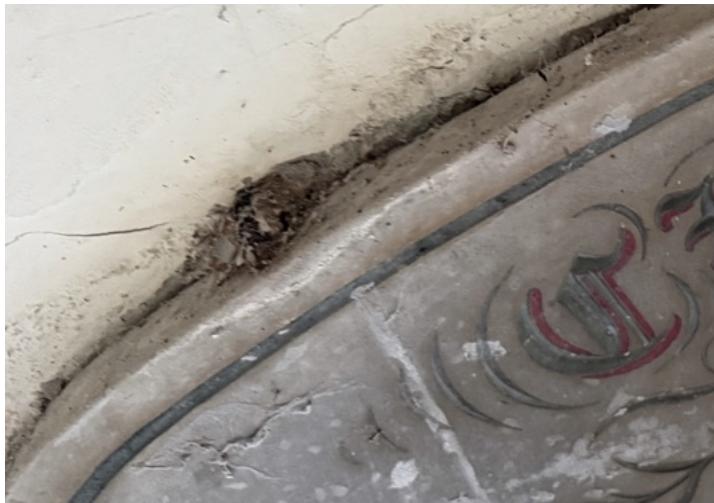
FIXINGS ~ There are two iron fixings at the top of each decalogue that appear to be corroding. The bottom stone brackets appear secure although the ferrous fixing of dexter bracket of Decalogue 1 is heavily corroded.

Figure 41 ~ Detail showing corroding iron fixing above Decalogue 1.

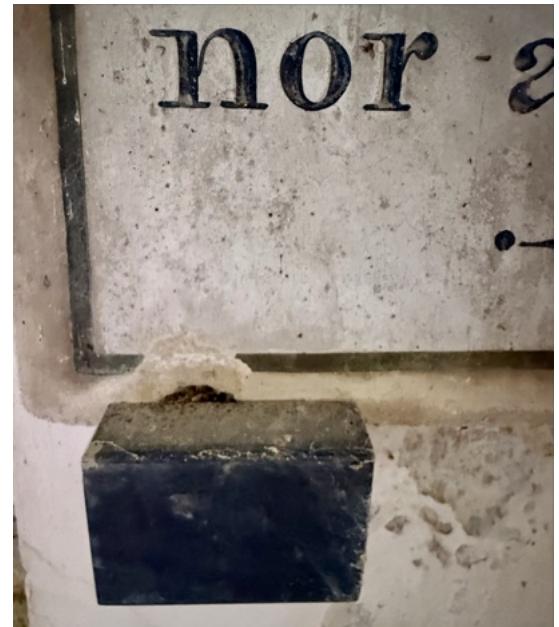
Figure 42 ~ Detail of lower dexter bracket and corroding fixing, Decalogue 1.

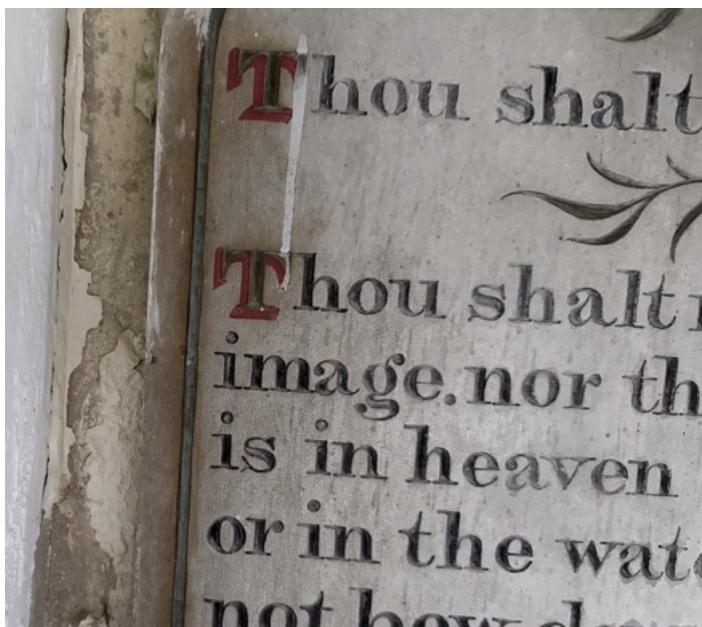
Figure 43 ~ Detail showing paint spill on decalogue 1, and paint peeling on the surrounding wall.

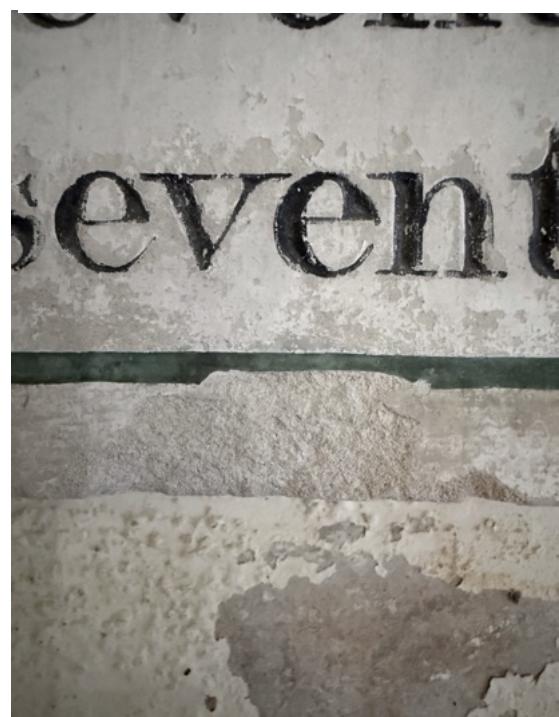
Figure 44 ~ Detail showing loss of stone on decalogue 1.

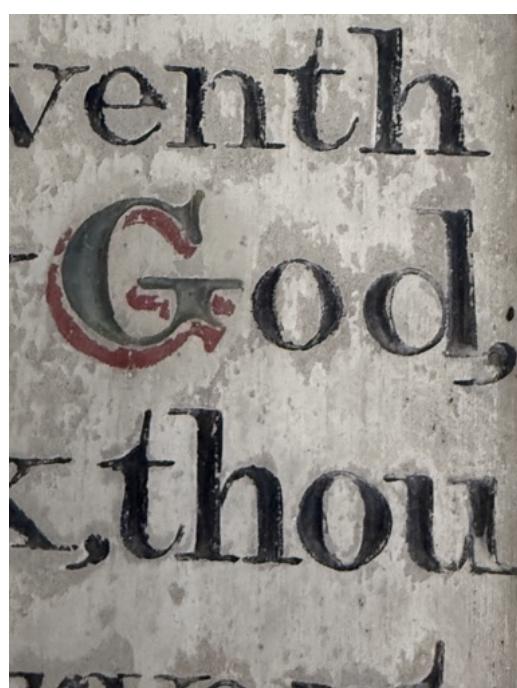
Figure 45 ~ Detail illustrating painted incised lettering on decalogue 1, with painted 'shadow' highlighting capital letters. The paint is chalky and friable. Extensive areas of loss of background colour surrounding letters.

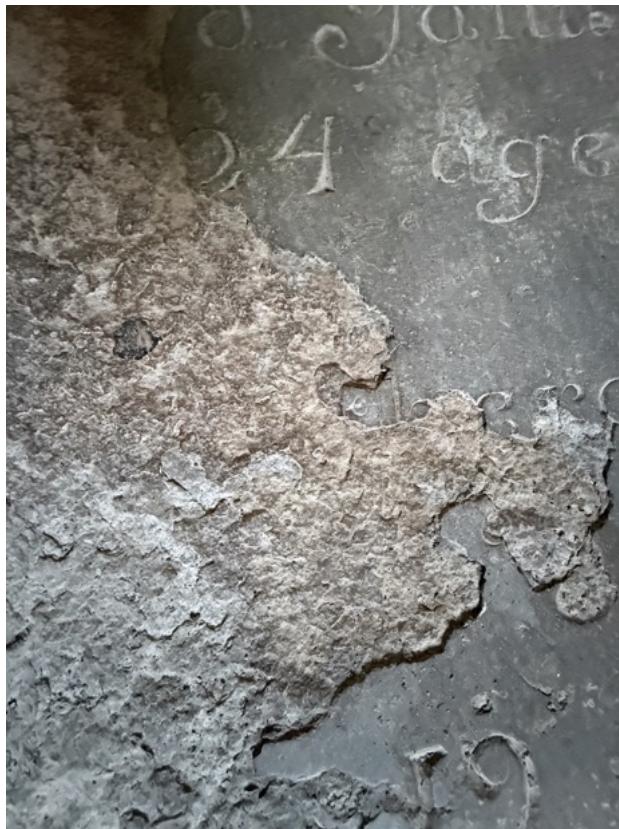
LEGIBILITY ~ The carved lettering is very worn. Only legible in some areas, due to loss of stone surface.

Figure 48 ~ Detail of laminating surface area on inscription of ledger stone 009.

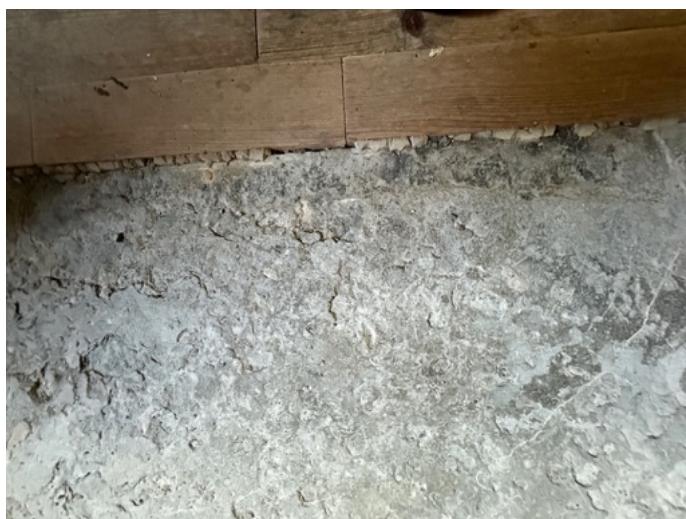
LOSSES ~ The surface of the stone is very worn with much detail of inscription lost due to the laminating surface.

JOINTS ~ Surrounding mortar is crumbling and loose.

Figure 52 ~ Detail illustrating laminating surface and crumbling mortar around ledger stone 010.

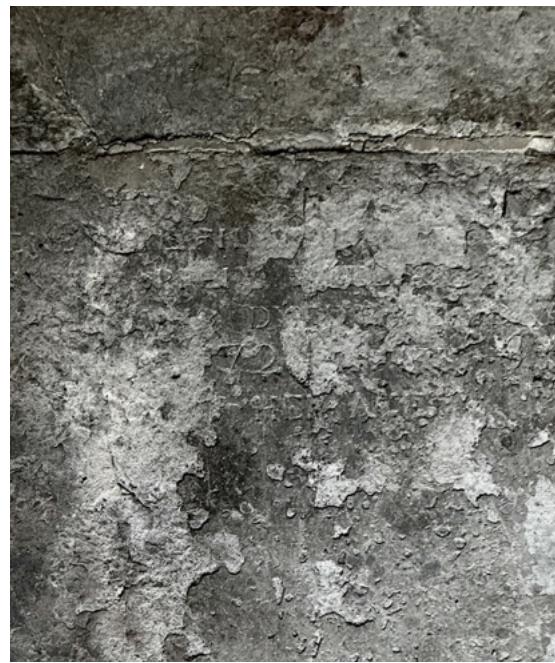
LEGIBILITY ~ Poor. The remaining lettering is extremely vulnerable to further loss.

Figure 51 ~ Detail illustrating faint lettering on ledger stone 010.

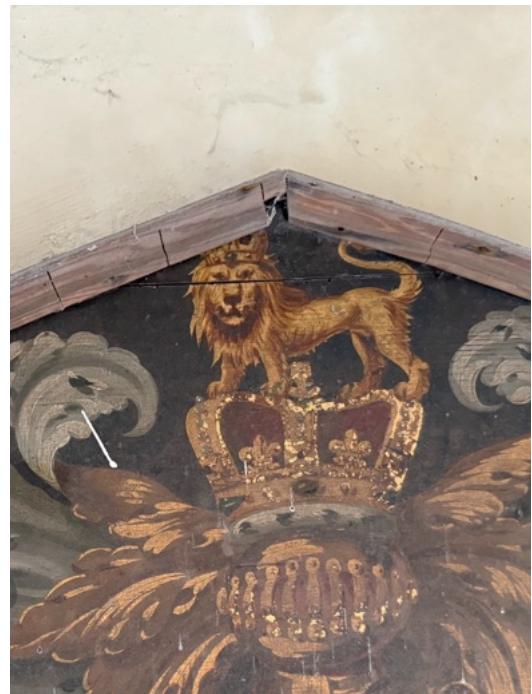
Figure 55 ~ Detail of loss to the wooden arched frame and paint spills on surface.

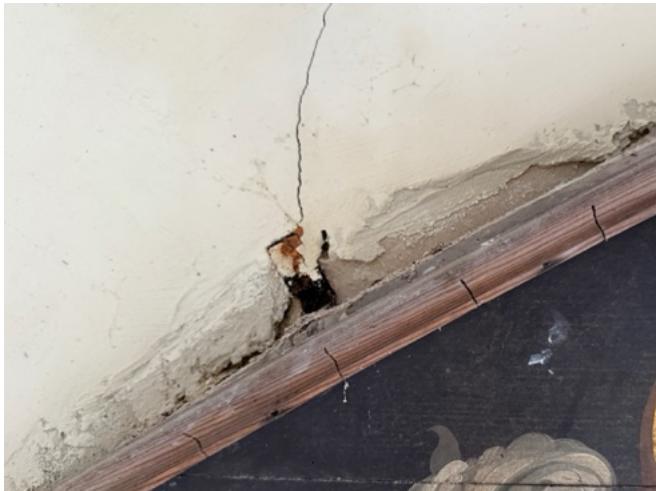
FIXINGS ~ Iron nails and fixings around the frame are corroding. Evidence of cracks in the wall around the Royal Arms, originating from corroding fixing.

Figure 56 ~ Detail of corroding fixing and frame.

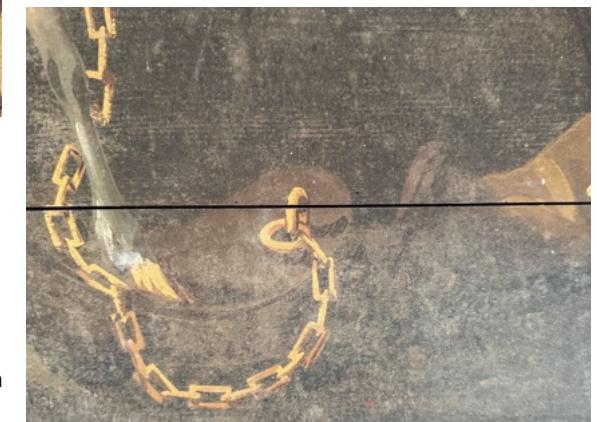
POLYCHROMY ~ The colours have a bloom which has caused them to lose their saturated appearance. The paint is cracked and there is a loss of surface layers, including the gold leaf details.

Figure 58 ~ Detail illustrating bloom and the desaturation of colours across the timber joint at foot of unicorn.

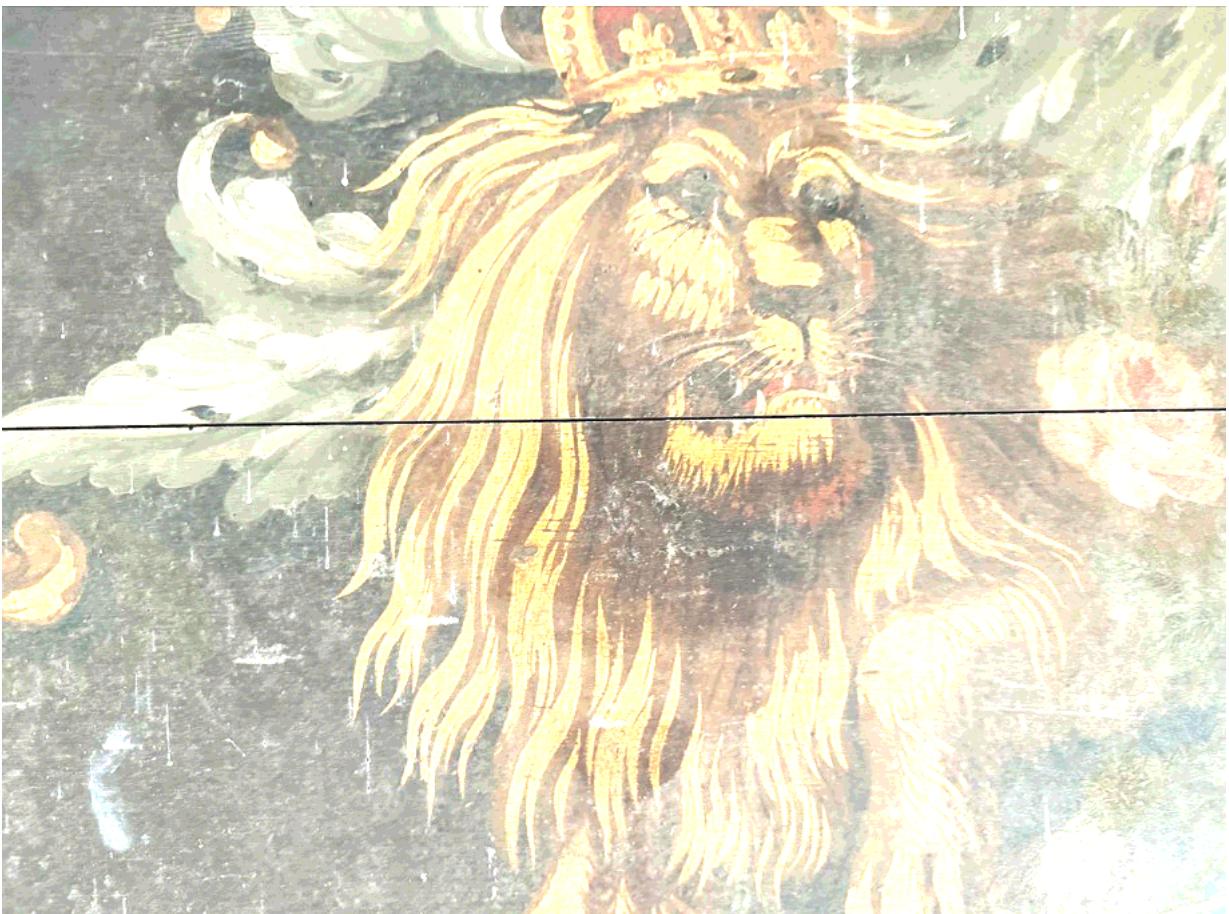
Figure 59 ~ Detail of lion's head illustrating soiling and desaturation of varnish layer.
