# DAN HUMPHRIES STAINED GLASS LTD

## St Eustace Church, Ibberton, Dorset

### Conservator's Report

Windows: Complete Glazing Condition inc. Historic Stained Glass Fragments  
Date: January 2026

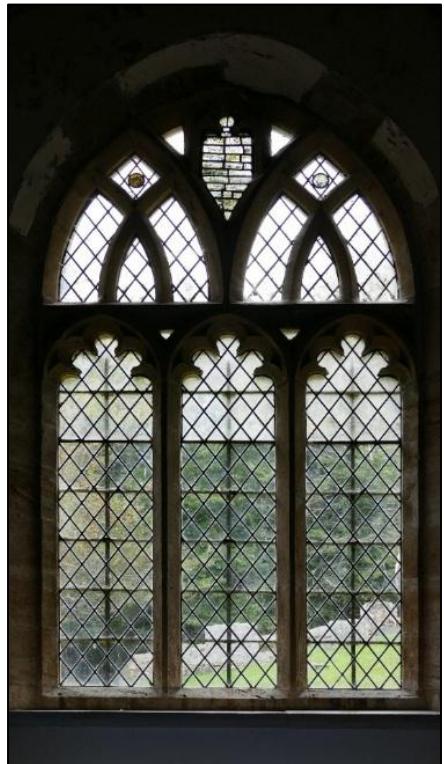
### Window I

- Rusty and expanded ext. ferramenta, associated cracked mortar and spalled mullions.
- Open masonry joint at top of ext. mullion between b and c, frassing at hoodmould and ext. jambs.
- Area of int. lead chewed by rodents, base of c.
- Multiple glass cracks at lobes of 2a and 2c, broken quarry in tracery A2.
- Dirt and algae on both faces, suggests regularly damp.
- Galvanised wire guard to B1 loose and beginning to rust. Single fixing into masonry at apex, also rusty.

- *Deinstall ferramenta, tip in ss, shot blast, prime and decorate bars and stanchions. Reinstall ferramenta, repoint and repair bar pockets with gauged hydraulic lime mortar.*

- *Clean quarries in situ; remove algae.*
- *Replace/repair broken quarries in situ as appropriate.*
- *Renew failed mortar repairs to perimeters.*
- *Replace ferrous fixing and supply additional ss fixings for loose wire guard in B1 if guard not being replaced in the short term.*

- *Renew wire guard in B1 with powder coated ss guard.*

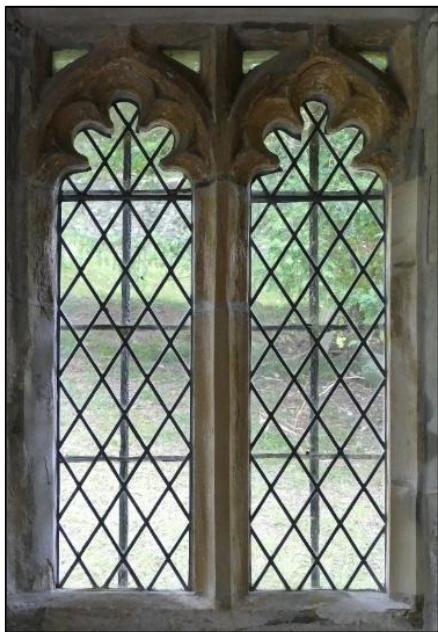
### **Window sII**

- Rusty and expanded ext. ferramenta, disrupted mortar at sills, associated cracks and failed repairs to ext. mullion and westernmost jamb.
- Deteriorated stone at int. apex light b.
- Multiple glass cracks top of light a, where pinched between cusps (fig.1, pg.17).
- Algae on lug bars and ext. glass surface.

- *Deinstall ferramenta, tip in ss, shot blast, prime and decorate bars and stanchions. Reinstall ferramenta, repoint and repair bar pockets with gauged hydraulic lime mortar.*

- *Clean quarries in situ; remove algae.*
- *Replace/repair broken quarries in situ as appropriate.*
- *Renew failed mortar repairs, local repointing of perimeters as required.*

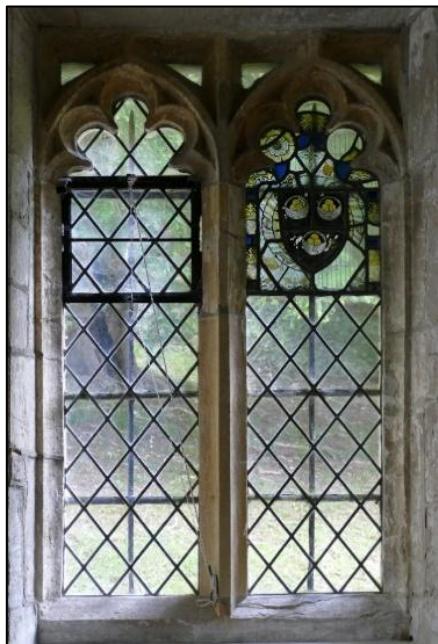
### **Window sIII**

- Rusty and expanded ext. ferramenta, associated cracks and spalls to ext. perimeters. Loss of ferrous material at bar tips.
- Lower 2/3 of int. mullion replaced.
- Casement fairly recently decorated but visibly rusty, masonry joint at springing line of mullion cracked through (fig.2). Casement opens half way, no bird guard.
- One cracked quarry in each light.
- Dirt and insect matter on both faces, small amount of algae.
- Rusty fixings on wire guard. Galvanised guard beginning to rust.

- *Deinstall ferramenta, tip in ss, shot blast, prime and decorate bars and stanchions. Reinstall ferramenta, repoint and repair bar pockets with gauged hydraulic lime mortar.*
- *Deinstall casement. Shot blast, prime and decorate. Clean and refit glazing into hopper, reinstall. Provide ss bird guard.*

- *Clean quarries in situ; remove algae.*
- *Replace/repair broken quarries in situ as appropriate.*
- *Renew failed mortar repairs, local repointing of perimeters as required.*
- *Replace ferrous fixings on wire guard with ss if guard not being replaced in the short term.*

- *Renew wire guard in light b with powder coated ss guard.*

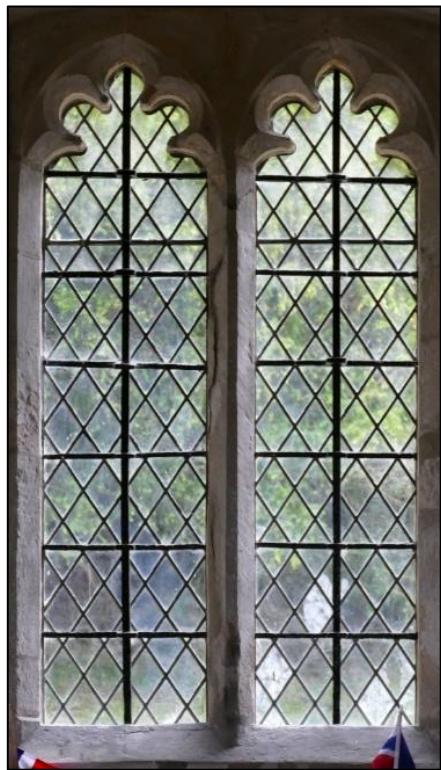
### ***Window sIV***

- Rusty and expanded int. ferramenta, associated cracks to int. perimeter mortar and glass both lights. Failed mortar repairs to int. mullion and jambs (fig.3).
- Masonry upstand at int. sill, poor design, no drainage holes.
- Outward bowing of panels, max. 20mm.
- Dirt and insect matter on both faces.

- *Deinstall ferramenta, tip in ss, shot blast, prime and decorate bars and stanchions. Reinstall ferramenta, repoint and repair bar pockets with gauged hydraulic lime mortar.*

- *Clean quarries in situ.*
- *Replace/repair broken quarries in situ as appropriate.*
- *Renew failed mortar repairs, local repointing of perimeters as required.*

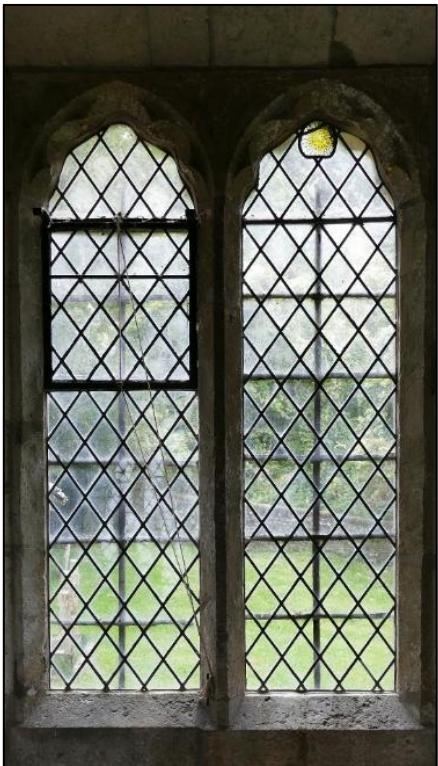
### Window sV

- Rusty ext. ferramenta, significant loss of ferrous material at lower bar tips (fig.4), no associated cracks to masonry.
- Missing cusps at lancet heads.
- Casement rusty but functional, no bird guard. Casement glazing detached at top L corner.
- Int. lead chewed by rodents, base of both lights.
- Inward bowing in light b, max. 10mm.
- Dirt and insect matter, especially upper sections, small amount of algae on ext. glazing.

- *Deinstall ferramenta, tip in ss, shot blast, prime and decorate bars and stanchions. Reinstall ferramenta, repoint and repair bar pockets with gauged hydraulic lime mortar.*
- *Deinstall casement. Shot blast, prime and decorate. Clean and refit glazing into hopper, reinstall. Provide ss bird guard.*

- *Clean quarries in situ; remove algae.*
- *Reinstall ferramenta, repoint bar pockets with gauged hydraulic lime mortar.*

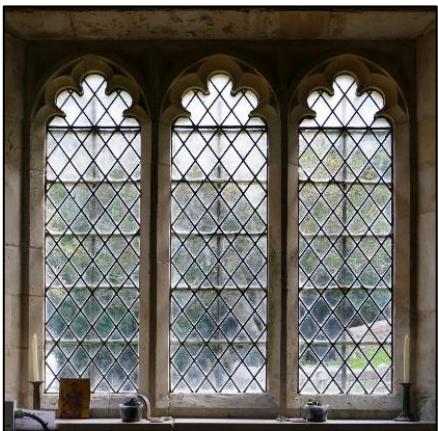
### **Window nII**

- Rusty and expanded ext. ferramenta, small associated spalls to ext. jambs.
- Crack through masonry at apex of light a, suggests structural movement. Minor frassing around ext. hoodmould and jambs.
- Missing perimeter mortar at int. jamb light a.
- Cracked quarries top of lights b and c where pinched in cusps.
- Dirt and insect matter on both faces, especially upper sections, algae on ext. glazing and int. wall above window.

- *Deinstall ferramenta, tip in ss, shot blast, prime and decorate bars and stanchions. Reinstall ferramenta, repoint and repair bar pockets with gauged hydraulic lime mortar.*

- *Clean quarries in situ.*
- *Replace/repair broken quarries in situ as appropriate.*
- *Local repointing to perimeter of light a.*

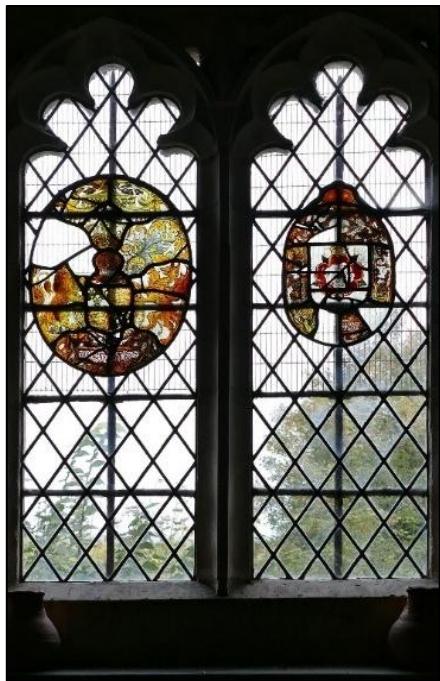
### Window nIII

- Rusty and expanded ext. ferramenta, associated cracked ext. joint in mullion adjacent to top bar.
- Open joint top of ext. jamb in light b, cracks in and below int. cast stone sill, damaged int. cusps.
- Some lichen accumulation on ext. leads.
- Minor outward bowing to panel heads, 5-10 mm.
- Missing glass in eyelet above light a.
- Insect matter and algae on int. glazing and sill, algae on lug bars and ext. glazing behind lug bars.
- Rusty fixings on wire guards. Galvanised guards beginning to rust.

- *Deinstall ferramenta, tip in ss, shot blast, prime and decorate bars and stanchions. Reinstall ferramenta, repoint and repair bar pockets with gauged hydraulic lime mortar.*

- *Clean quarries in situ; remove algae.*
- *Replace missing glass in eyelet above light a with matching tint.*
- *Local repointing to open masonry joints at perimeter.*
- *Replace ferrous fixings on wire guards with ss if guards not being replaced in the short term.*

- *Renew wire guards in both lights with powder coated ss guards.*

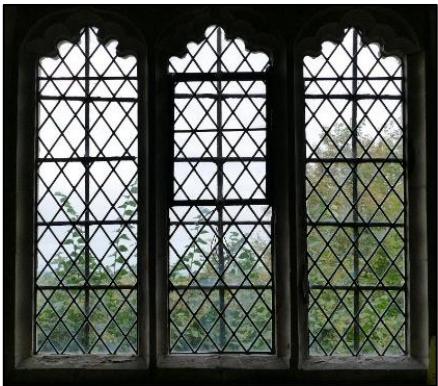
### **Window nIV**

- Rusty and expanded ext. ferramenta, associated large spalls to int. and ext. jambs and mullions. Crack in int. mullion between b/c. Numerous mortar repairs many now failed. Loss of ferrous material at bar tips.
- Crack at int. apex of light b and above int. east jamb associated with structural movement. Cracks, open joints and deteriorated stone at int. sills
  - structural movement in north aisle was stabilised in 2025.
- Minor rusting of casement.
- Cracked quarries top of lights a and c.
- Lightly dirty both faces, algae on int. sill.

- *Deinstall ferramenta, tip in ss, shot blast, prime and decorate bars and stanchions. Reinstall ferramenta, repoint and repair bar pockets with gauged hydraulic lime mortar.*
- *Deinstall casement. Shot blast, prime and decorate casement, clean and refit glazing into hopper, reinstall. Provide ss bird guard.*

- *Clean quarries in situ.*
- *Replace/repair broken quarries in situ as appropriate.*
- *Repoint approx. 30% perimeters, renew failed mortar repairs.*

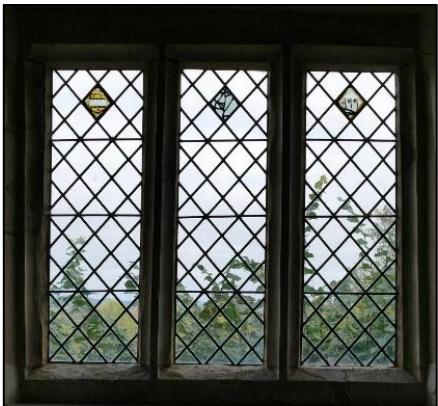
### **Window nV**

- Nonferrous int. saddle bars, all good condition.
- Displaced masonry and missing mortar at west jamb, cracks to int. and ext. mullions and sills associated with structural movement
  - structural movement in north aisle was stabilised in 2025.
- Lightly dirty both faces.

- *Clean quarries in situ.*
- *Local repointing of upper west jamb and sills as required.*

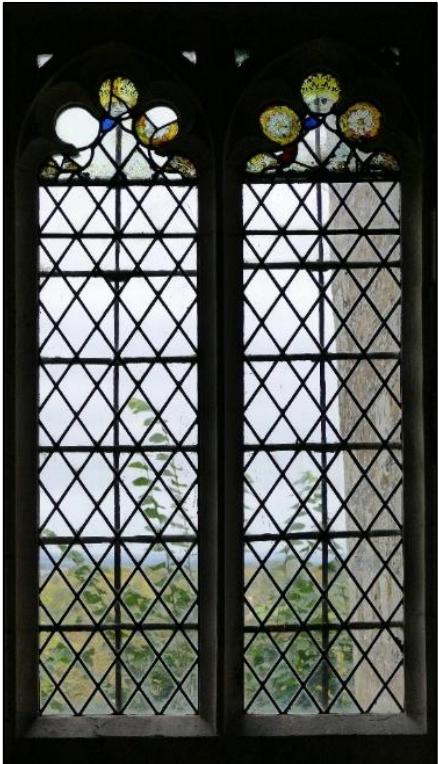
### **Window nVI**

- Rusty and expanded ext. ferramenta, associated spalls to ext. jambs and mullions (some repaired), and cracks to glass.
- Glass missing from easternmost eyelet above light b. Mortar missing in adjacent eyelet.
- Lightly dirty both faces, accumulated debris behind top lug bar.

- *Deinstall ferramenta, tip in ss, shot blast, prime and decorate bars and stanchions. Reinstall ferramenta, repoint and repair bar pockets with gauged hydraulic lime mortar.*

- *Clean quarries in situ.*
- *Replace missing glass in eyelet with matching tint, local repointing of eyelet with missing mortar.*
- *Supply and fit ext. ss wire guards to historic glazed heads as other windows, secure with ss fixings.*

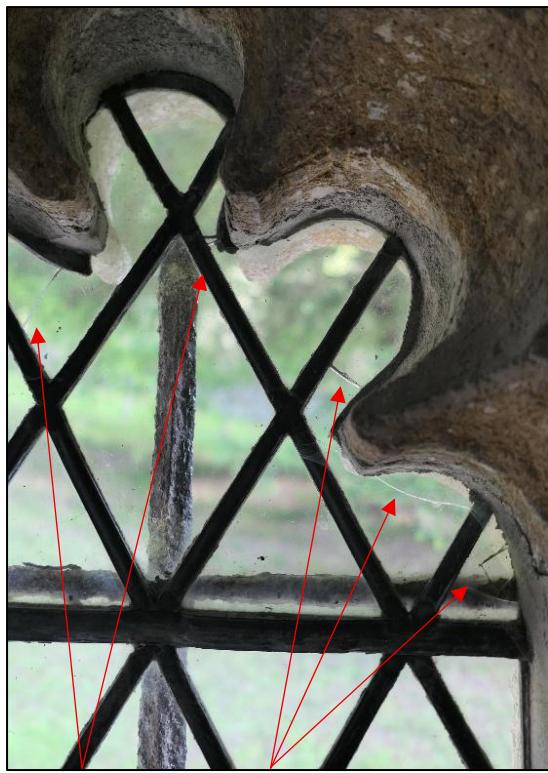
*Fig.1 – cracked glass at the cusps, window sII, interior, light b*

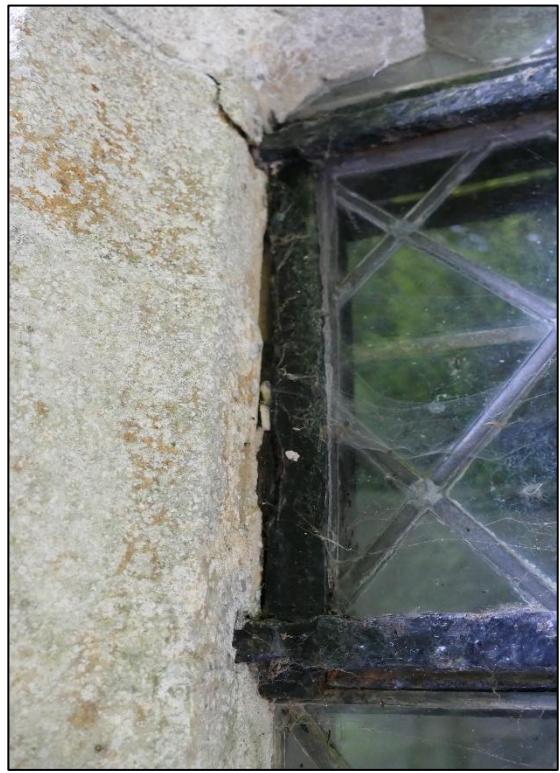
*Fig.2 – Masonry joint cracked from inside through to outside due to rusting casement, window sIII, exterior a/b*

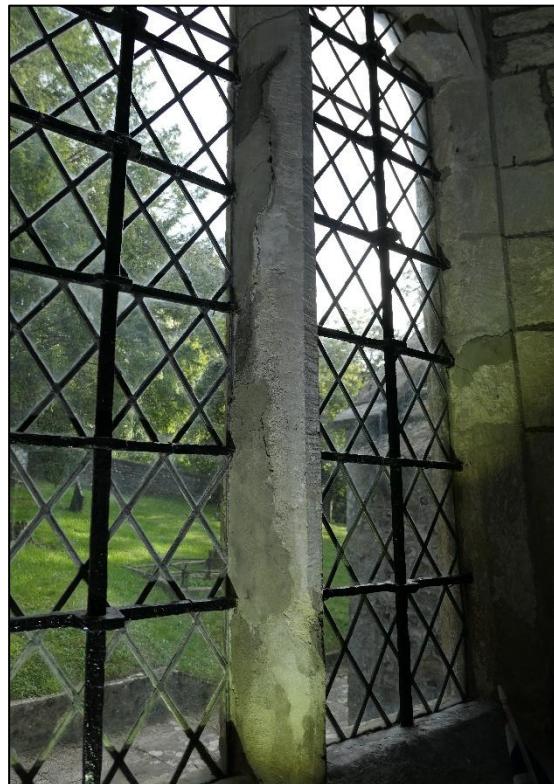
*Fig.3 – Several failed mortar repairs to spalled mullion, window sIV, interior.*

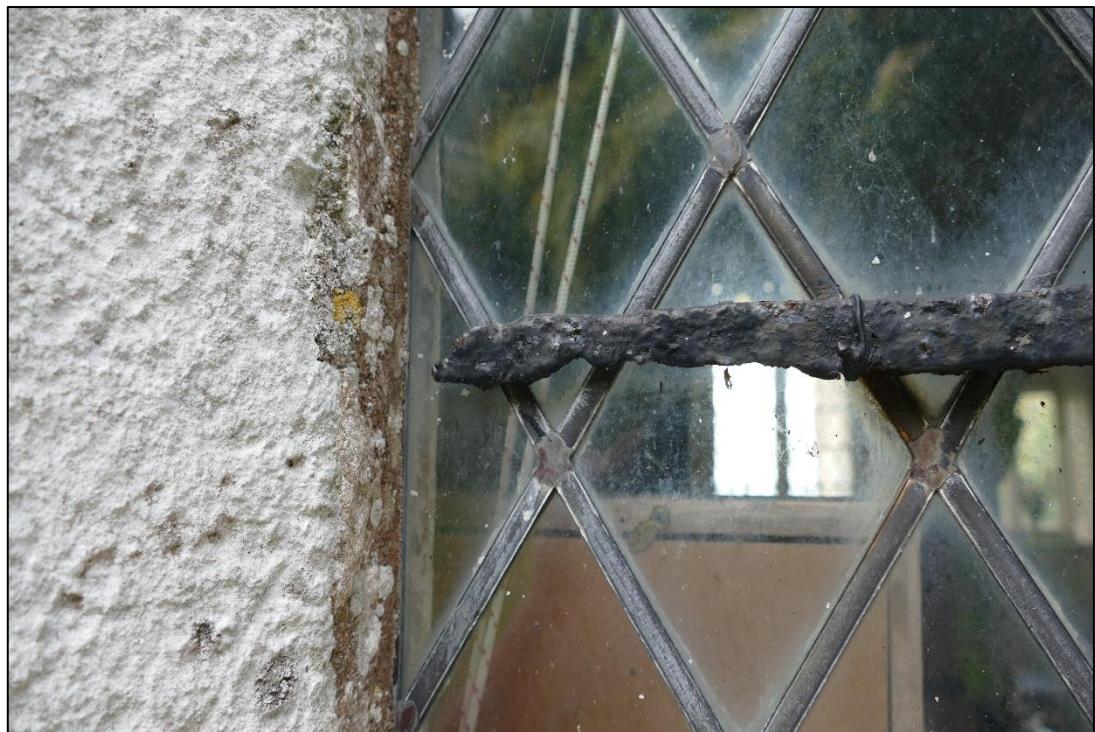
*Fig.4 – Medieval lug bar tip completely rusted through and lost, window sV, exterior.*

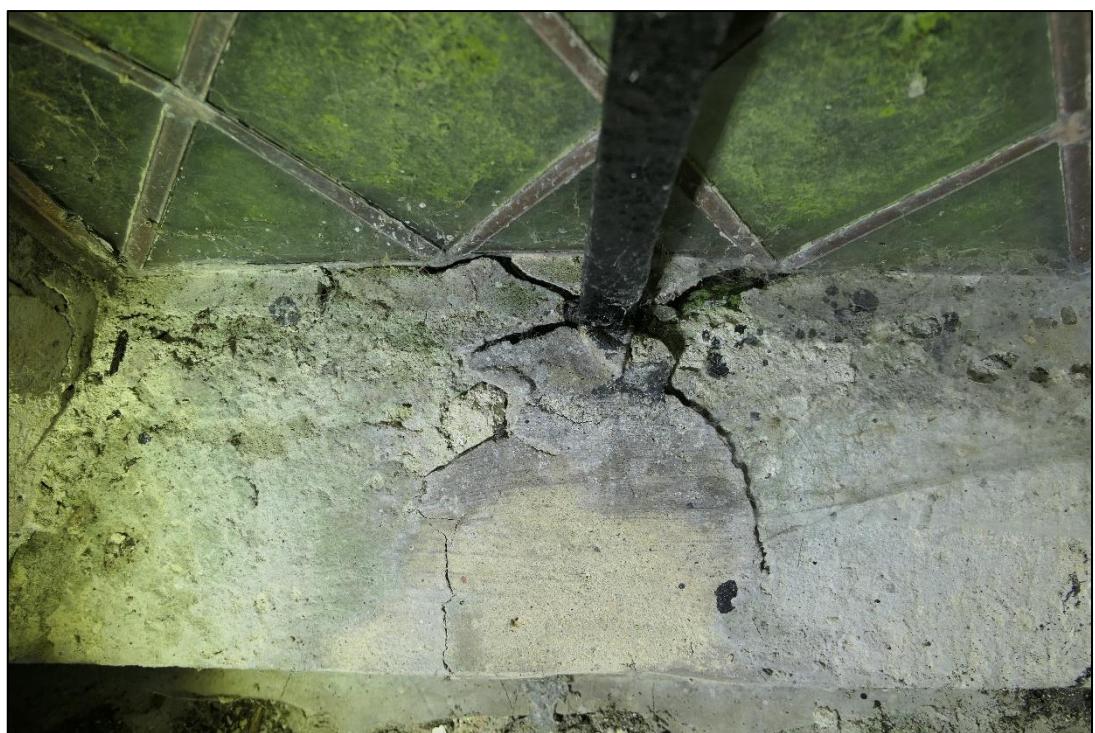
*Fig.5 – Rusted and expanded stanchion now jacking open the sill. Thick green layers of algae on both faces of the glass, window wI, interior.*

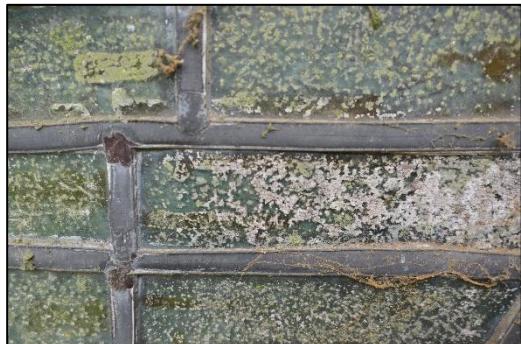
Fig.6 - Dirt and corrosion products collected in surface pits, ext. of B1

There is a single hairline crack running part way though the roundel in C2. Dirt within the crack and lichen growing over it suggests it is stable and has been there for many years without progressing. All of the medieval glass exhibits moderate pitted corrosion on both faces – see Glass Corrosion in Appendix 1. The pits have collected dirt, water and algae/lichen which appear as dark patches from a distance. White opaque corrosion products are also present, further reducing the transparency of the glass in some areas (fig.6).

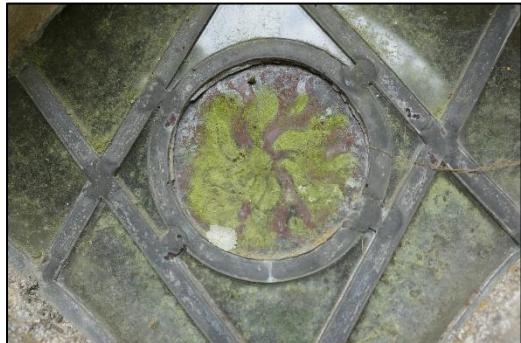
Fig. 7 - Thick, obscuring and potentially damaging layer of algae on glass, ext. of C1

The roundel in C1 is inverted so the painted surface faces the exterior and is covered in algae (fig.7). Since algae requires water to survive, its presence indicates regular wetting of the surfaces which is contributing to the ongoing deterioration of both the paint and glass. The paint is in poor condition overall across the three panels with C2 the worst affected, having lost 95% of paint from the interior face. As well as general fading through age and repeated washing from condensation cycles, corrosion pits forming beneath the paint have caused it to flake off in many places.

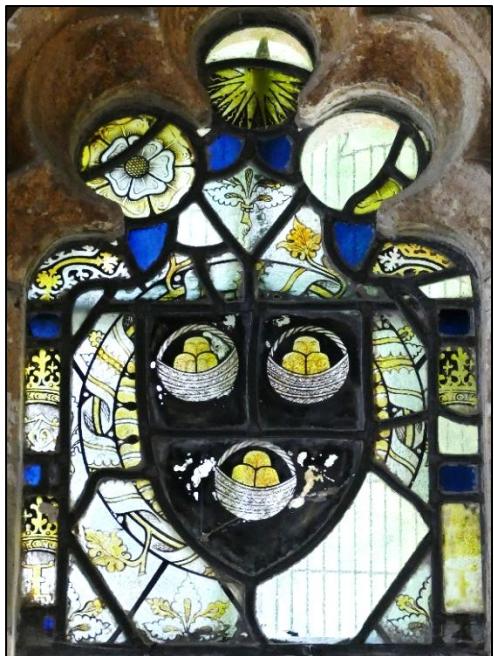
Panel 2b

There is a crack in the glass in the bottom section of the shield. Surface deposits along the crack on the inside face may be remains of a previous strap lead repair but appear more likely the result of rain water washing corrosion products through the crack. There is mild to moderate pitted glass corrosion on the exterior of all of the medieval glass with opaque white corrosion products inside the pits. There is very little dirt or microbial growth on the glass surfaces, so the transparency of the glass and legibility of the detail remains good.

The paint is in a reasonable condition with only one border piece containing the letter I/J exhibiting severe loss from the inside face. Some areas of the dense black matte on the shield have come away in large flakes, and the back painting has corroded along with the glass surface due to environmental exposure (fig.9). Otherwise, the paint is well retained and legible.

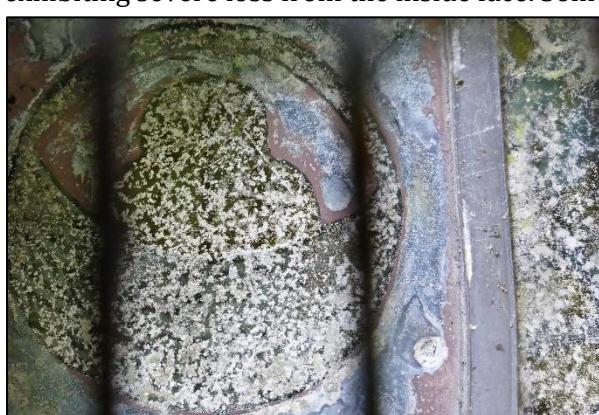
Fig.9 - Corroded back painting and pitted glass surface with white corrosion products, ext. of escutcheon, 2b.

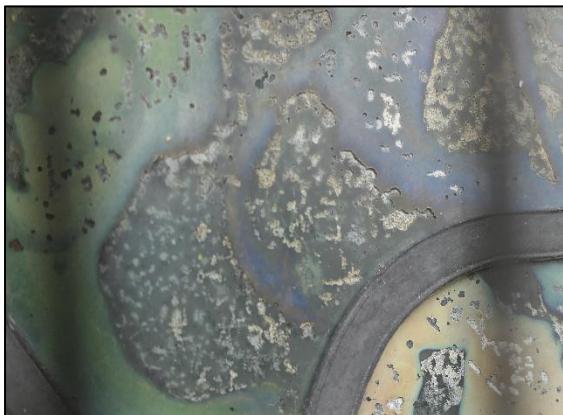
Fig.10 – Corrosion pits conjoining causing areas of surface loss, ext. of panel 1a.

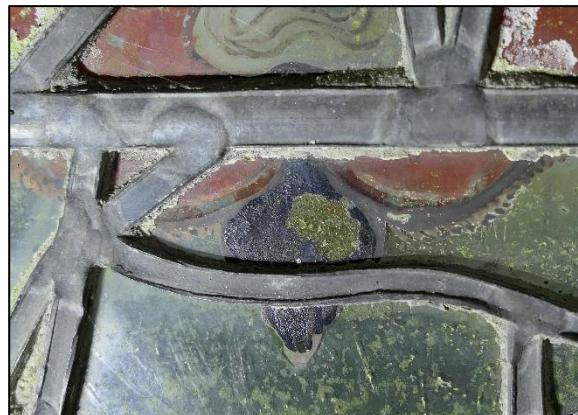
Fig.11 – Blue enamel on rose leaf (silver stain on reverse to make green colour) flaked away and damaged glass surface beneath, int. panel 1b.

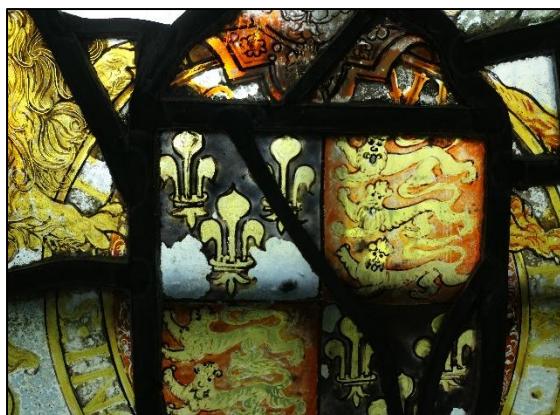
Fig.12 – Blue enamels now grey due to chemical leaching/alteration, int. 1a.

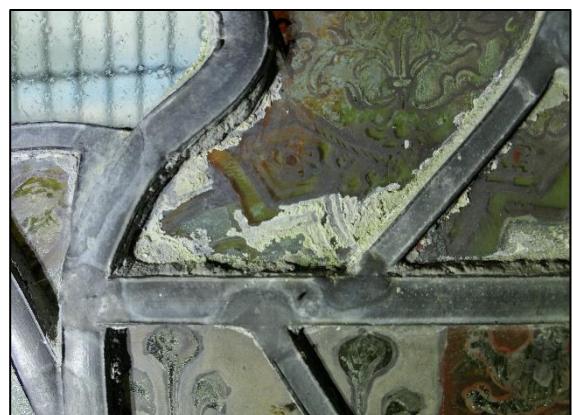
The lead is modern, as in the other windows, and in good condition except for some chalky crusts on the inside face leached from the leaded light cement (fig.13).

Fig.13 – Calcium carbonate deposits on glass leached from leaded-light cement under lead flanges, int. 1a.

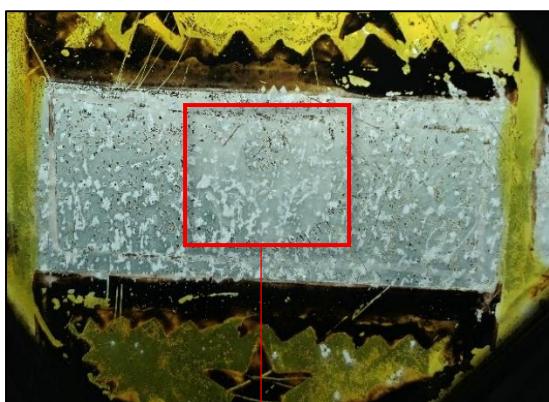
Fig.14 – Faint crescent shaped surface alteration where glass paint has been lost, int. 1a.

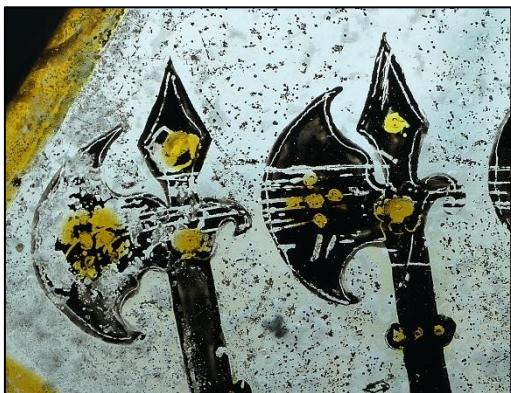
Fig.15 – Scratched and flaking glass paint on pitted interior surface, int. 1c.

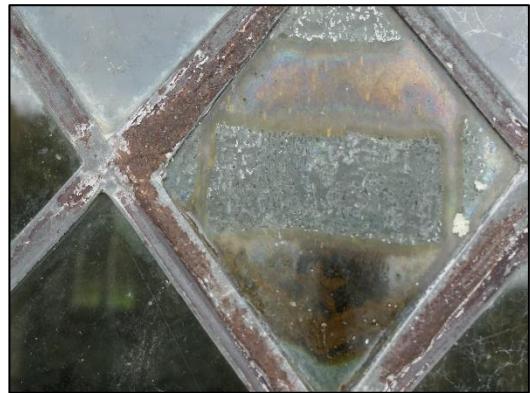
Fig.16 – Reddish corrosion products on ext. lead cames, ext. 1a.

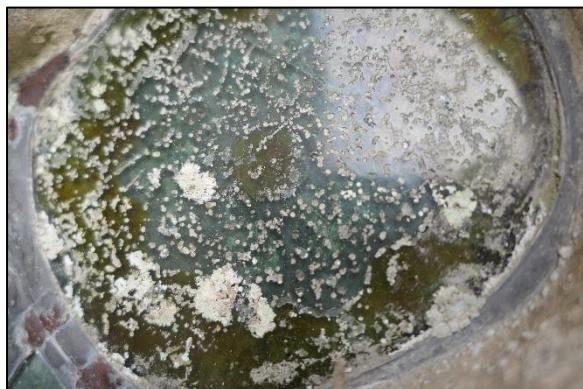
Fig.17 – Pitted exterior surface of lobe in 2b, dirt, corrosion products and lichen colonies.

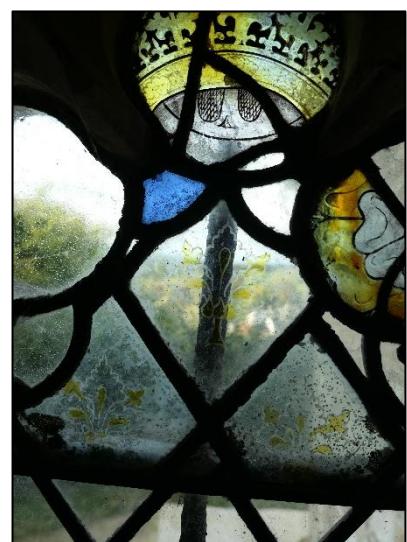
Fig.18 – Faded and lost glass paint on painted quarries, int. face, 2a.
