Bianca Madden MSc ACR  
Conservator of Wall Painting and Polychromy  
The Garden Flat 5 Rawlinson Road Oxford OX2 6UE  
07789067364/01865 513144 bianca@biancamadden.com  
www.biancamadden.com

Conservation Condition Assessment and Proposed Treatment Strategy  
12 Apostle Wall Paintings, St Paul's Church, Whiteshill, Stroud, Glos

March 2026

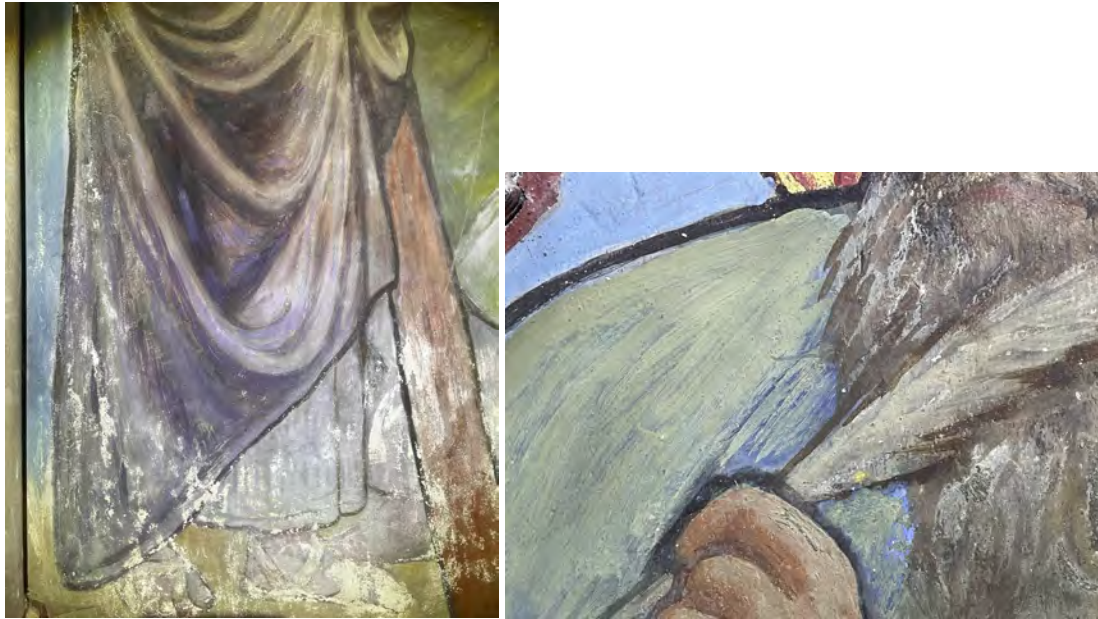
At least one phase of previous retouching is evident on the 12 Apostle paintings, most noticeably on the lower and mid sections, where the water-related damage is most severe. This includes re-outlining elements and repainting areas of the drapery - with more extensive work on individual figures. For example, the figure of St Bartholomew (third arch from the left: Ss Bartholomew and Philip, just before the central three blue-painted panels) shows considerable retouching, particularly on the feet and drapery. The panel following the central three, Ss Matthew and Thomas, displays substantial intervention, with the proper right side of St Matthew heavily retouched and extensive outlining of St Thomas. In the final panel of the six, Ss Simon and Matthias have had retouching/repainting of the drapery, as well as details on the lower part of the painting, including the feet and dice. There is also evidence of repainting of the blue backgrounds on the upper areas of several of the paintings. The colour closely matches that used on the central panels, suggesting this work may date from a single phase of retouching/redecoration rather than two distinct interventions.

*Repainting on the drapery of St Peter, left (fluorescing slightly purple in UV) re-outlining also visible. Right, retouching on St Matthew, as well as on the blue background (top left of photo)*

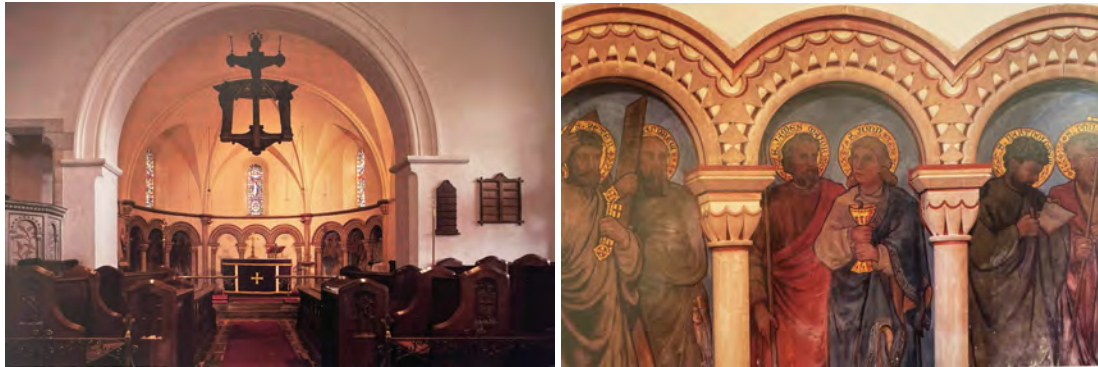
paintings) or it may have been due to an aesthetic choice, to simplify the earlier scheme. The subsequent boarding of these arches can be assumed to be almost certainly due to their, by then, compromised condition. Parish research is ongoing to identify additional archival images or recollections that might clarify when the boarding was installed and when the blue painting was carried out. Establishing the timing of these interventions will help to understand how long water ingress and deterioration have affected all the panels, and when the three central panels, now the most severely damaged, were considered beyond repair.<sup>4</sup>

*The apse as it appeared in 2011, with the central panels boarded over, left, and right, detail of the left-hand/north group of paintings. Images taken from the 2011 PCC publication on the church*

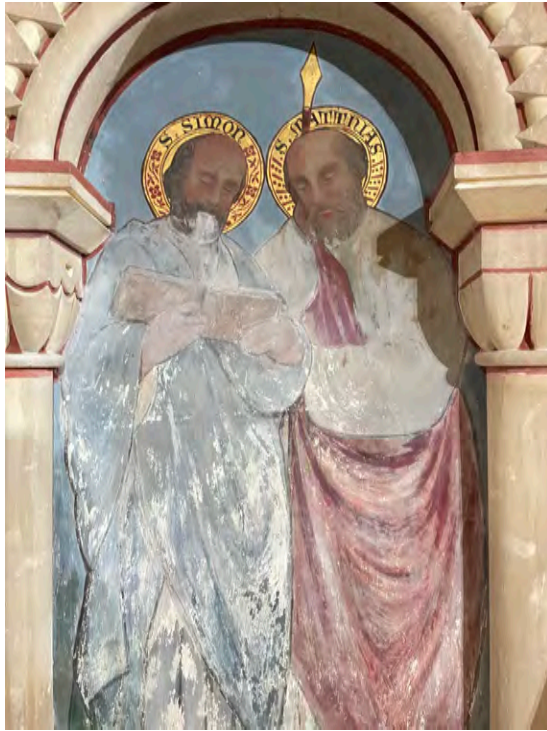
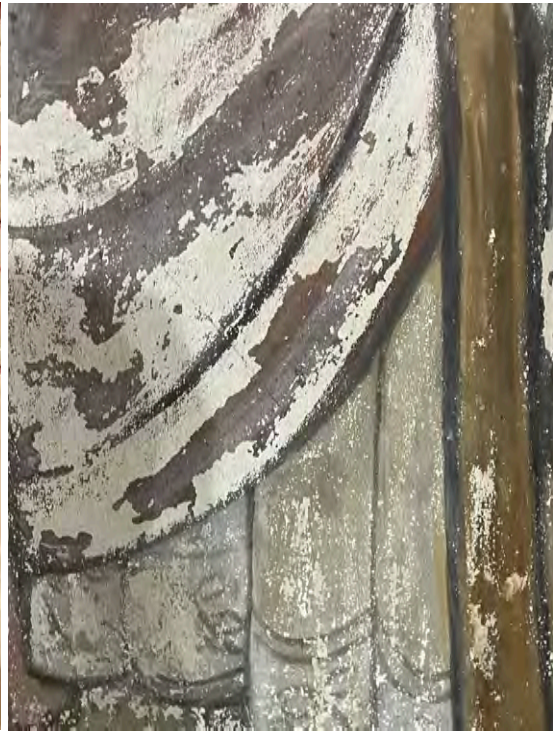
Overall, the wall paintings show widespread deterioration associated with moisture ingress and the movement of soluble salts within the masonry and plaster. The most visible effects include surface blooming, powdering, flaking, and loss of the paint layer, as well as areas of detachment within the underlying plaster. These conditions are most pronounced from mid-height to the lower parts of the paintings, where the paint layer is particularly affected. In several panels, the feet and lower parts of the garments have deteriorated substantially, and the plaster substrate is detached or hollow-sounding in places, especially towards the base of the walls.

*Blooming, powdering and flaking paint Ss Simon and Matthias, left, and severe flaking and powdering on the garments of St Thaddaeus, right*

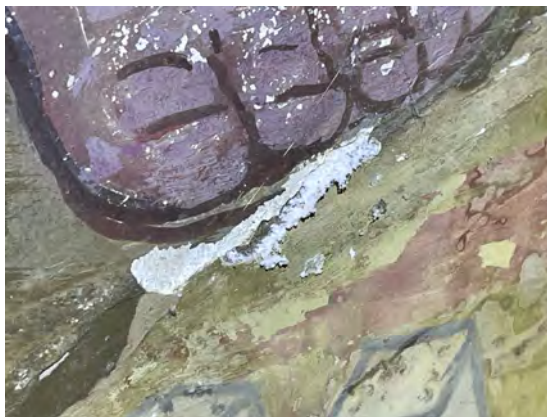
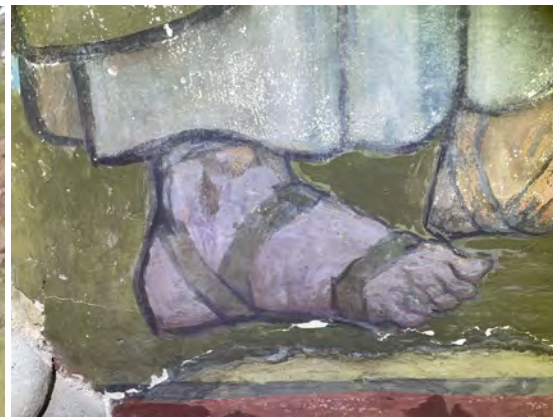
*Visible salt efflorescence, Ss Simon and Matthias, left, and right, paint flaking along the lines of a plaster detachment – as well as powdering paint, relining and retouching – Ss Bartholomew and Philip*

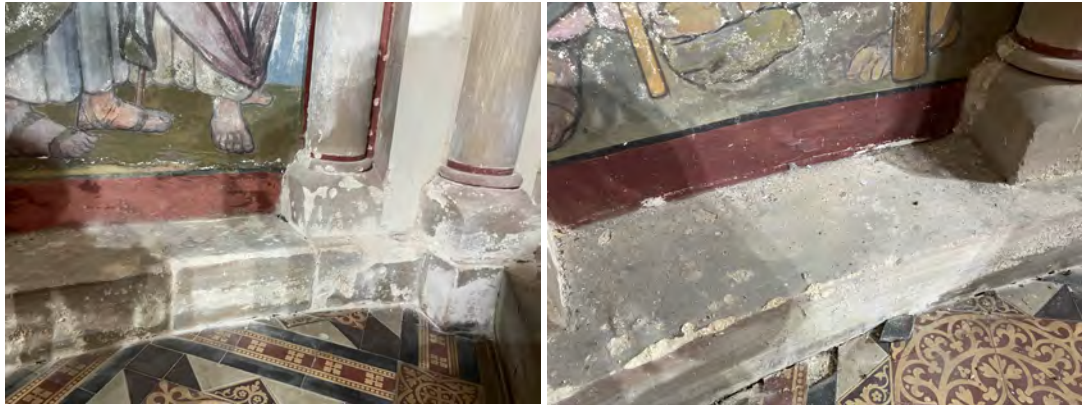
The carved stonework of the arches and columns framing the paintings also show evidence of moisture-related deterioration, including powdering and localised spalling at lower levels. This is particularly noticeable in the columns adjacent to the paintings of Ss Peter and Andrew and Ss Bartholomew and Philip.

*Detail of the condition of the surrounding stone, Ss Bartholomew and Philip, left. Right, spalling surrounding stonework, Ss James Major and Thaddaeus, as well as fragments of the painted surface on the stone step*

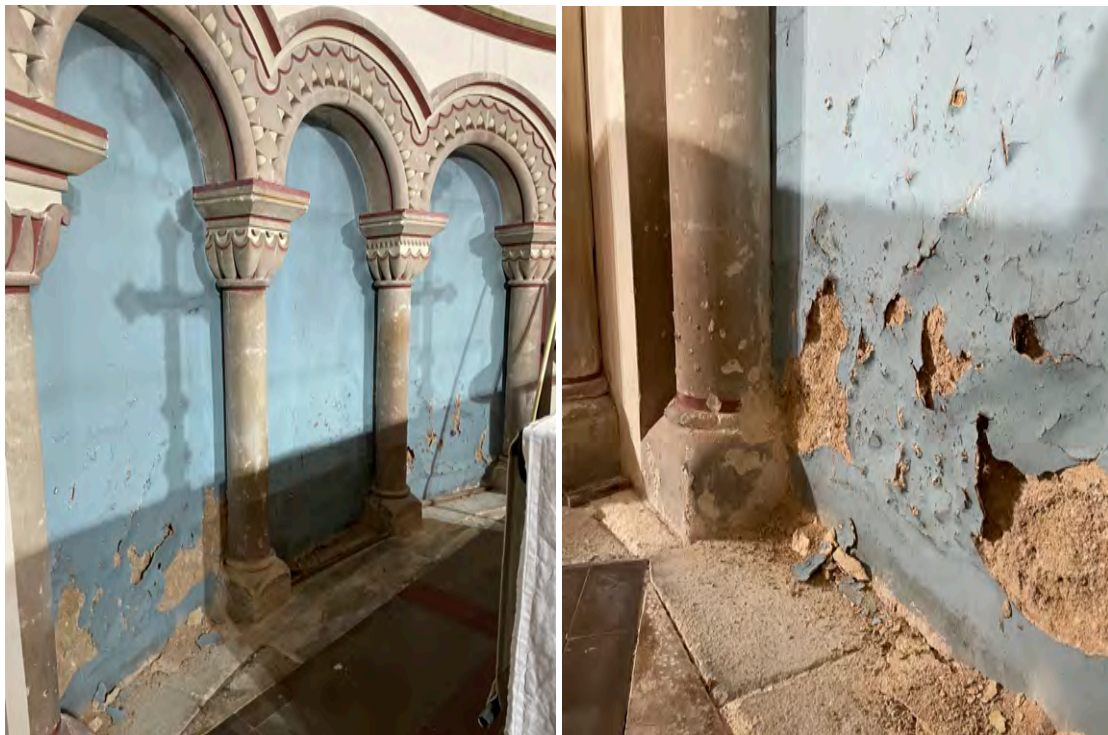
The three, blue painted, central panels behind the altar, display the most severe deterioration. From approximately mid-height downwards, the plaster is extensively detached, blown, and locally lost, with quantities of fallen material visible at the base of the walls. In some areas, the plaster appears to be held in place largely by the modern paint layer. Traces of the earlier polychromy are visible beneath lifted or detached sections of the blue coating, including exposed areas of yellow ochre, red, and gilding.

*Overview of the blue painted panels, left, and right, detail of the condition of the first of these panels*

The blue paint, likely applied to cover extensive existing damage from water ingress and salt activity, may have inadvertently contributed to the deterioration: being relatively impermeable to water vapour, it may have trapped moisture and salts behind the surface, promoting eventual detachment and loss of plaster.

The three central panels behind the altar are in poor condition, with extensive plaster detachment and a modern blue overpaint. The primary aim of treatment will be to stabilise the plaster substrate and prevent further loss of original material. Options for future surface treatment will be discussed in consultation with the parish.

- **Plaster consolidation:** Detached, hollow, or blowing plaster will be secured to the substrate using lime-based grout with hydraulic additives (e.g., Rhinish Trass) to form a stabilising bridge.

- **Plaster repairs:** Areas of loss, vulnerable edges and cracks will be filled or supported using lime mortar - lime putty and fine aggregate (sharp sand 1:3), with fine surface fills applied where required using a fine surface mortar - marble dust and lime putty (3:1).

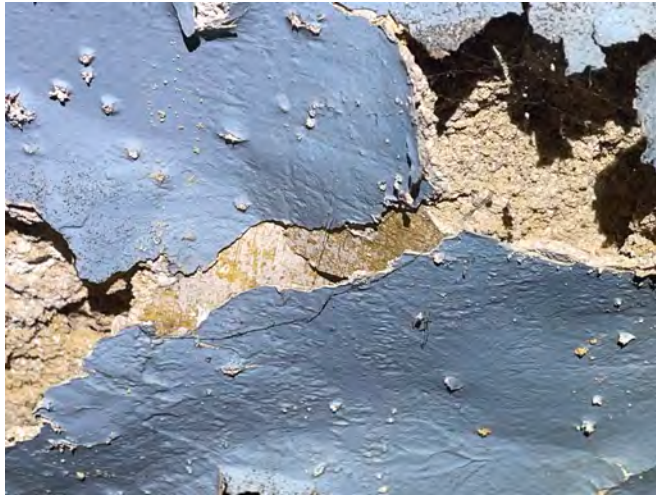
*Traces of yellow ochre painting, visible beneath the blue layer*

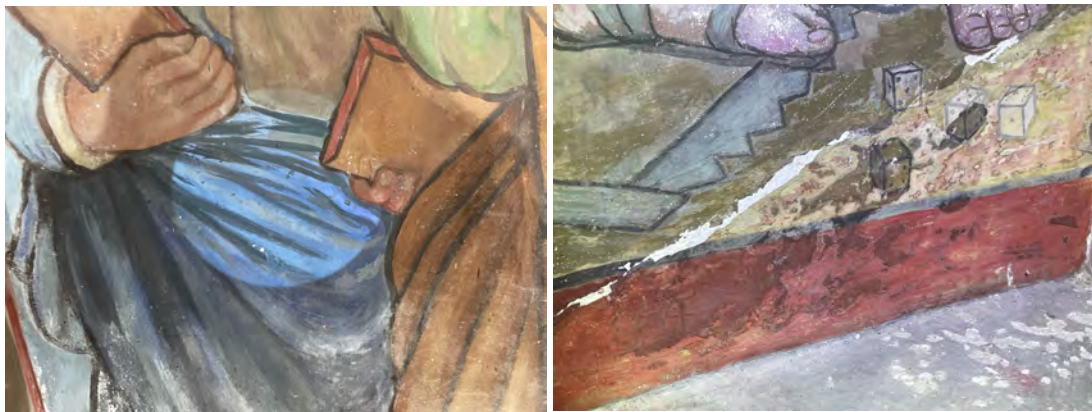
There is clear evidence of at least one previous campaign of retouching on the surviving figurative wall paintings (see **5. Previous Interventions: Wall Paintings**). This is most visible in the reinforcement of outlines, repainting/retouching of drapery, and repainting in lower areas, where deterioration has been greatest. The extent of this intervention varies between panels but is particularly noticeable in the paintings of Ss Matthew and Thomas and Ss Simon and Matthias. While in several panels, the upper blue background also appears to have been repainted, possibly during the same phase of intervention (see **5.**). Additional localised damage includes minor cracks, surface abrasions, and small losses, as well as splash marks on the panels next to a stand with a lighter, which are likely the result of candle wax.

*Details of retouching (highlighted in UV) on St Matthew left, and right retouching and relining, lower part of Ss Simon and Matthias*

- **Treatment of previous retouching:** Areas of previous retouching which are visually intrusive will be adjusted or reduced where this can be safely undertaken without risk to the original materials.

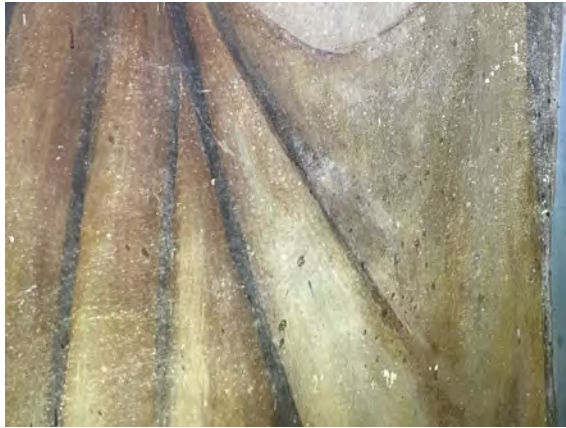
*Splash marks, possibly candle wax, on the drapery of St Thomas*
