## Danby Wiske - Diocese of Leeds

### Recently revealed wall paintings – Preliminary report

Peter Martindale – 6 May 2026

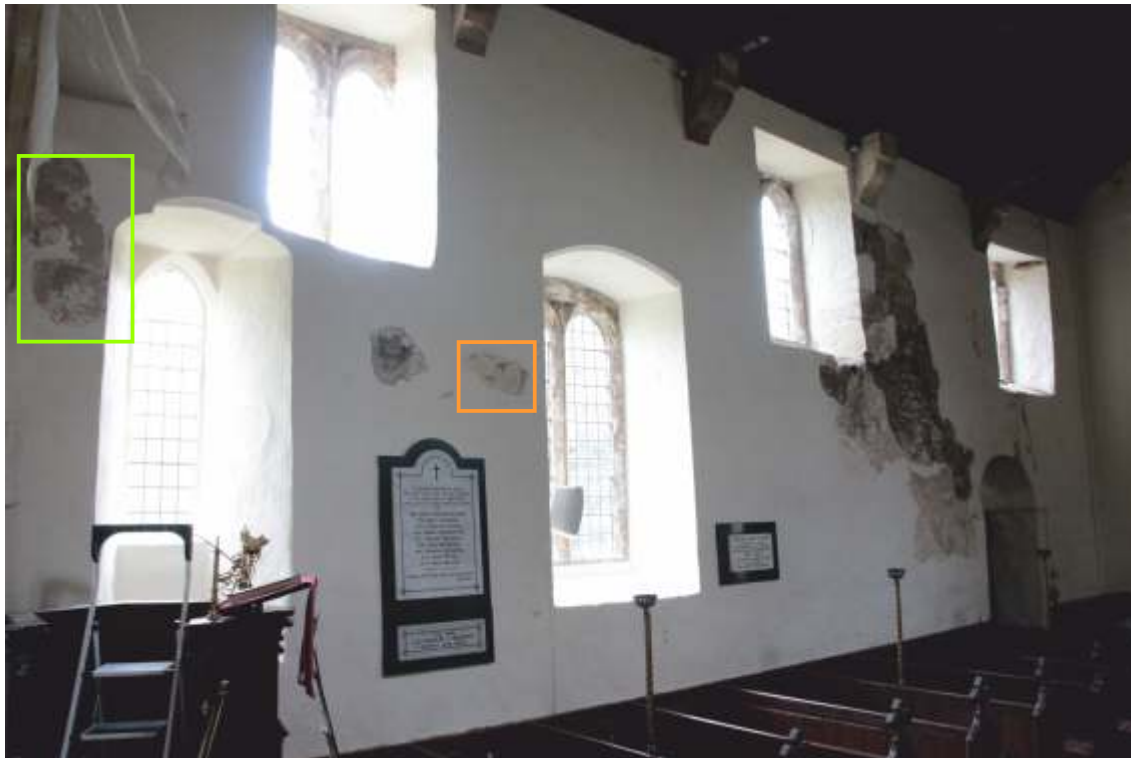
2 - Below - South nave wall looking west. Areas of wall painting studied in this report identified as follows - green rectangle area 'a' - orange rectangle area 'b'.

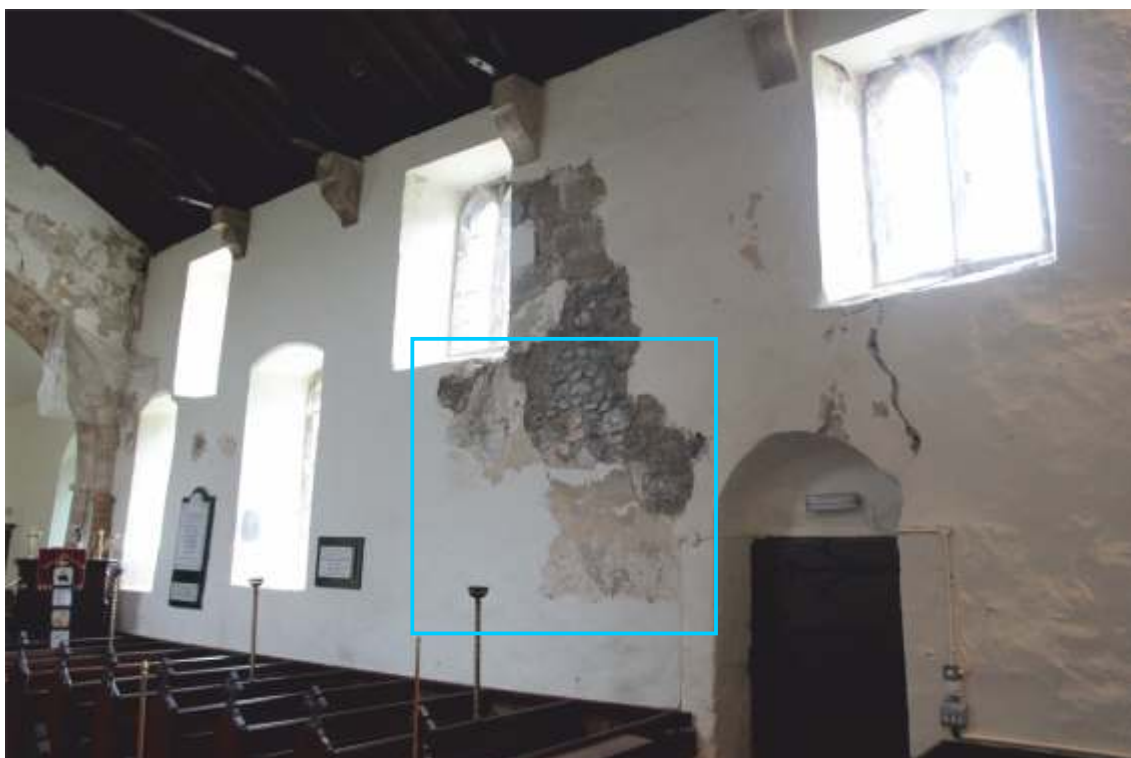
3 - Bottom - South nave wall looking east. Area 'c' of wall painting described in this report identified with blue rectangle.

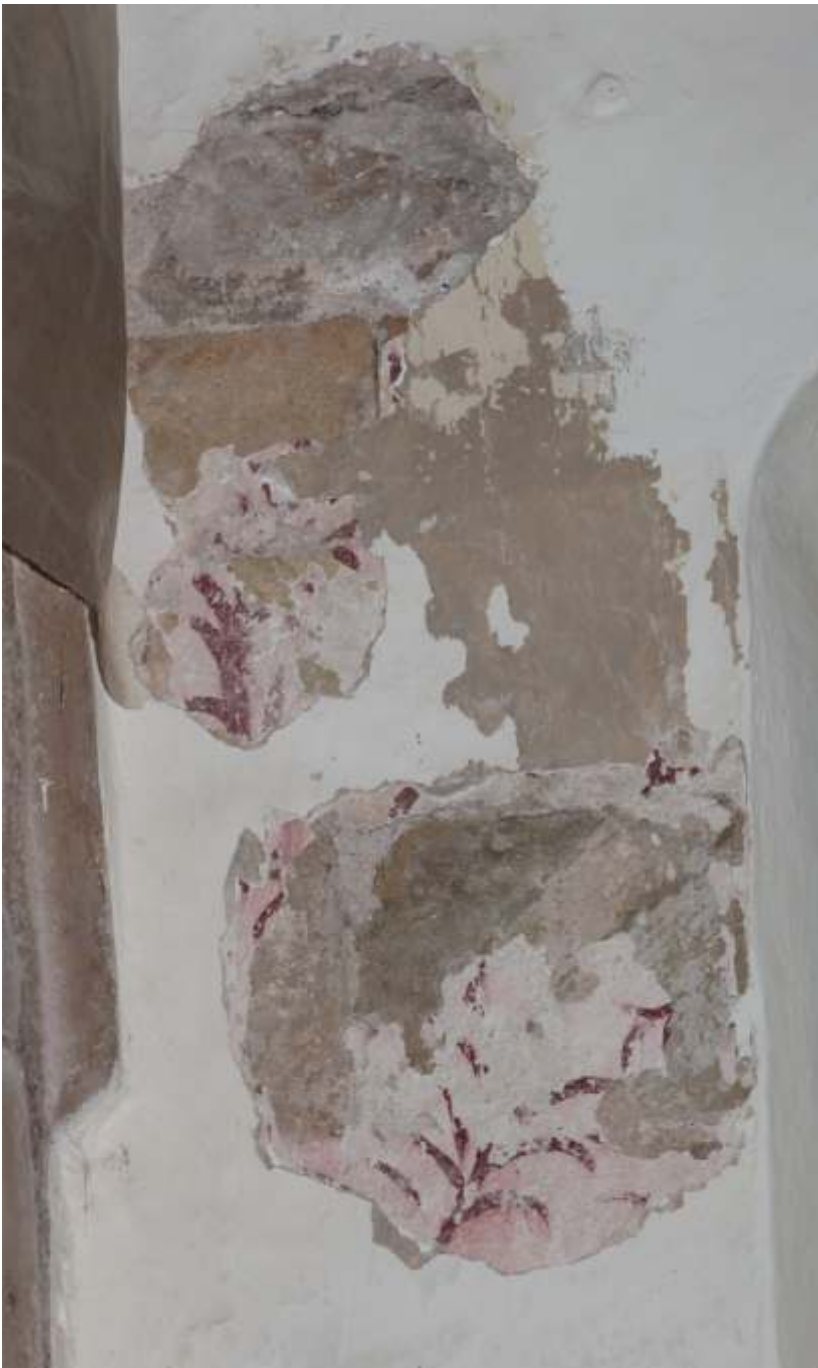
It comprises red paint on a lime ground (appearing pinkish). Foliate forms are described by the red paint, and what has been revealed is (in this area) the first layer of decoration. The decorative layer appears to extend into the window splay, under later layers of paint.

The condition of what has been revealed is, fair, but there are fragile areas of detached lime ground and paint flaking. The edges of the islands of paint are vulnerable.

4 - Left - Area 'a'. Medieval painting which appears to be the first layer of painted decoration layer applied to the interior building fabric. The medieval paint layer may extend into the adjoining window reveal.

All areas of revealed wall painting, whose condition is fragile (detached plaster, flaking paint and vulnerable edges of painted plaster) need to be consolidated. The measures carried out need to be documented in an illustrated report.

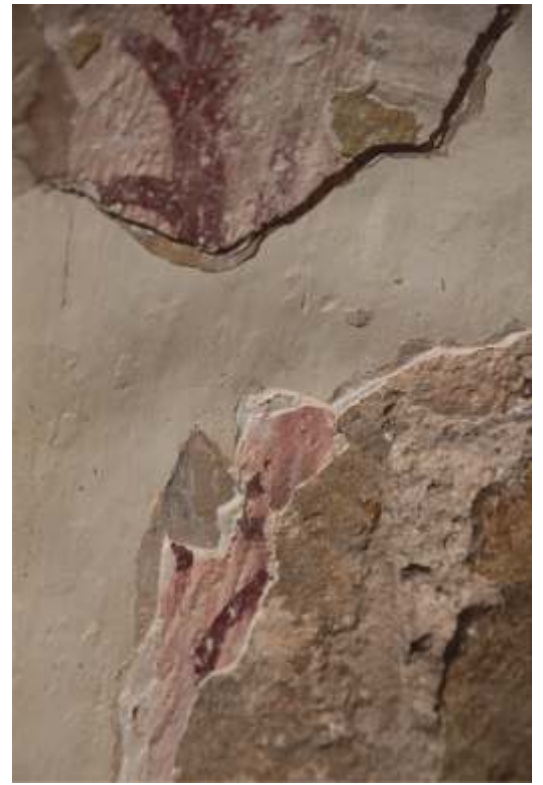
5 - Above - Photo in raking light showing the paint and ground layers. The medieval paint has been painted over a number of times.

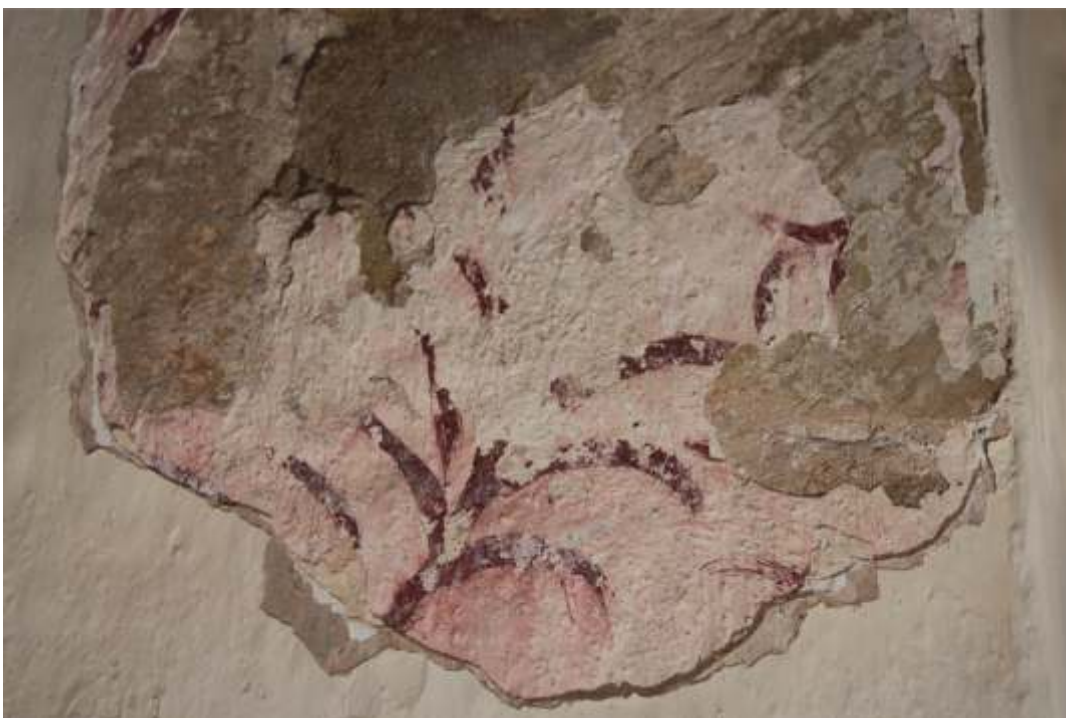
6 - Below - Detail from 4 showing areas of paint flaking and detachment of the lime ground.

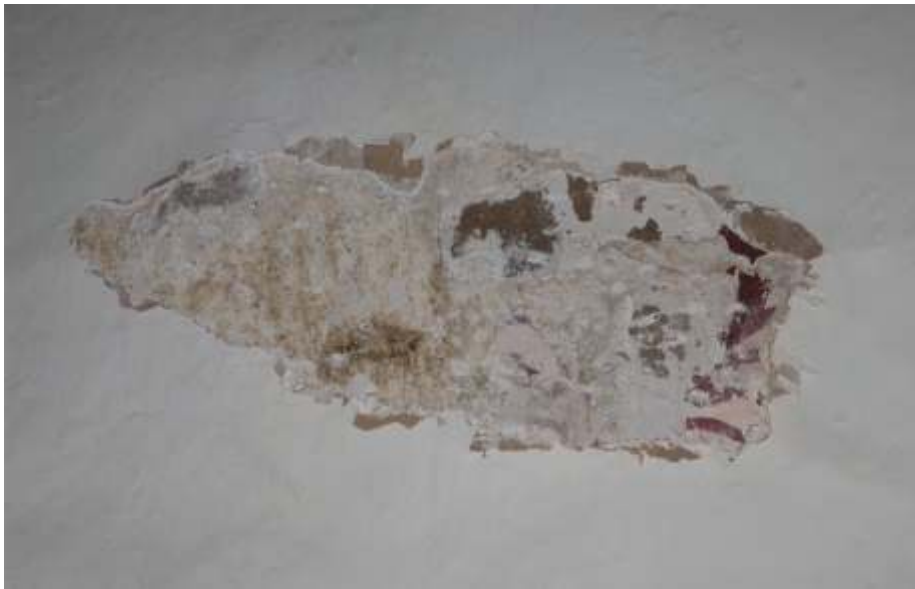
This area was studied at a distance only. Traces of red paint can be seen, and their appearance appears identical to the more extensive traces of wall painting described in 'a' above. The condition of the paint and plaster has not been inspected at close hand. The area revealed is around 50 cm wide. Photo 7.

7 - Left - Area 'b' of paint believed to be medieval and similar if not identical to that in area 'a'.

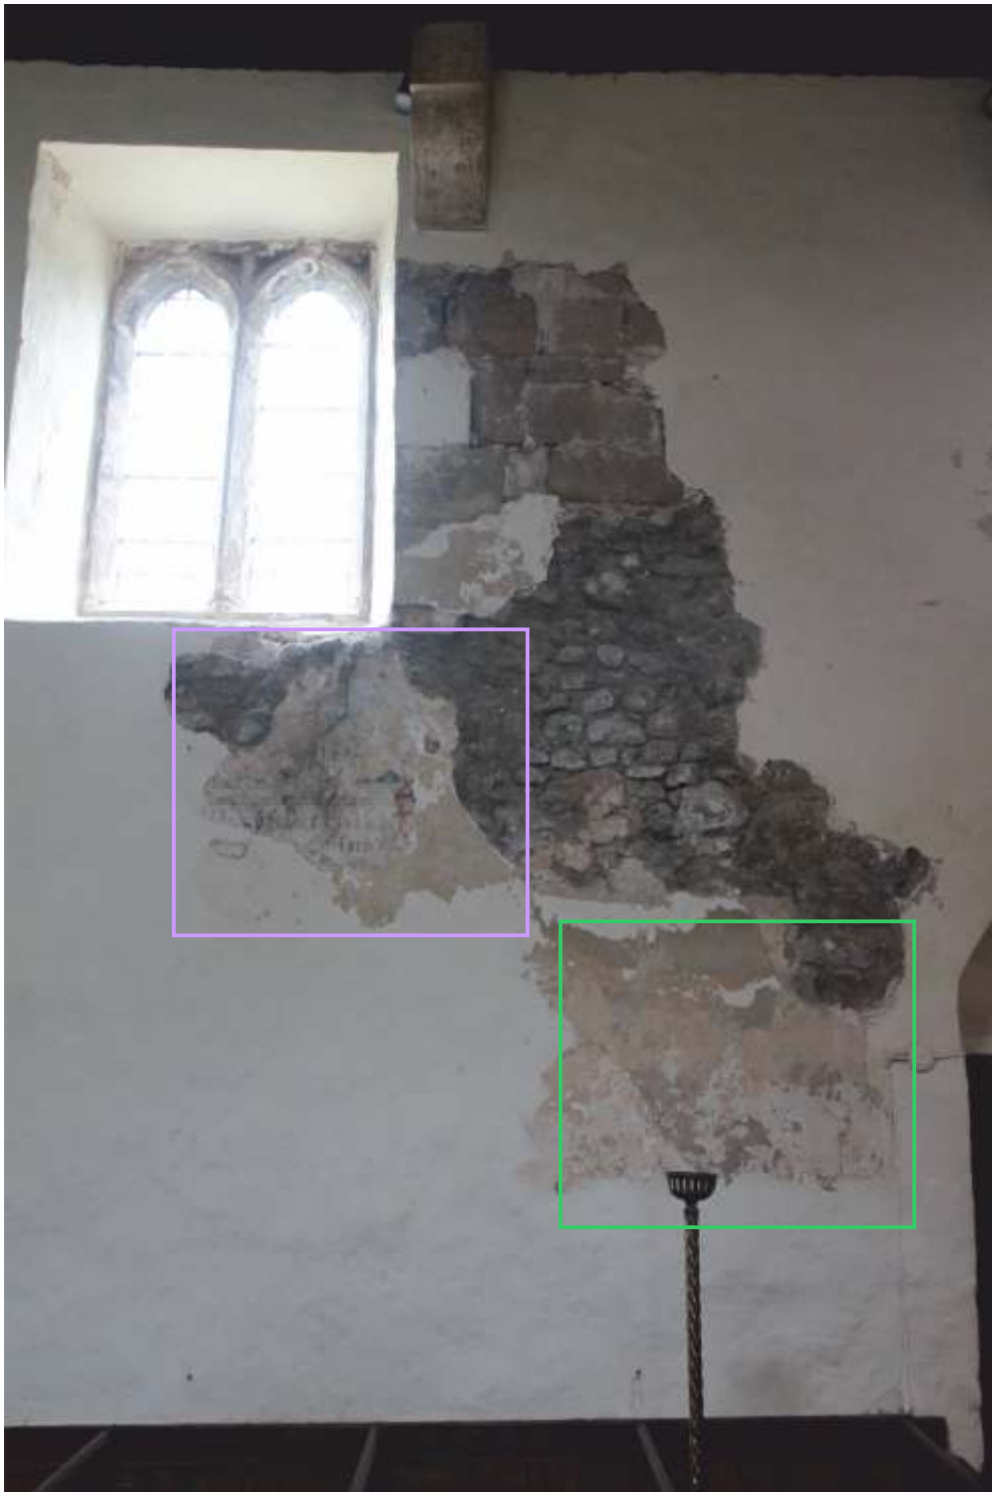
8 - Below - Area 'c' and fabric around area 'c'.

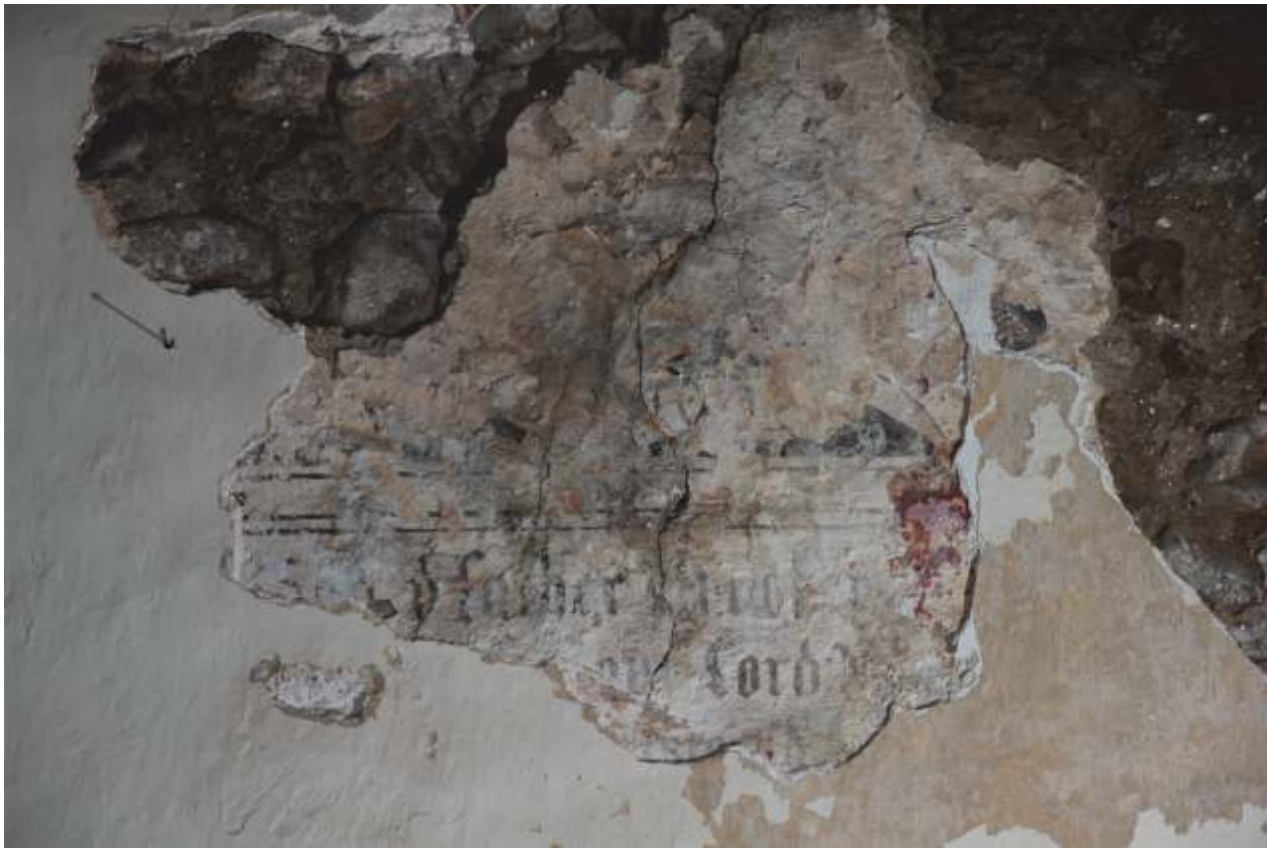
- Red medieval paint believed to be coeval to that in 'a' and 'b' above.
- Some lettering from a post-Reformation text, and a border to that text above. That border above appears to comprise elements from two styles of border; a simpler one, and another with elements of bead and reel decoration. Closer examination is needed to check that there are indeed two separate text borders as appears to be the case.

9 - Above - Detail from 8 as indicated by mauve rectangle. Some lettering from a post-Reformation text is very evident, as is the decorative border above it. That border appears to be of two types, a more simple one, and a more ornate one with bead and reel decoration. This area needs closer inspection at a later date.

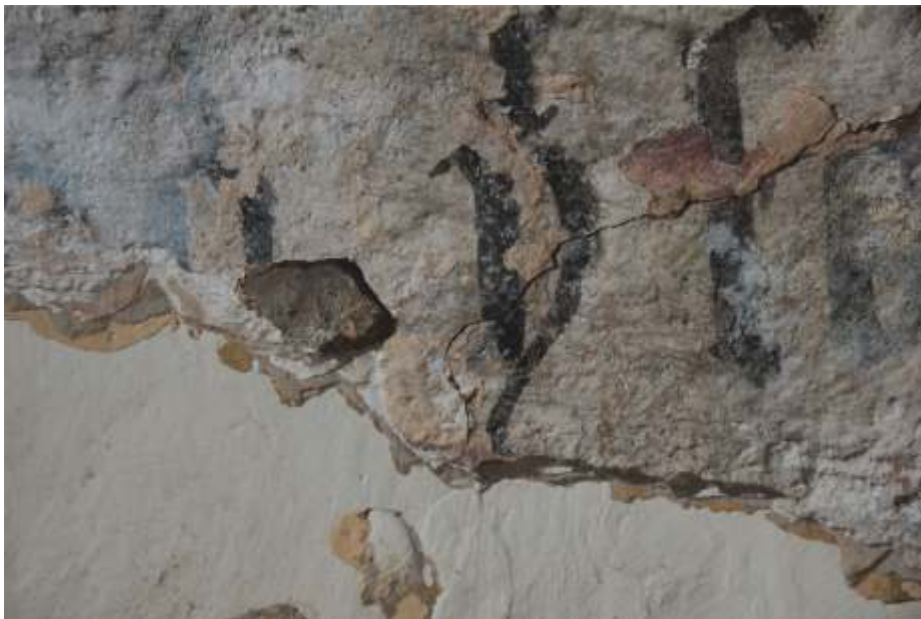
The condition of what has been revealed is better than anticipated upon first viewing. There are fragile areas of detached plaster and ground, and there are instances of paint flaking; there too are cracks in the plaster support, and the edges to islands of paint are vulnerable.

10 - Left - Detail from 9 showing an area of fragile wall painting. Here there is a loss, in which the underlying building fabric can be seen. A section of the letter 'f' is missing, and in that loss red paint from the underlying medieval paint can be seen.

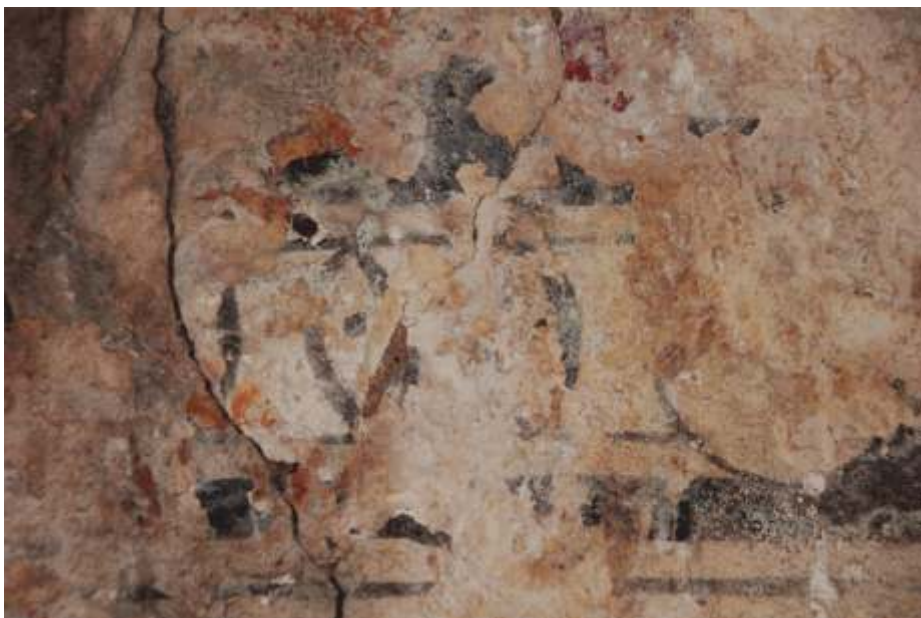
11 - Below left - Detail from 9 showing the decorative border to the painted text. There appear to be elements from two borders here, a simpler linear one and a more complex one involving bead and reel decoration. In places underlying medieval paint can be seen where there are losses in the post-Reformation layer(s).

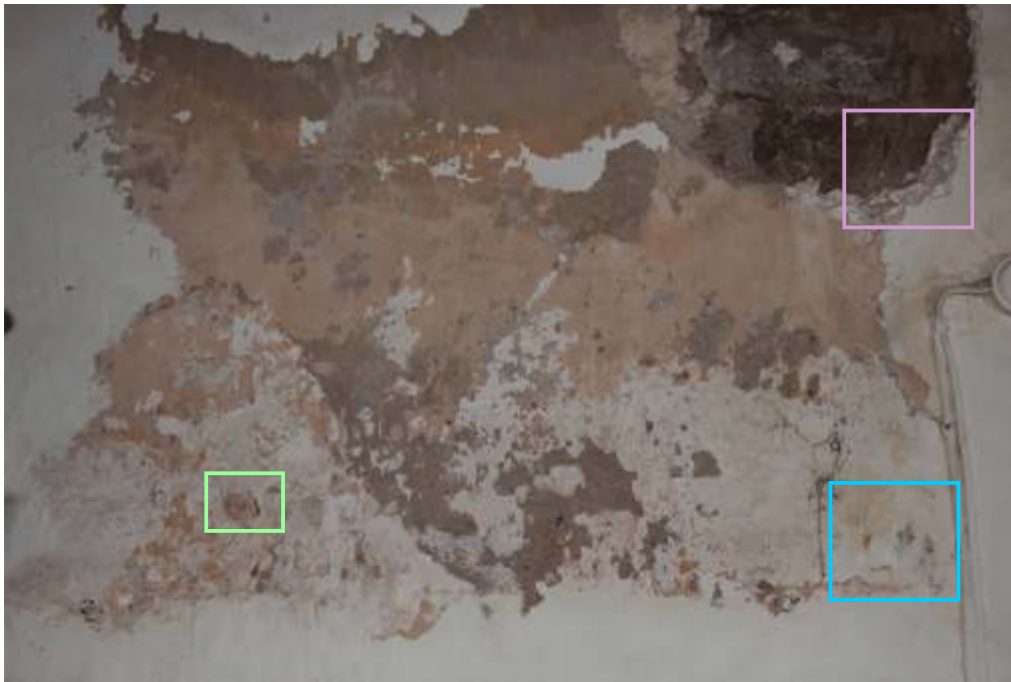
12 - Left - Detail from 8, the green rectangle. Here instances of wall painting can be seen.

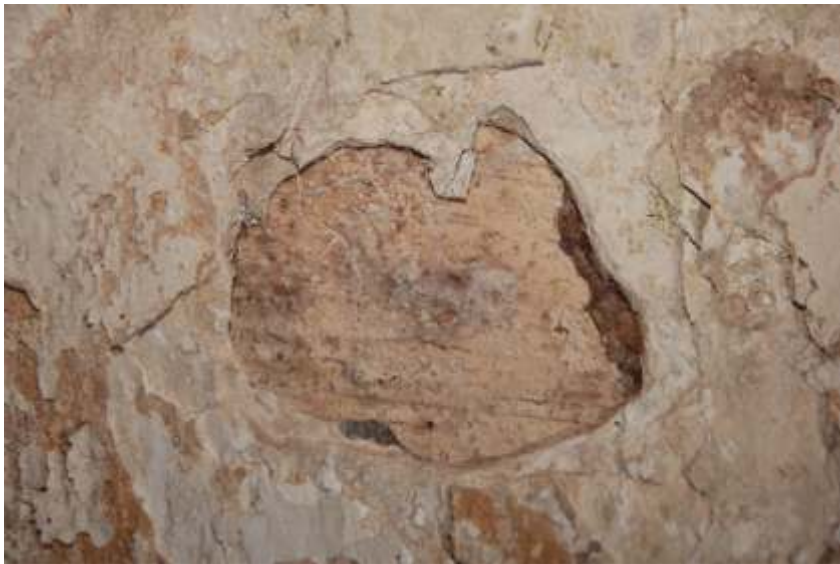
13 - Detail from 12, green rectangle. A loss in later paint layers reveals an earlier layer upon which traces of paint can be seen. Black at the bottom and dull yellow at right.

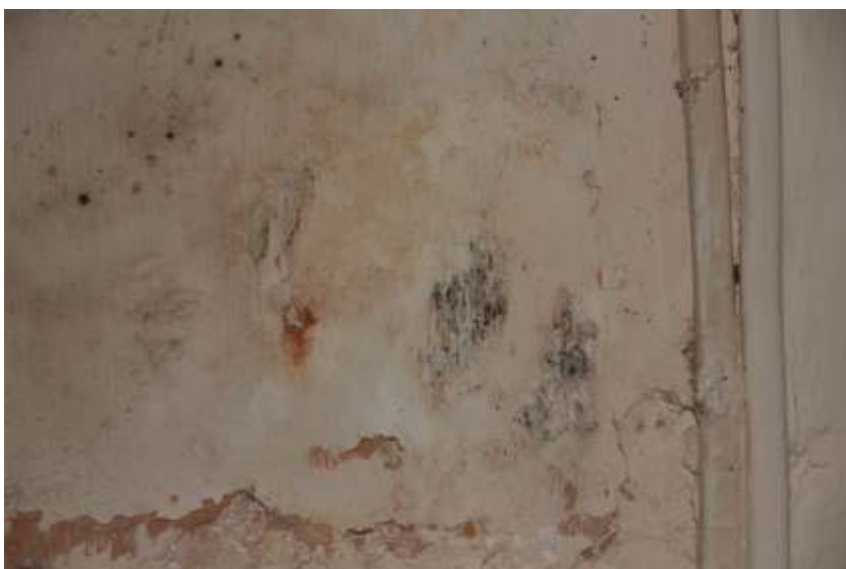
A small instance of abraded black paint was noted close to the south door. It could be a vestige of post-Reformation decoration, or it might be an anomaly.

14 - Detail from 12, blue rectangle. Abraded traces of black paint can be seen here, possibly post-Reformation, or an anomaly.

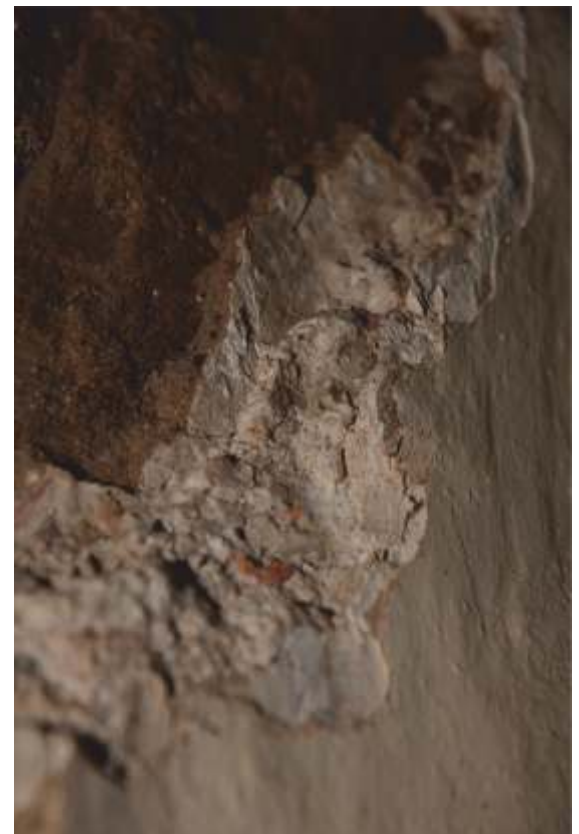
When viewing the edges to some losses it is possible to gain an appreciation of the number of paint and plaster layers that remain on the wall in some places, photo 15.

15 - Detail from 12, mauve rectangle. Looking slantwise at the side of the loss. Numerous paint and plaster layers can be seen, along with traces of early medieval paint.

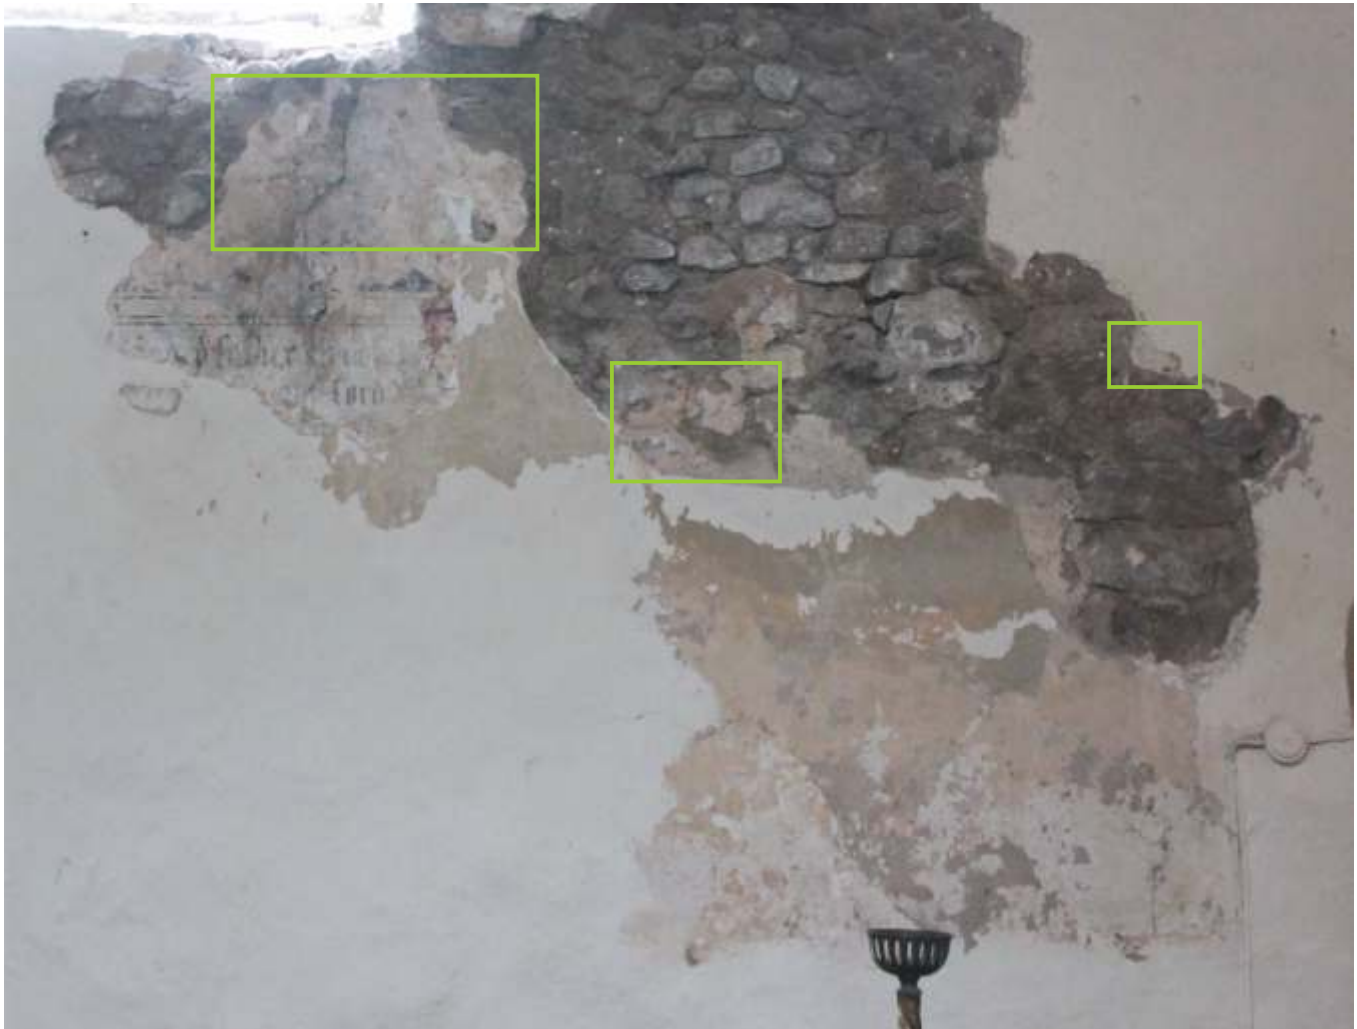
16 - Detail from 8. Within the green rectangles there are traces of wall painting. These are mostly red from the medieval scheme, but there is some later black (post-Reformation).
