st mary's church
cowley
gloucestershire

quinquennial inspection
report number 2

date March 2015

Dates of Inspection: 26th February 2015

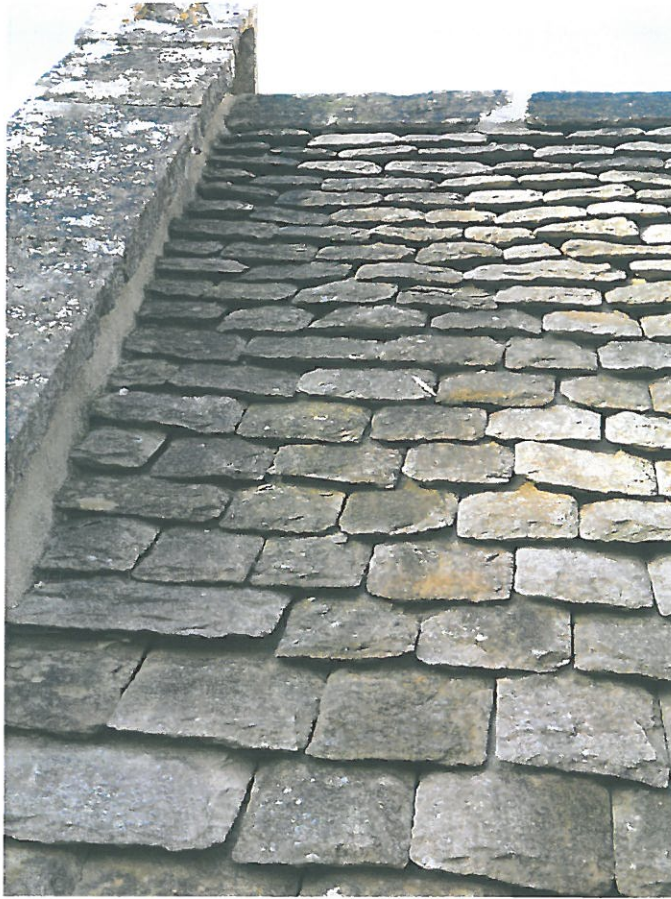
One tile noted as delaminating to east slope of porch. There is a small amount of delamination noted to tiles on the north slopes of the nave and chancel. This damage is caused by frost and cannot be avoided.

Detail showing delaminated tile to south porch.

Replace one tile to the east slope of the south porch.

Monitor condition of tiles over next quinquennium.

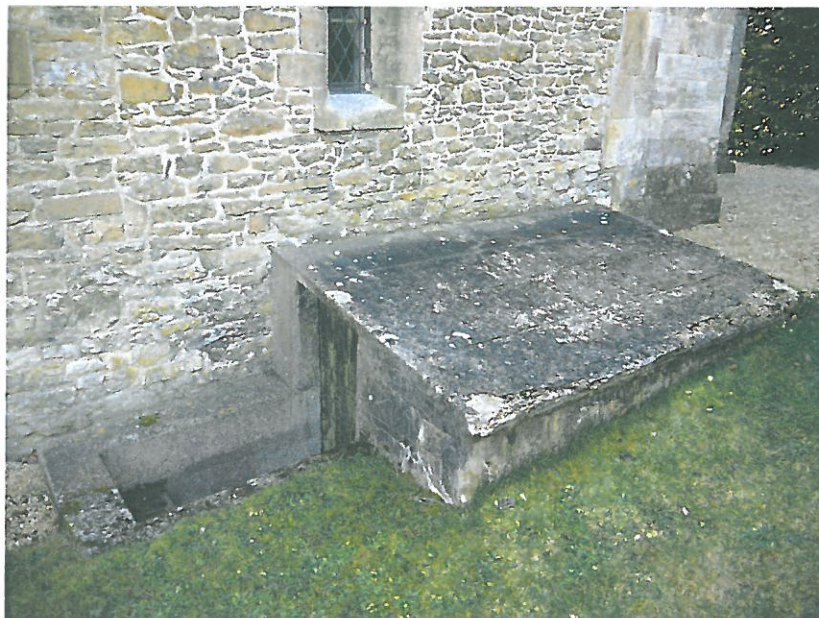
The concrete to the roof over the boiler room is spalling.

Spalled capping to old boiler room.

Carry out mortar repairs to the roof over the boiler room.

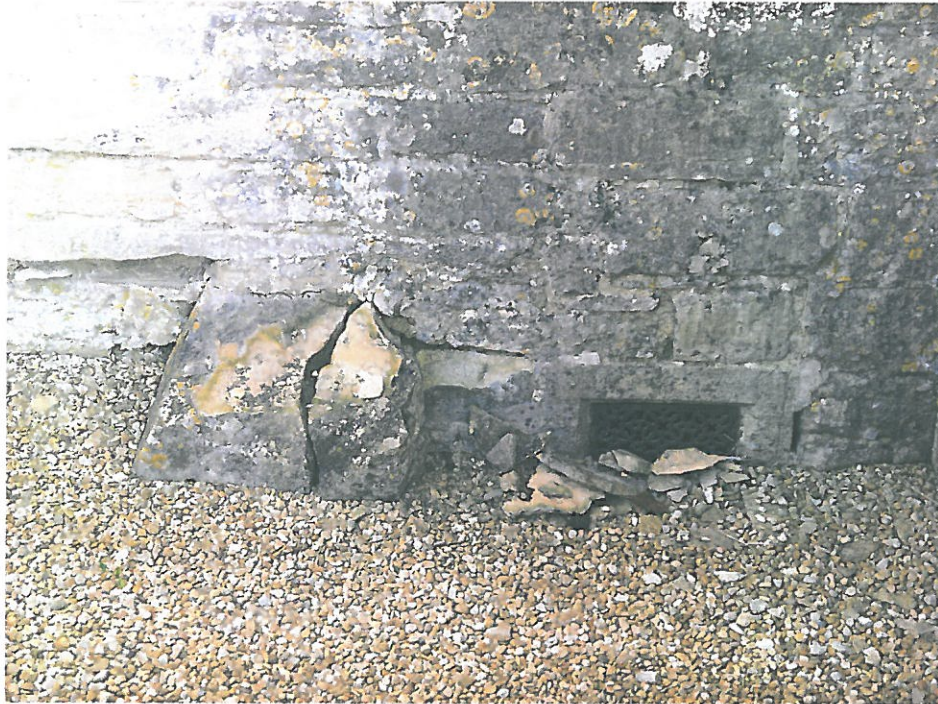
The stone plinth block to south wall of nave, by the south porch has fractured.

Fractured plinth block to tower.

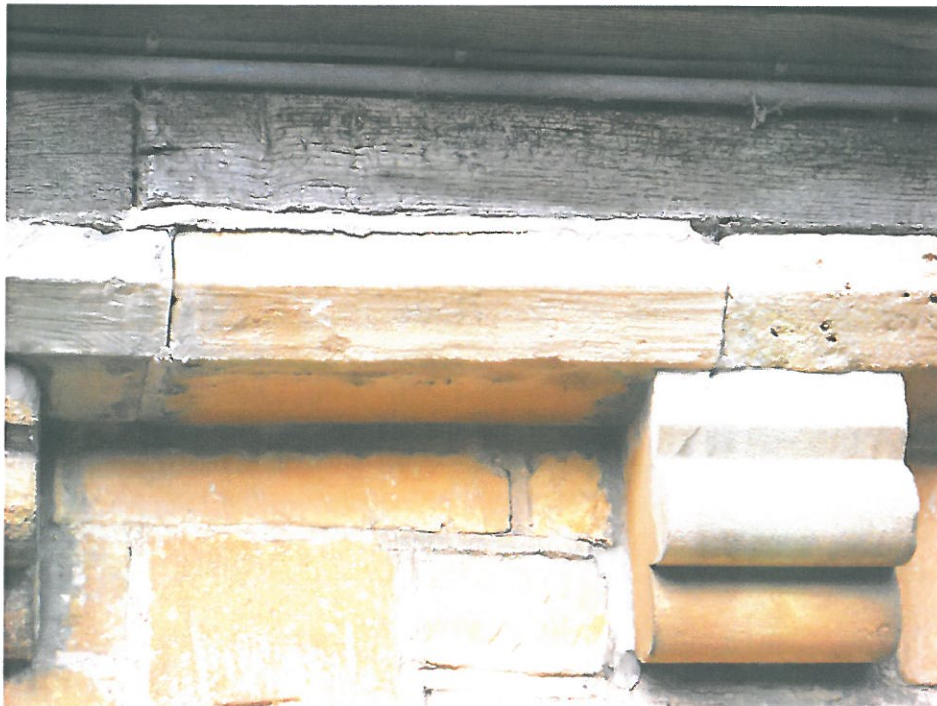
I also noted one displaced corbelled eaves stone to the west of the south porch with a split in the corbel.

Detail of dislodged eaves stone and fractured corbel.

Monitor condition of eaves stone and corbel over the next five years.

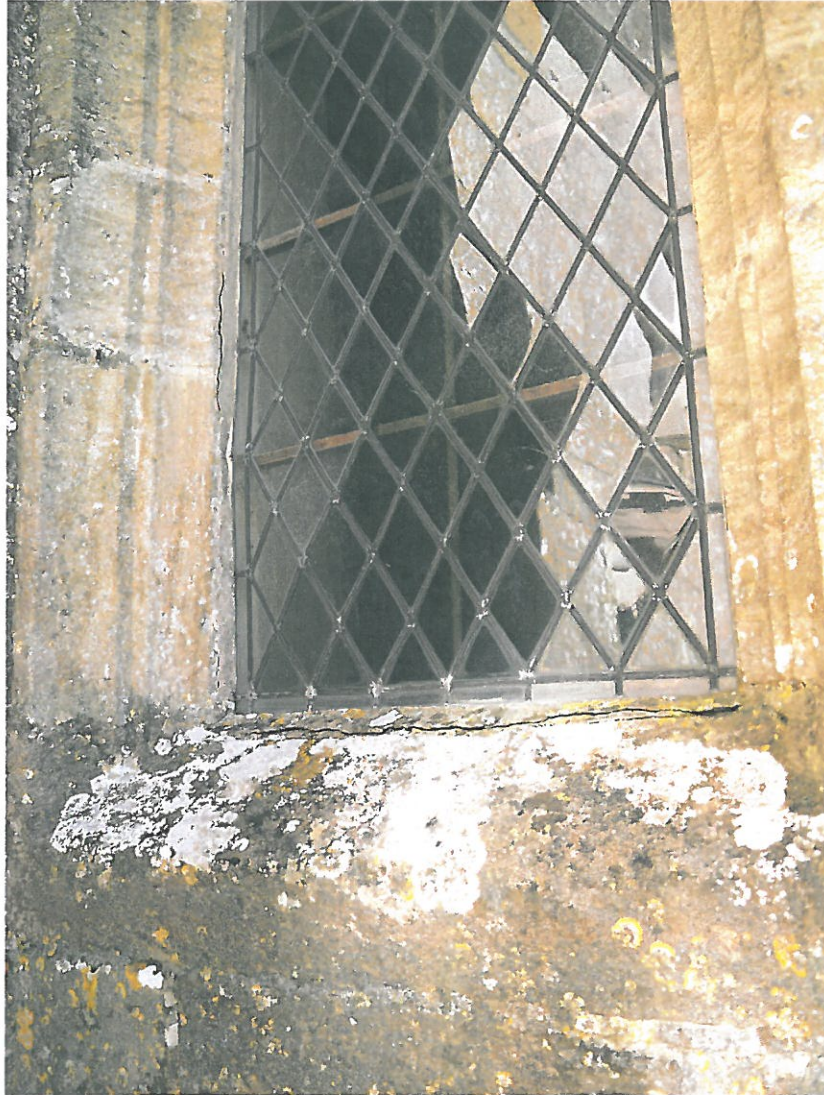
Detail showing defective pointing to west window of nave.

Replace one tile to the east slope of the south porch.	A
Rake out pointing to reveal of W2 and repoint.	A

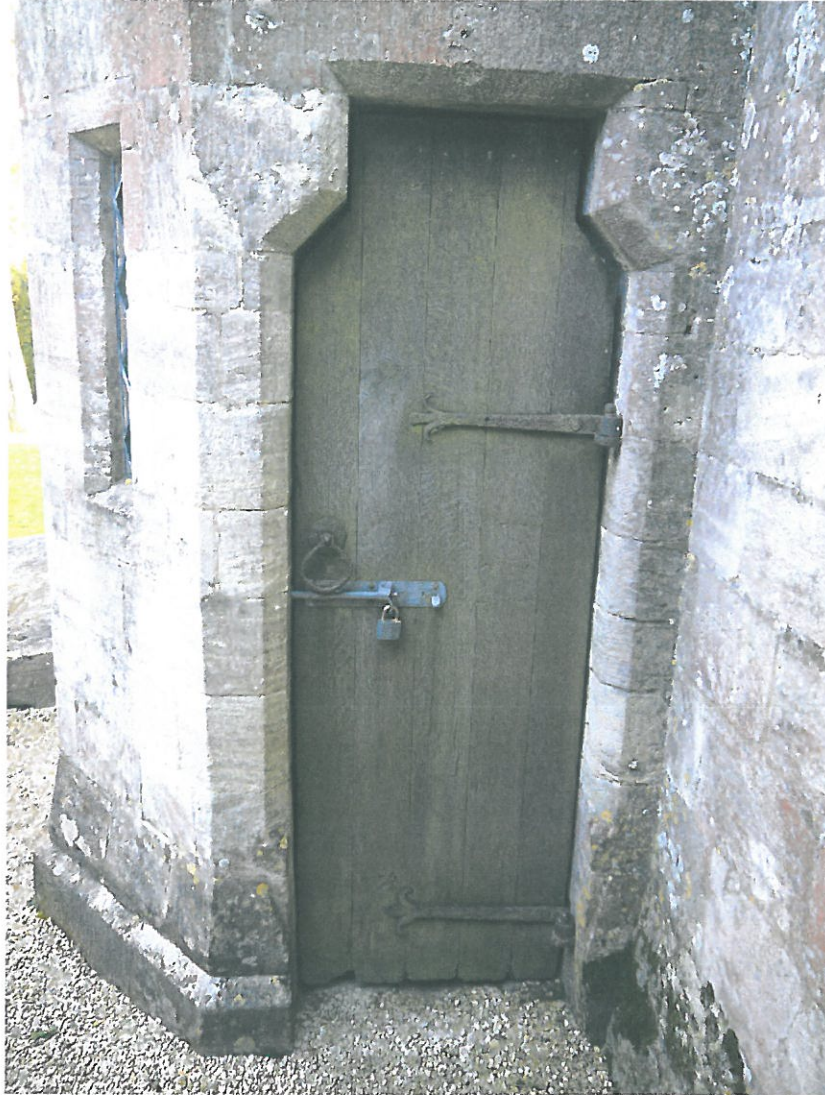
The metalwork to doors ED1 and 3 is rusty.

Poor decorative condition of metal work to door to tower.

Rub down, rust treat and re-paint.
