st giles church,  
coberley

quinquennial inspection  
report number 1

3<sup>rd</sup> November 2017

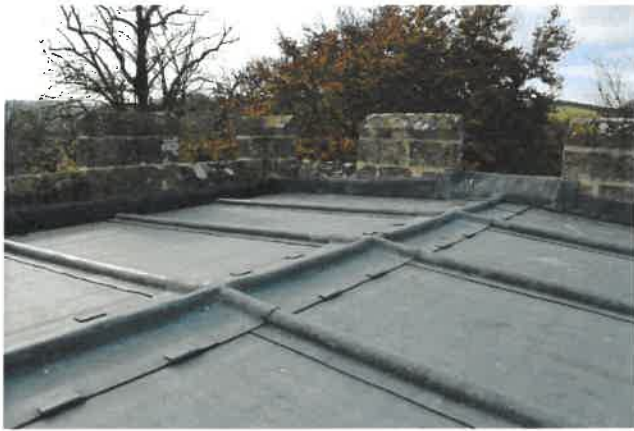
The Tower Roof has been re-leaded, with new flashing and repairs to the parapets and is all in good condition. Gutters to north and south sides discharging to chutes, all were clear and working well.

Tower roof new lead covering.

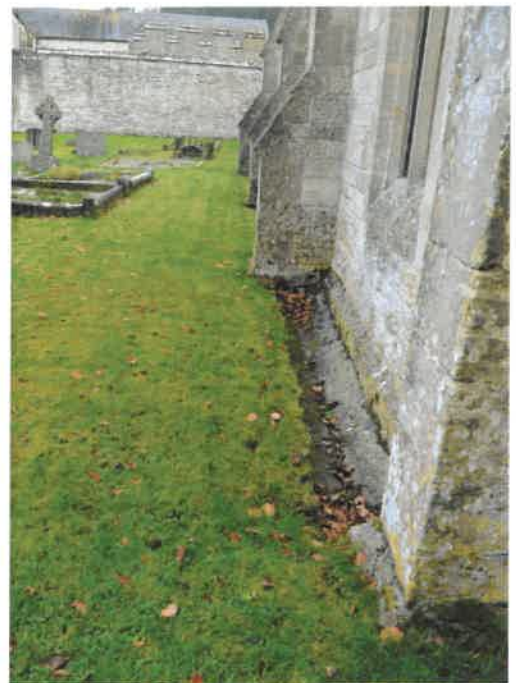
To the south side of the north aisle, a gulley grid is missing. To the east side a gulley grid is mortared in so cannot be easily removed to rod the drain. The location of soakaway and drains is unknown so it is not possible to report on the effectiveness of the drains and whether faults in the drainage may be contributing to the dampness in the church.	
	If the channels are to be retained then the outlets need to be maintained clear and any cracks pointed or made good regularly. Outlets need to be inspected regularly and rodded to ensure they are running clear.	
	<b>Recommendations</b>	
	Clear blocked gutters and downpipes replace missing gulley grids.	A
	Take off gutters and downpipes overhaul/replace defective sections and redecorate.	B
	Clear gulley rod outlets. Re-point any cracks in the concrete channels.	A
	Monitor effectiveness of the channels and consider removal of concrete.	MON
iii)	<b>Walls</b>

Concrete drainage gulleys.

| 6. | Clear gulley rod outlets. Re-point any cracks in the concrete channels. | A |

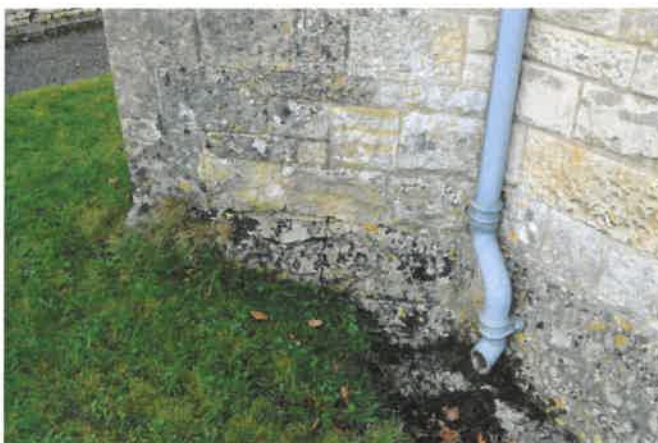
High ground level, damaged plinth stones.

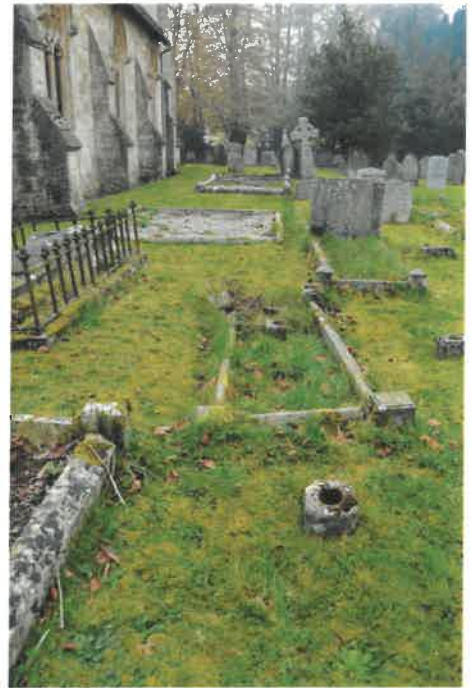
Some maintenance in the churchyard with pruning of trees and clearance of undergrowth to the western boundary would improve that part of the churchyard and the trees. Repair is required to several tombs which have settled due to ground movement. The condition of boundary walls should be monitored and repairs advised to the owner.

Settlement in ground affecting tombs.

Carry out repair to sunken tombs and stabilise.

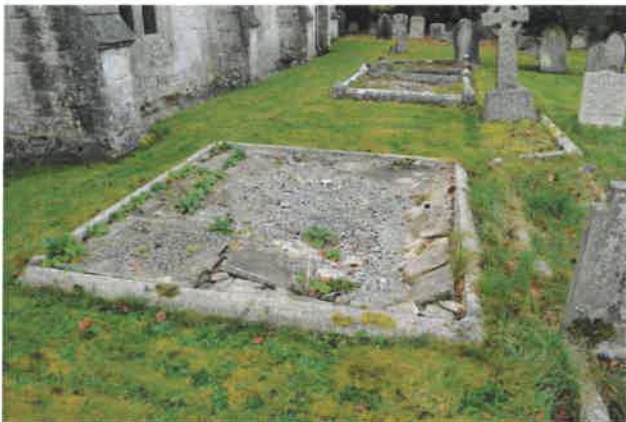
Settlement of tomb to north side.

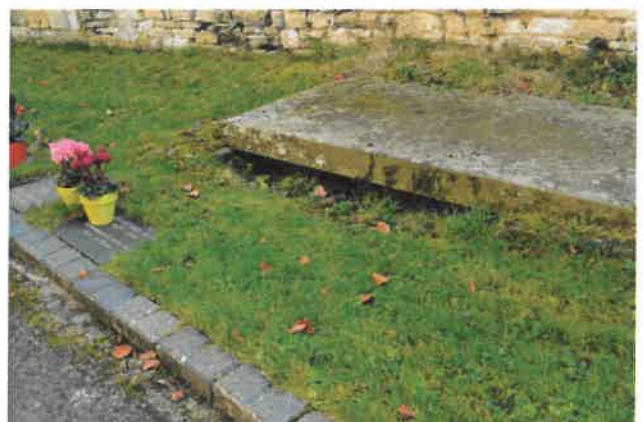
To the south of the porch there is the stump of a cross shaft and base. It is leaning but appears to be stable. The side of a tomb directly opposite the south porch has fallen in leaving a visible void there is also evidence of frost damage.

Side to grave slab has fallen in.

Repair stone to side of tomb to south of porch.

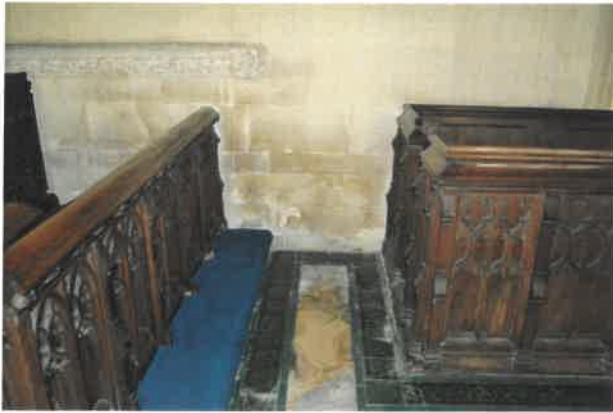
The chancel walls are fine jointed ashlar limestone with carved limestone dressings. There is evidence of historic water ingress on the south wall and damp at lower levels causing staining and blistering of the surface of stone to the east end of the choir stalls. The carved stone dressings around the chancel and sanctuary are in good condition.

Rising damp to chancel.

Consider cleaning of damp stained walls following remedial works to drainage. **C**

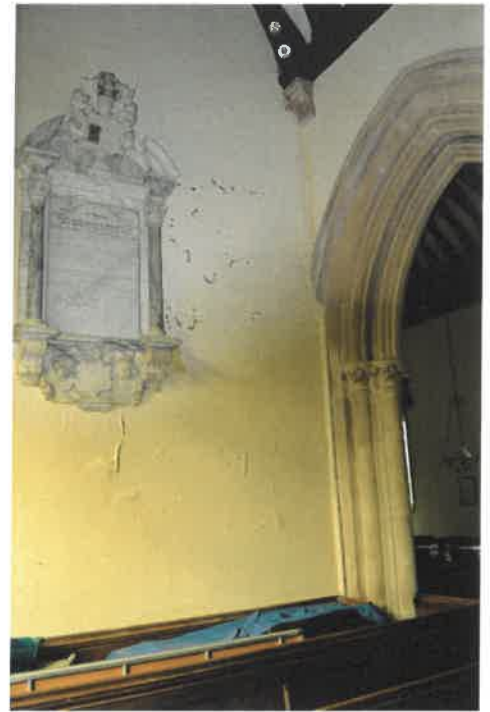
The south aisle/chapel is painted plaster similar to the Nave. There is damage to paint and plaster on the west wall, resulting from penetrating damp from blocked gutter and down pipe over the porch. This was noted in the previous report. The downpipe was found to be blocked on the day of inspection and may still be saturating the wall in times of heavy rain.

Penetrating damp to west wall south aisle.

Monitor west wall of chapel and when the fabric has sufficiently dried out repair plaster and re-decorate. **C**

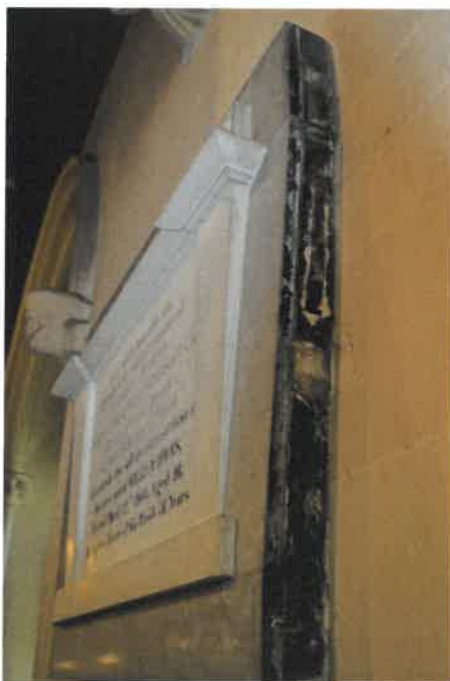
Hicks Monument on Chancel north wall. Marble with engraved and painted lettering. The marble face is detaching from the wall and cracks evident in the side possibly due to rusting iron cramps.

Fracture and damage to monument in chancel.

Arrange for inspection of Hicks memorial by conservator and carry out repairs.
