STAINED GLASS CONSERVATION REPORT

Following a condition survey Holy Well Glass was asked to carry out conservation works at St. Thomas of Canterbury Church, Birtsmorton. Works comprised of removal from site of all panels in Window sII; a two-light window (main lights 12 ½ x 53") with a single kite shaped tracery element, and of single tracery lights from Windows sV, sVI, sVII, nIII, nV, nVI, nVII, and panel 2b from WI. Conservation work was carried out in the workshop before panels were re-fitted. Additionally a bespoke internally ventilated protective glazing system (EPG) has been designed, manufactured, and fitted. Repairs were also carried out to the surrounding stonework by HWG masons. The relevant windows and panels can be seen on the diagram and photos below.

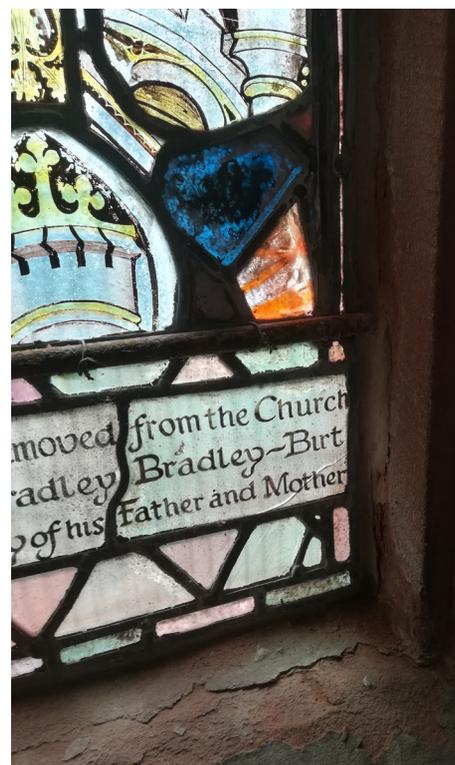
sII panel 1b during site removal. Friable masonry visible at sill level. Hard cement mortar visible at perimeter

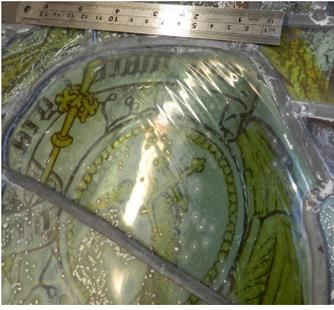
Crown glass, external surface

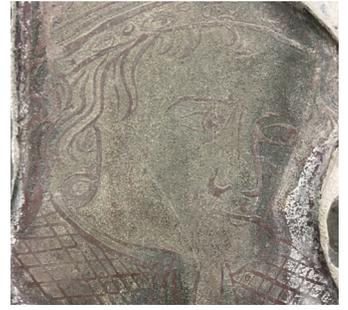
Blanket corrosion, internal surface

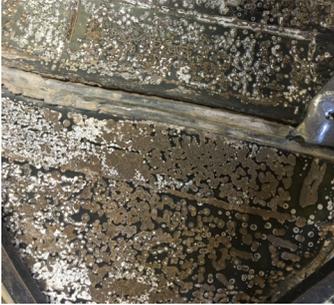
Severe pitting, internal surface

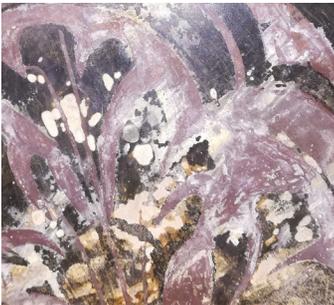
Corrosion deposits, internal surface

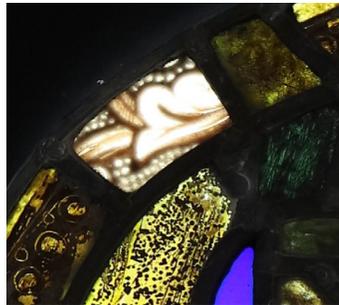
Historically reversed glass, internal surface

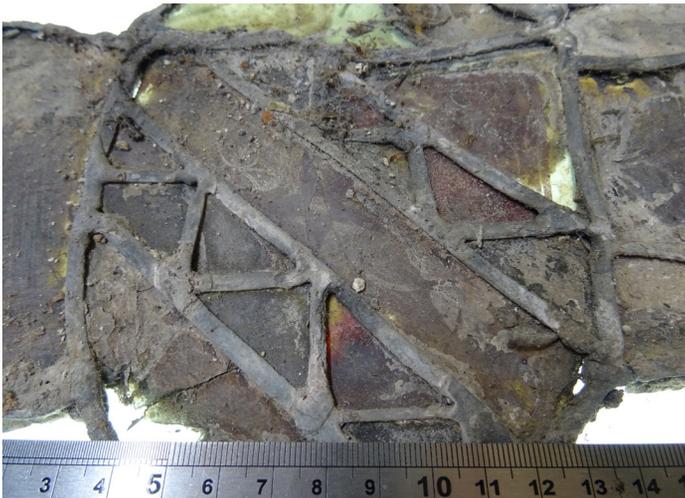
nVI tracery panel, internal view, before conservation

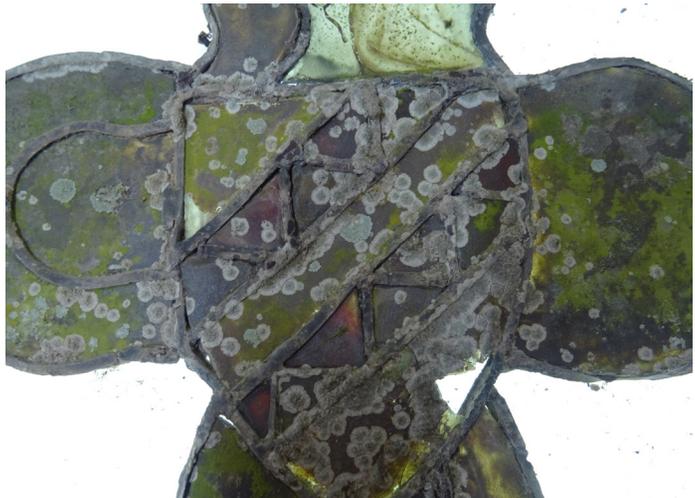
nVI tracery panel, external view, before conservation

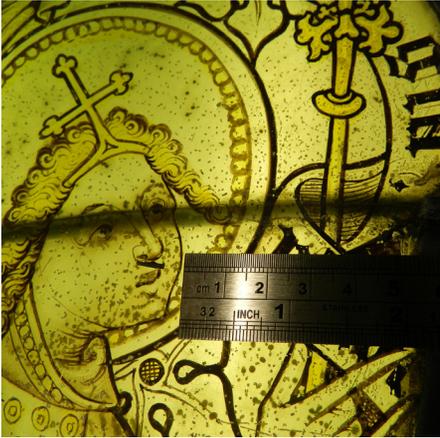
sV panel 1b break across face, strapped externally, before conservation, internal view

Impact breaks, single/double breaks and small gaps repaired using Araldite 20:20; a conservation grade two-part epoxy resin. In sII panel 1b the disfiguring historic repair lead across the large central figure was removed, and the broken sections edge-bonded, thus making the iconography much clearer. The shield section of nV tracery required a resin fill to mend the hole in the glass.

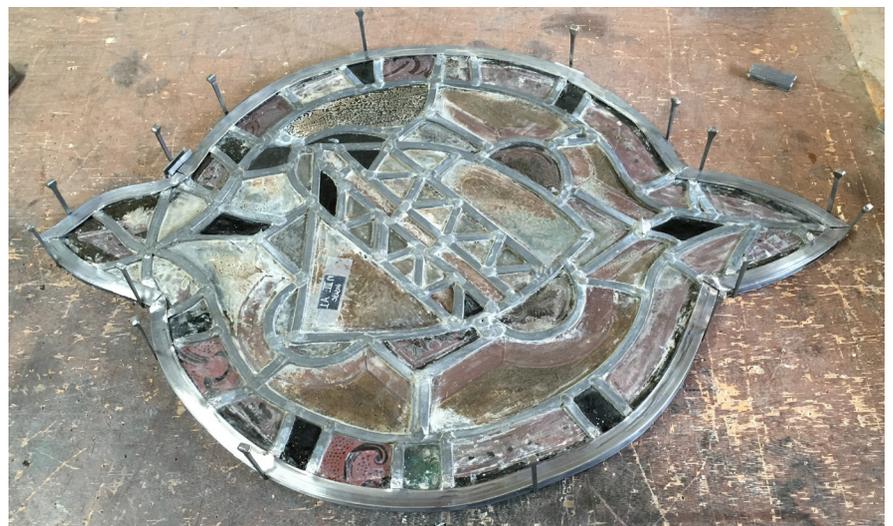
Window nIII tracery panel, during re-placement of perimeter leads

Panels have been leaded where necessary with commercially available lead comes, in a profile matching the original lead width and depth. For most panels new leads were limited to replacement of edge-leads and small sections. Only the more weakened lead structures in tracery panels from sV and nVII needed to be fully re-leaded. As much medieval lead as structurally possible has been kept (see diagram). The soldering technique has been mirrored. Panels soldered with 60/40 lead/tin solder. Leads used were 1/8", 3/16", and 1/2" flat profiles.

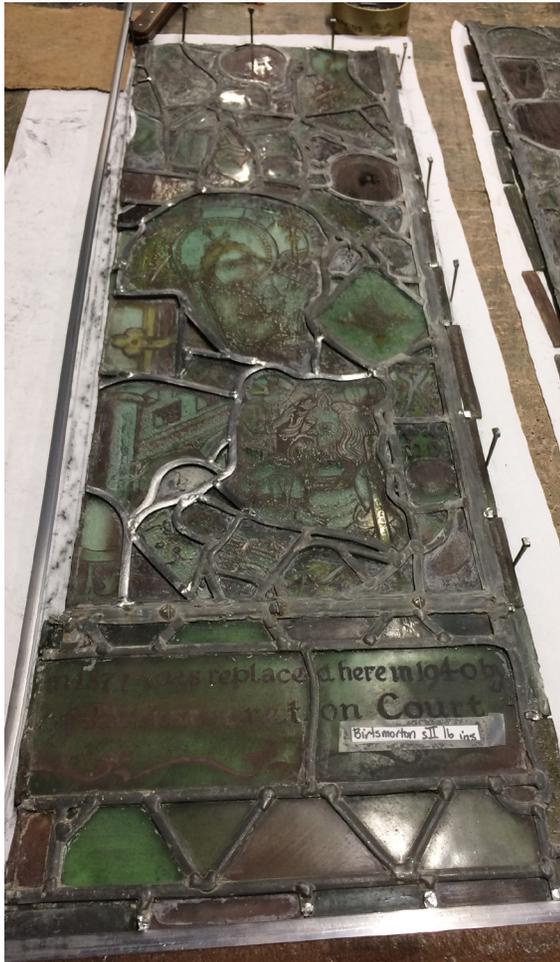
Window sII panel 1b - Re-leading centre left section after edgebond repairs to the glass, and adding new perimeter leads

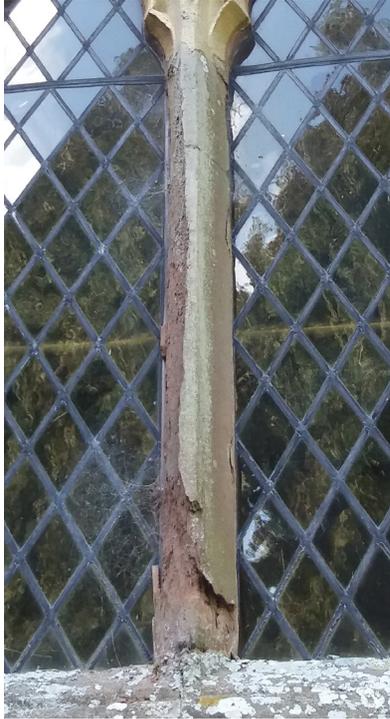
nIII before stonework repair, external elevation

nIII sandstone mullion fully replaced like-for-like. To enable this, nIII leaded light panels removed. Labelled prior to removal and surrounding historic fabric protected. Perimeter mortar chipped out by hand using dummy & tungsten-tipped chisels. Leaded lights eased from openings and removed. Window nIII propped and existing mullion removed. Replaced old stone for new, pre-worked (including glazing groove) and cut to size. Removed old copper ties from nIII leaded lights and replaced for new. Re-fitted leaded lights and pointed in lime mortar (1:3 - St Astier NHL 3.5: Whiteball Red Sand).

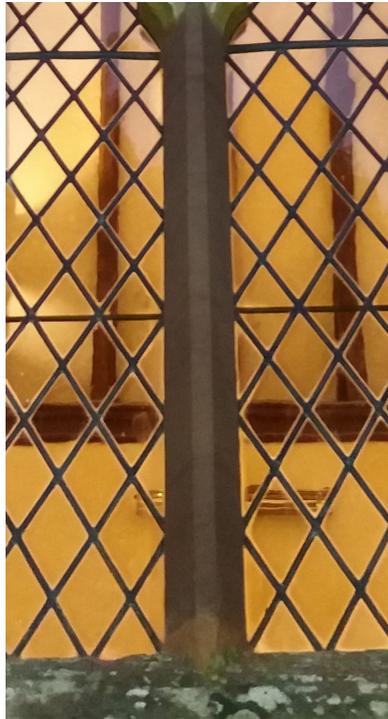
nIII after stonework repair, external elevation

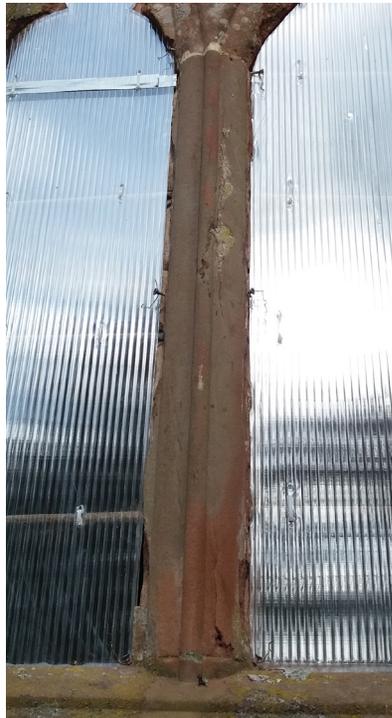
sII before stonework repair, external elevation

sII stone mullion cut back to the glazing line externally, new half stone replacement cut, and fitted using stainless steel dowels to pin in place, which were coated in a stone resin to prevent future rusting.

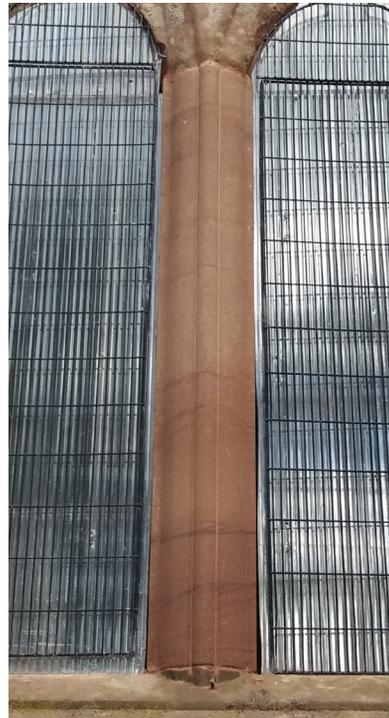
sII after stonework repair, external elevation

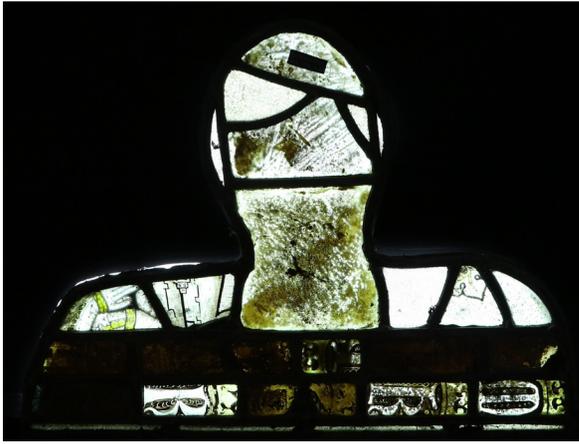
Window WI panel 2b, before conservation, transmitted light, internal

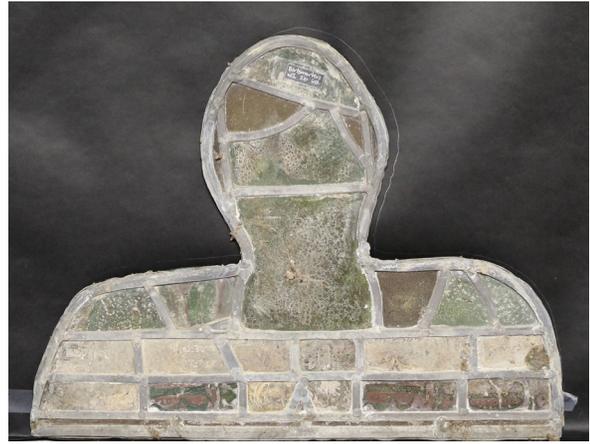
Window WI panel 2b, before conservation, reflected light, internal
