**Condition survey of the wall paintings within the Chantry
Chapel, Church of St Michael and All Angels**

Skelbrooke, Diocese of Sheffield

January 2017

**SKELBROOKE
SOUTH YORKSHIRE**

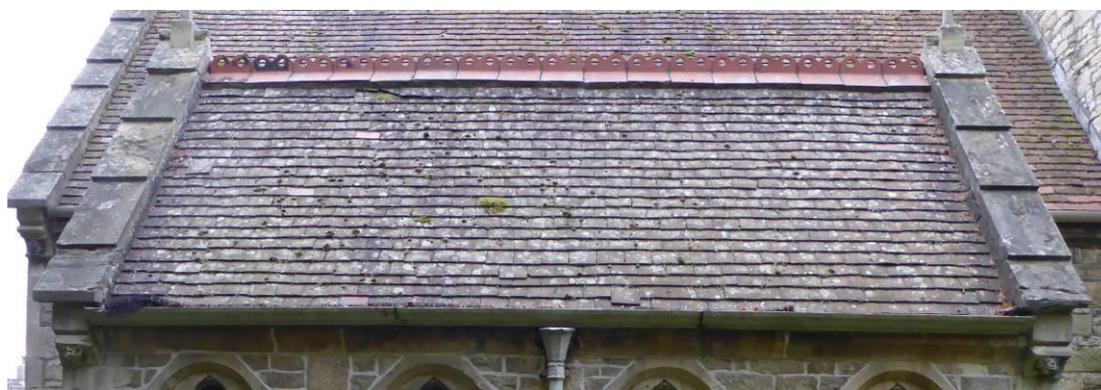
Figure 2: Overview of the Chantry Chapel roof, showing slipped and damaged tiles.

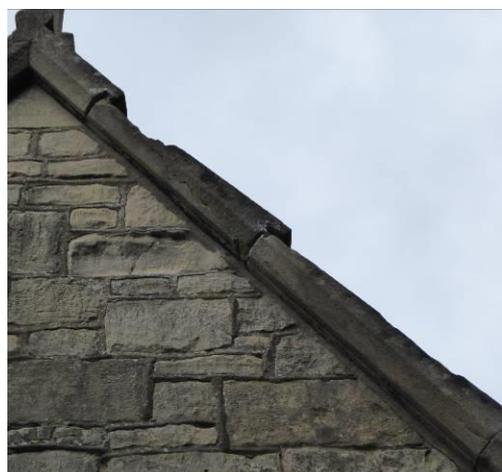
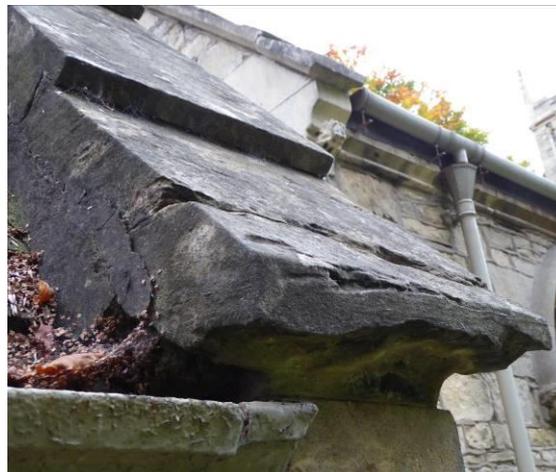
Figure 3 & Figure 4: Detail of damaged stone slabs to east gable (left) and west gable (right).

The edges of the roof at the gable ends are constructed of stone slabs carved to slot into each other forming a stepped ridge to shed water. On the east gable end, several of the stone slabs have losses and fractures, see figure 3, which may be causing water to run down the face of the elevation, possibly causing some of the damage to the stonework and pointing noted below. The lowest stone slab on the west gable end has also got a crack through to the bottom, see figure 4, which may be allowing moisture to ingress. The flashing material appears to be cementitious and an area mid-way up the west end of the roof has detached from the gable end, see figure 5.

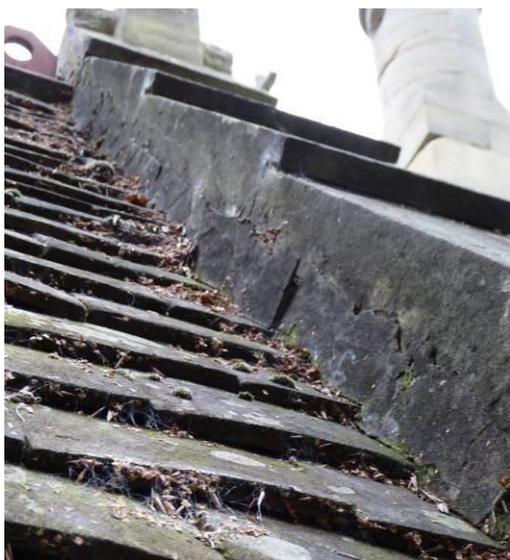
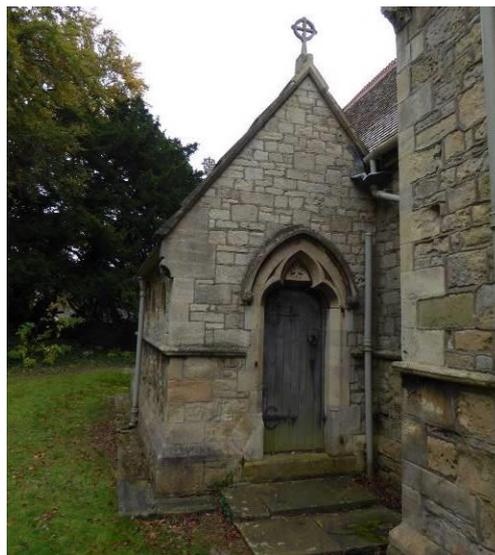
Figure 5 & Figure 6: Detail of damages flashing to west end of roof (left), and west elevation (right)

The stonework to the west elevation, see figure 6, generally looks in good condition, apart from around the doorway and to the cornice. The doorway reveals have back weathered considerably with extensive losses, holes, scaling, flaking and powdering of the stone surface, see figure 7. This damage appears to be ongoing but has seemingly developed over a long period of time, as there is evidence that gaps have been filled in the past. There are loosened mortar repairs, which are cementitious and also causing further deterioration to the stone.

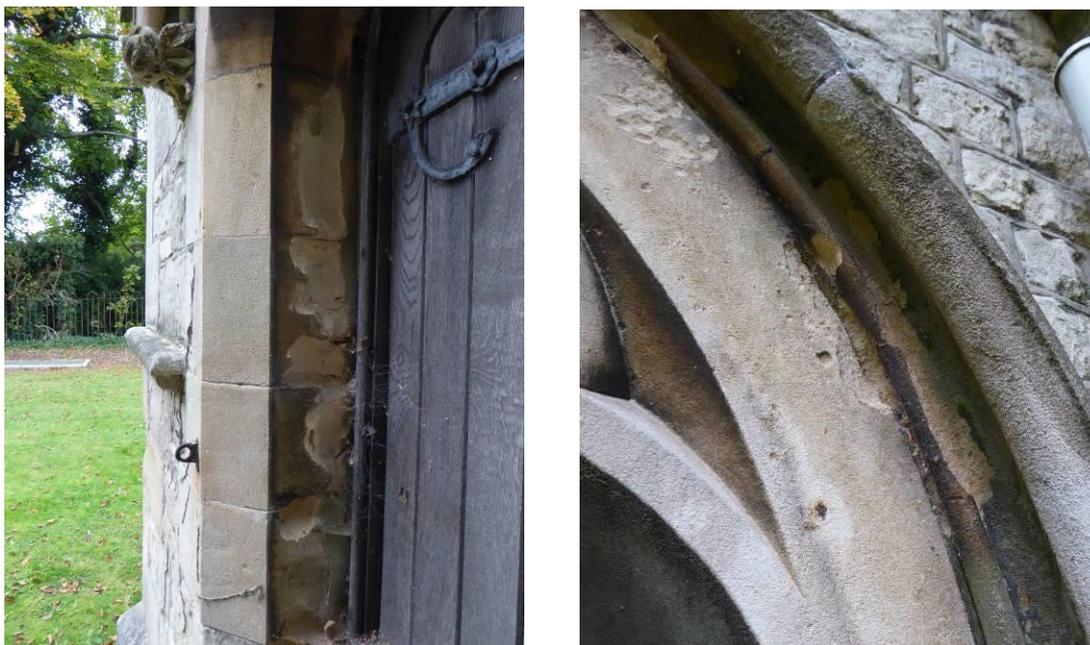
In addition, the right (south) side of the moulded arch shows extensive stone deterioration which is associated with water damage, see figure 8. There is a downpipe with a lead hopper in the adjacent corner where the chapel joins the main body of the church. The gutter appears to drop towards the end and it is fitted with a gutter brush which is intended to prevent leaves from settling in the gutter. We were informed by the vicar that this brush was put in at some point over the summer after the gutters had been cleaned out. Leaves are clearly trapped in the bristles.

Figure 7 & Figure 8: Details of damages around the doorway.

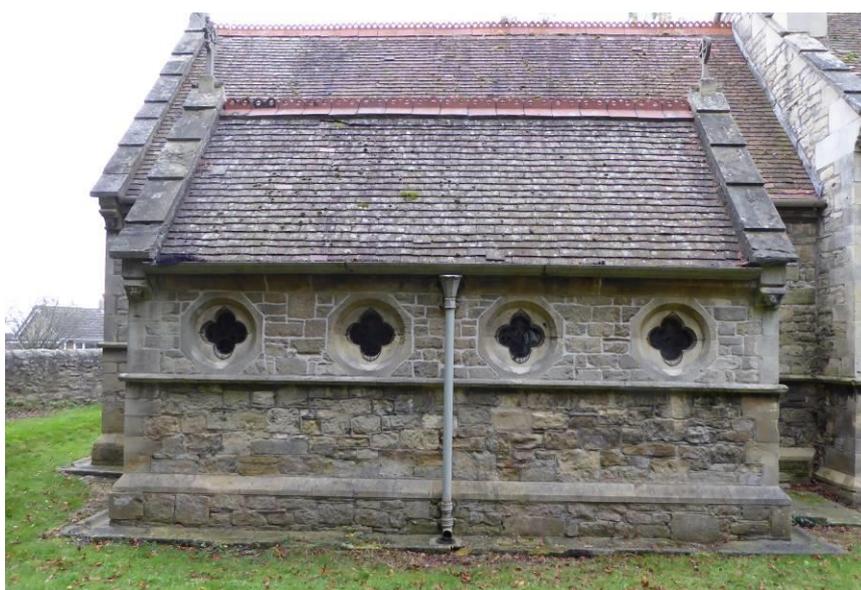
Figure 9: Overview of the north elevation

Erosion of the stone surface is evident in the east corner of the north wall suggesting that water has been over-flowing in the past, or is currently over-flowing. There is also an area of very damp looking stone to the north-west corner which may relate to water over-shooting the gutter and running down the wall, as some water run-off staining is evident, see figure 11.

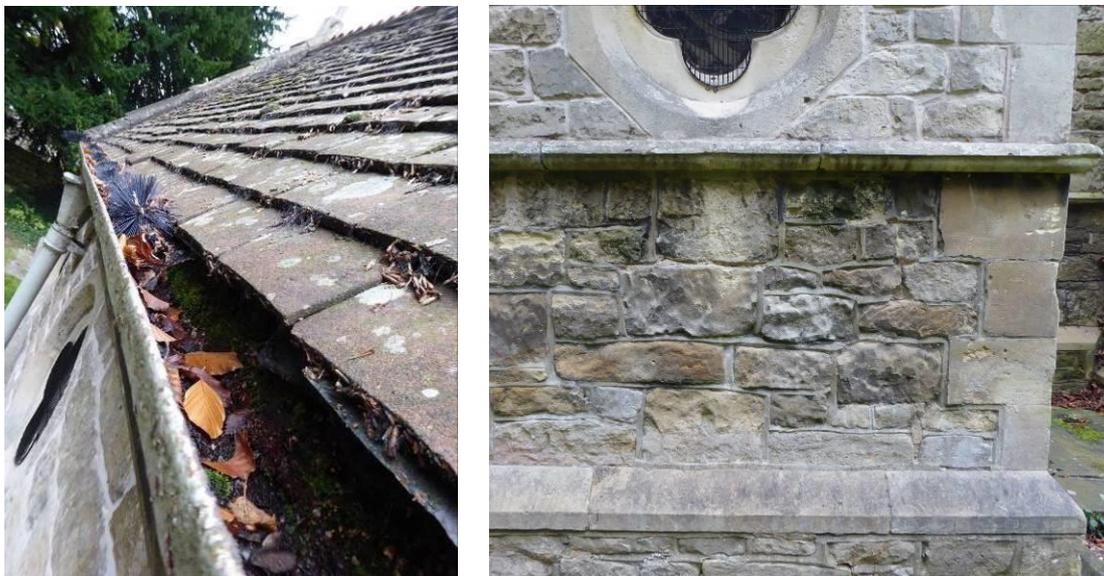
Figure 10 & Figure 11: Detail of debris in gutter and gutter brush (left), overview of water damage below string course (right).

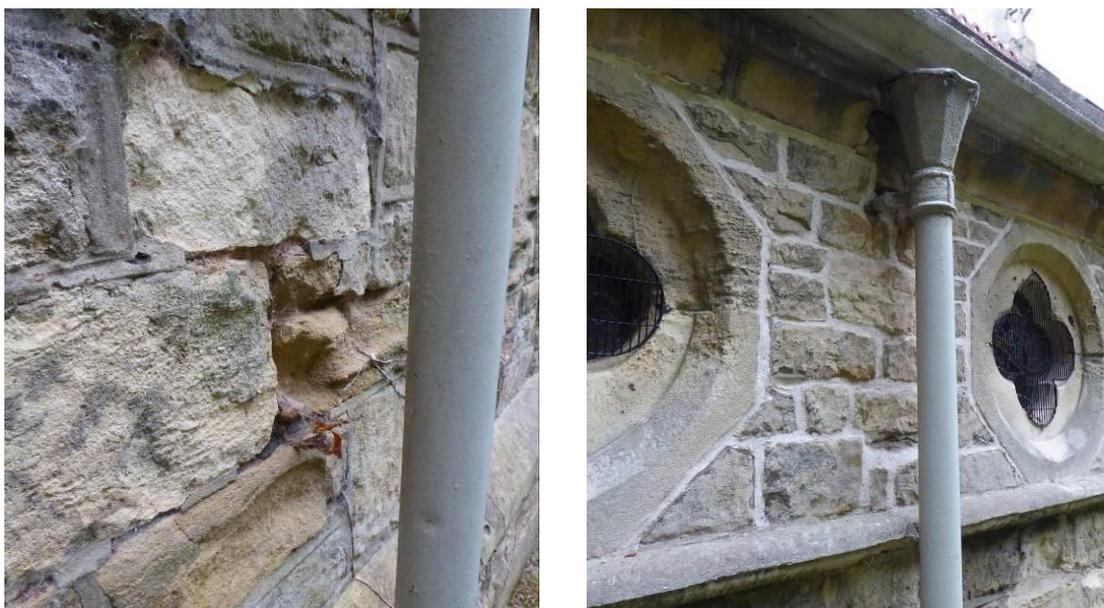
There is erosion to the stone surface in several areas notably behind the down pipe in the centre of the elevation, see figure 12. This could possibly be due to the wind channelling in that area, or could be related to a leak in the down pipe or hopper in the past. As the stone in this area is presently dry, and there is little or no biological growth, if the deterioration was due to moisture penetration, this issue appears to have been resolved. There is an area of eroded stonework below the string course, which is situated directly beneath the junction of two sections of guttering.

Figure 12 & Figure 13: Detail of area of deep erosion behind downpipe (left), overview of new lime pointing above string course (right).

The pointing has been replaced in many areas, especially to the upper wall above the string course, and looks generally sound, see figure 13. Below the string course the pointing is more modern and appears to be lime based. However, the older pointing below this is the thick moulded type, which appears to be cementitious, with small patches of later re-pointing. The stone has eroded in places, especially in this area, possibly due to the inadequate pointing mortars. There are also some failing and open joints to the lower part of the stonework, especially in the north east corner where moisture will be able to penetrate.

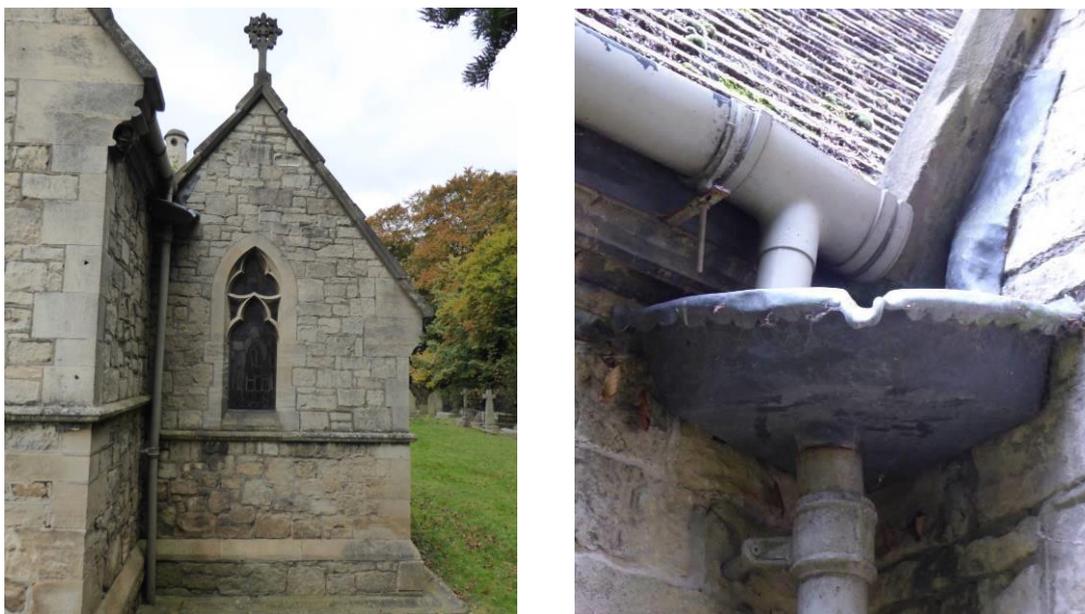
Figure 14 & Figure 15: Overview of east elevation (left), detail of lead hopper and flashing (right).

The stonework and pointing to the east elevation generally appears to be in good condition with predominantly moulded historic cement pointing present, see figure 14. However, small patches of repair above the window and in the north east corner were noted and some deterioration below the moulded string course is evident, where it is apparent that water damage has caused deterioration of the pointing and the stone, see figures 16 and 17.

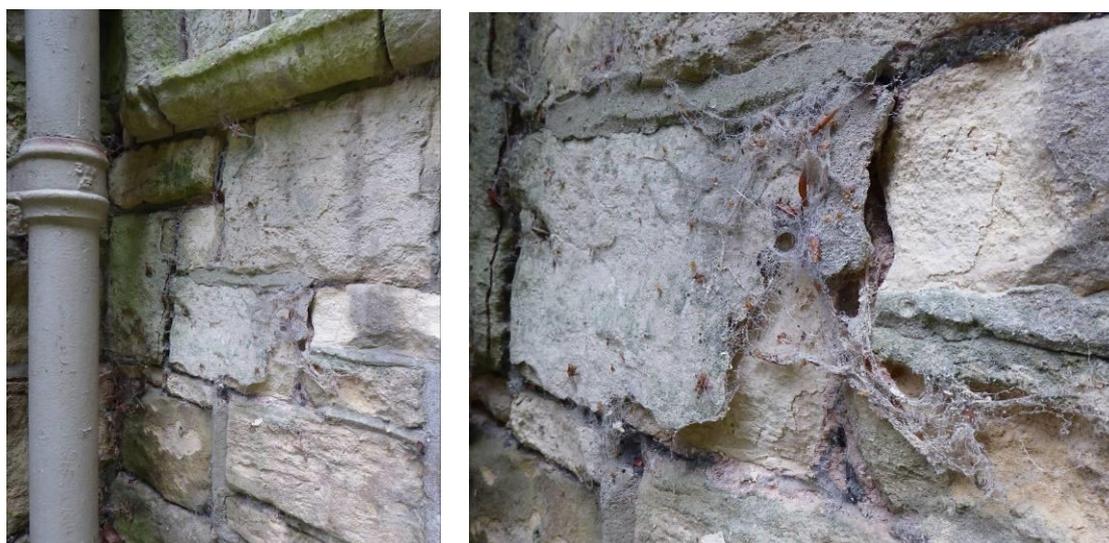
Figure 16 & Figure 17: Details of damaged and eroded stonework below string course in close proximity to the downpipe.

The stone in this area has suffered from prolonged moisture ingress and is showing scaling, flaking and mould growth. This is most likely associated with the rain water disposal system in the south east corner, where mildew is clearly evident on the walls and to the drainage channel on the floor. Water drip marks are evident behind the lead hopper, which is quite shallow. There is an area of lead lining fitted into the joint between the gable head stone, however, if the water is over shooting from the gutter or from the main roof, this may not be adequate.

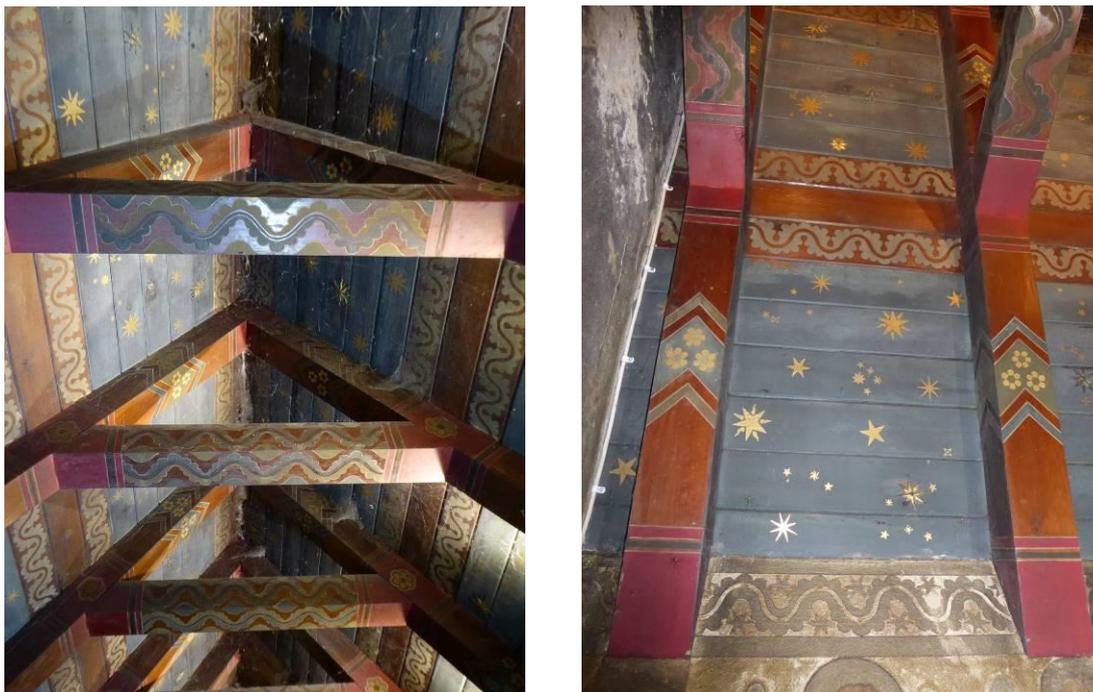
The style of the decoration to the roof timbers is typical of high Victorian designs, and the condition is generally good. There are heavy dust and dirt deposits and extensive areas of cobwebs, particularly towards the apex of the roof, see figures 19 and 20. The applied gilded stars are likely to be a copper alloy as green corrosion product was evident to numerous areas, see figure 21. Some dark spots were also noted to the timbers, which appeared to be either staining from previous condensation or mould spots, suggesting high humidity levels/condensation events. This is generally to be expected, due to warm air within the chapel rising and forming condensation as it comes into contact with the colder roof timbers.

Figure 19 & Figure 20: Overview of painted roof timbers showing extent of cobwebs and dirt deposits (left) and detail of north-west panels

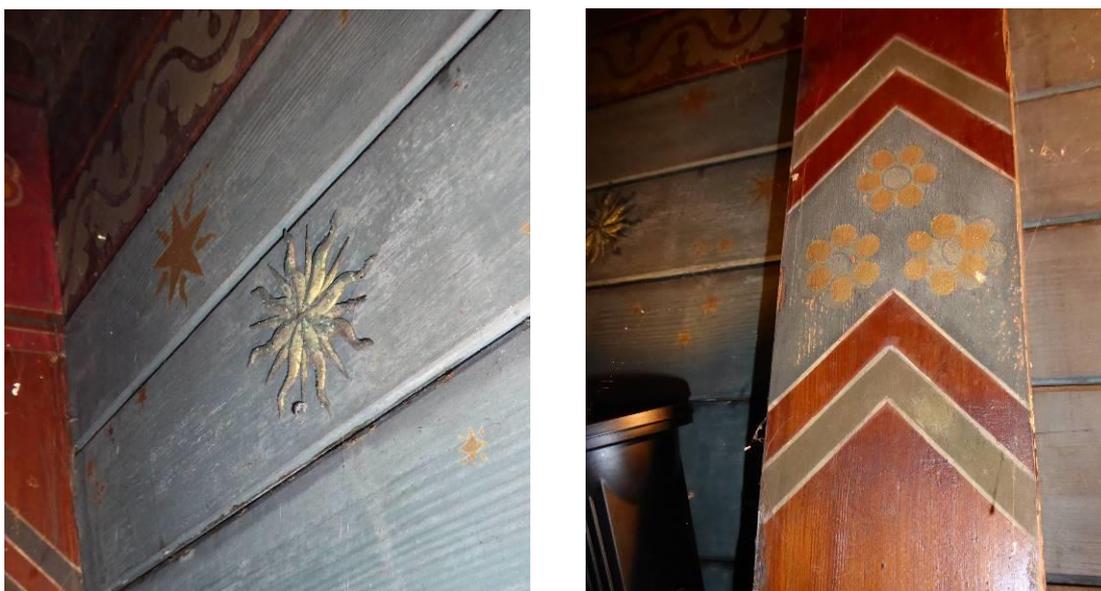
There are localised areas of flaking and paint loss which appear to be related to previous moisture ingress as well as differential movement of materials. For example, there are areas of paint loss along the lower edge of the south face of the roof timbers, where there have been historic issues with moisture ingress from the valley between the Chapel and the Sanctuary. The timbers are currently dry and there appeared to be no indication of recent moisture ingress. In addition, differential rates of expansion and contraction of the timber substrate and the paint layers following fluctuations in temperature and humidity appear to have resulted in numerous small areas of cleavage/micro flaking and paint loss, see figure 22.

Figure 21 & Figure 22: Detail of applied star, with green corrosion product evident suggesting the use of copper alloy (left) and detail of beam decoration (right), with micro flaking and loss to the paint layer, as well as 'shadows' of a possible earlier scheme beneath the currently gilded flowers.

During the inspection, evidence of a previous decorative scheme beneath the three flowers in the chevron design to the lower timber beams was noted, see figure 22. The 'shadows' of earlier flowers could be seen, which are similar in shape to the extant scheme but are slightly off set. A sample of paint was taken for analysis and the findings are discussed in the following chapter.

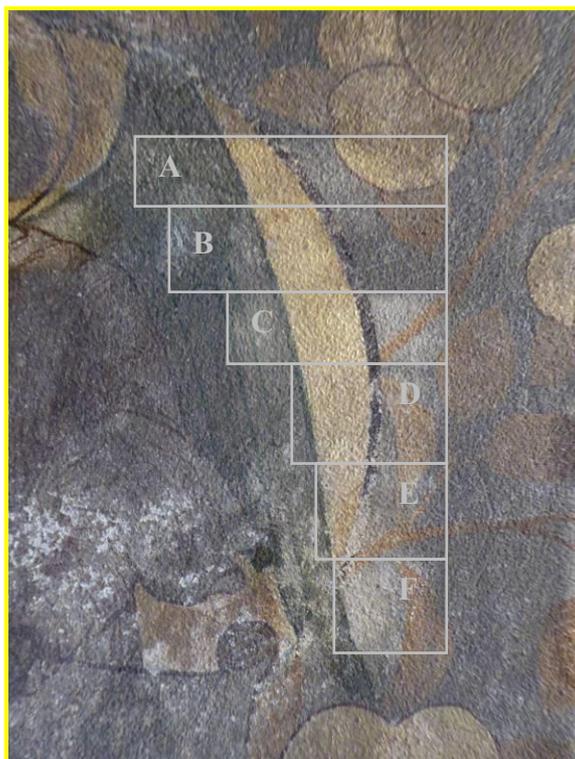
Note: water and salt damage to lower part of test area proved difficult without further tests and prior consolidation
