St. Peter's Church, Milton Bryan

ARCHITECT'S REPORT ON NEW ROOFING OPTIONS FOLLOWING FAILURE OF THE TOWER ROOF

October 2021

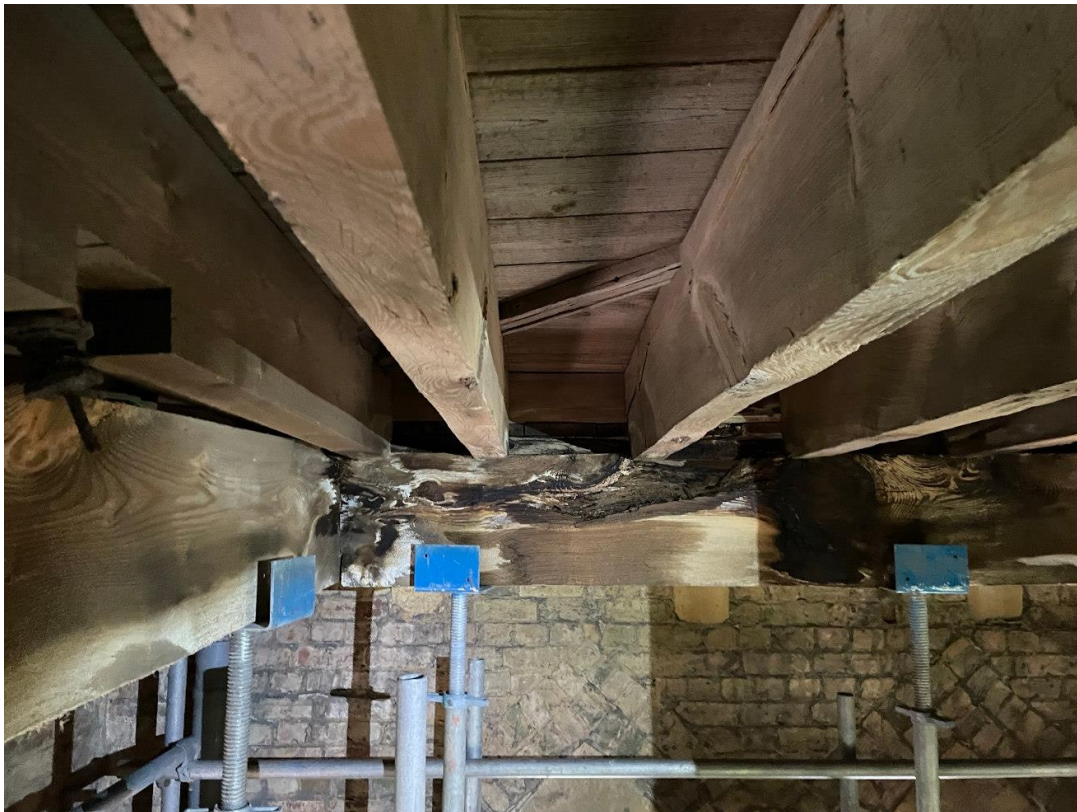
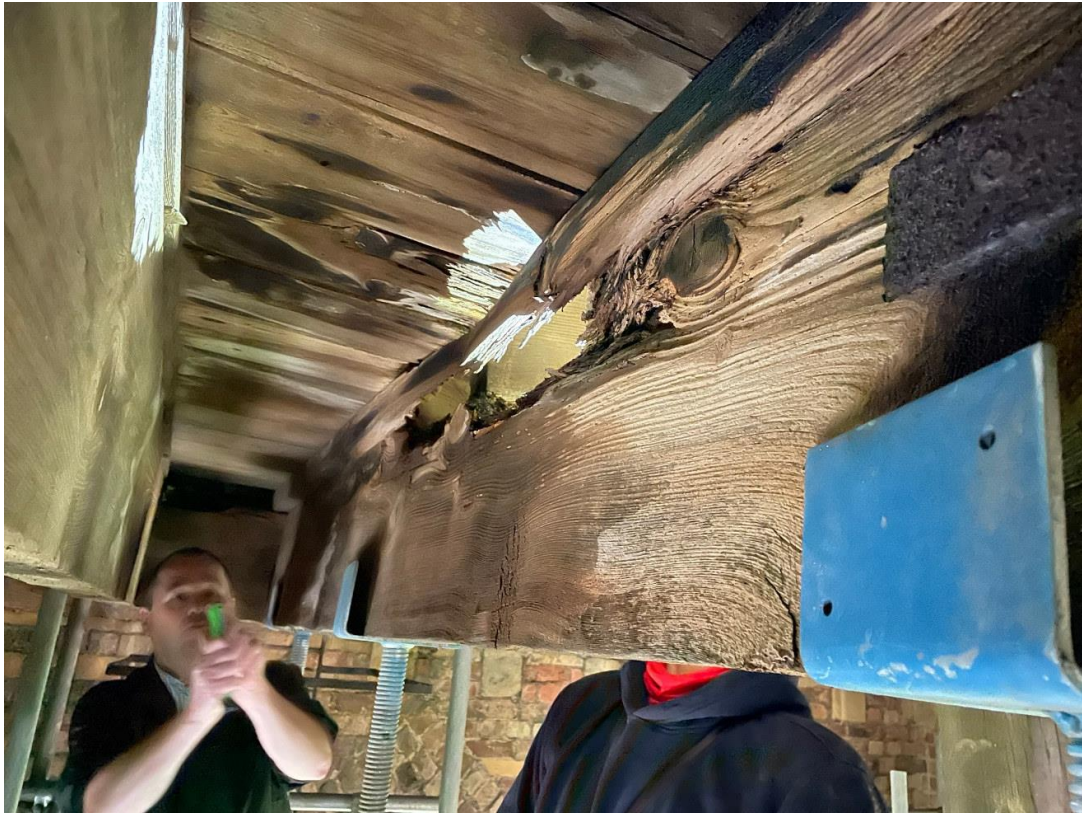
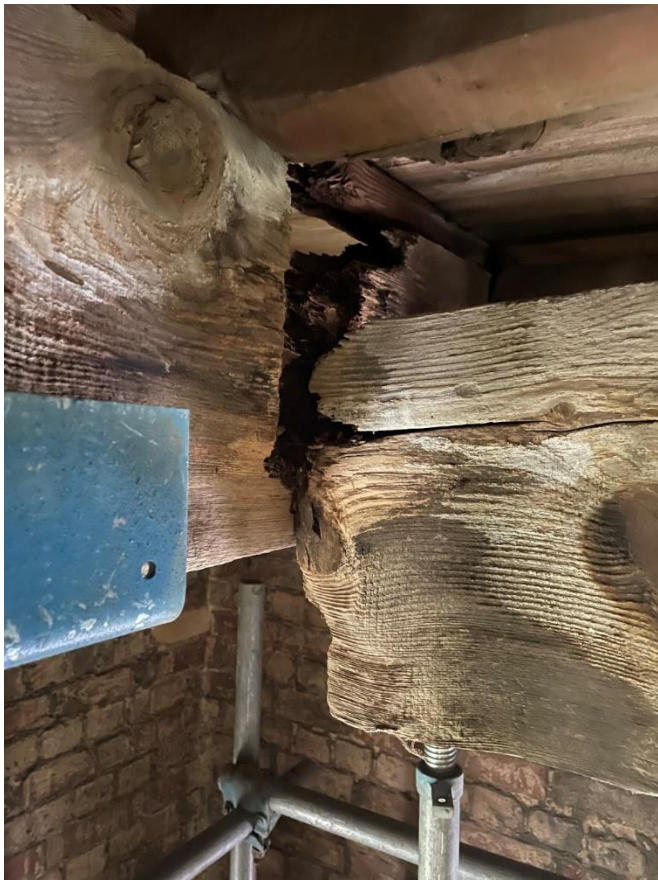
Due to a lack of funds the project was put on hold during the pandemic, and in May this year the parish discovered that due to further water ingress, the timber beams and their bearings were failing in two areas of the roof structure, and that temporary propping of the beams was urgently required. A birdcage scaffold has since been designed and the propping is now in place, however the PCC are now facing ongoing hire costs and liability for keeping the scaffold in place whilst a more permanent solution is considered. The options for this are discussed within this report and indicated on the accompanying drawings. Photographs of the water damage to the timbers are included below.

Given these factors, and the extent of the water damage (as shown in the above photographs), a conservation-led, repair-based approach is not considered to be economic in this particular instance, nor appropriate given the age of the timbers. We are therefore asking that an alternative option be considered in that the existing 1970s roof and covering be stripped out and replaced with a modern, lighter and simpler roof construction. The three options that we have considered are detailed further below, and in the submitted drawings. All three options incorporate the proposed safer access to the tower roof from the approved 2018 scheme, and use 50 x 195mm C24 roof joists at max. 400 c/s.
