115 – St Andrew and St George

Photos for Repair of Aisle Rooves

Date: 5th November 2025

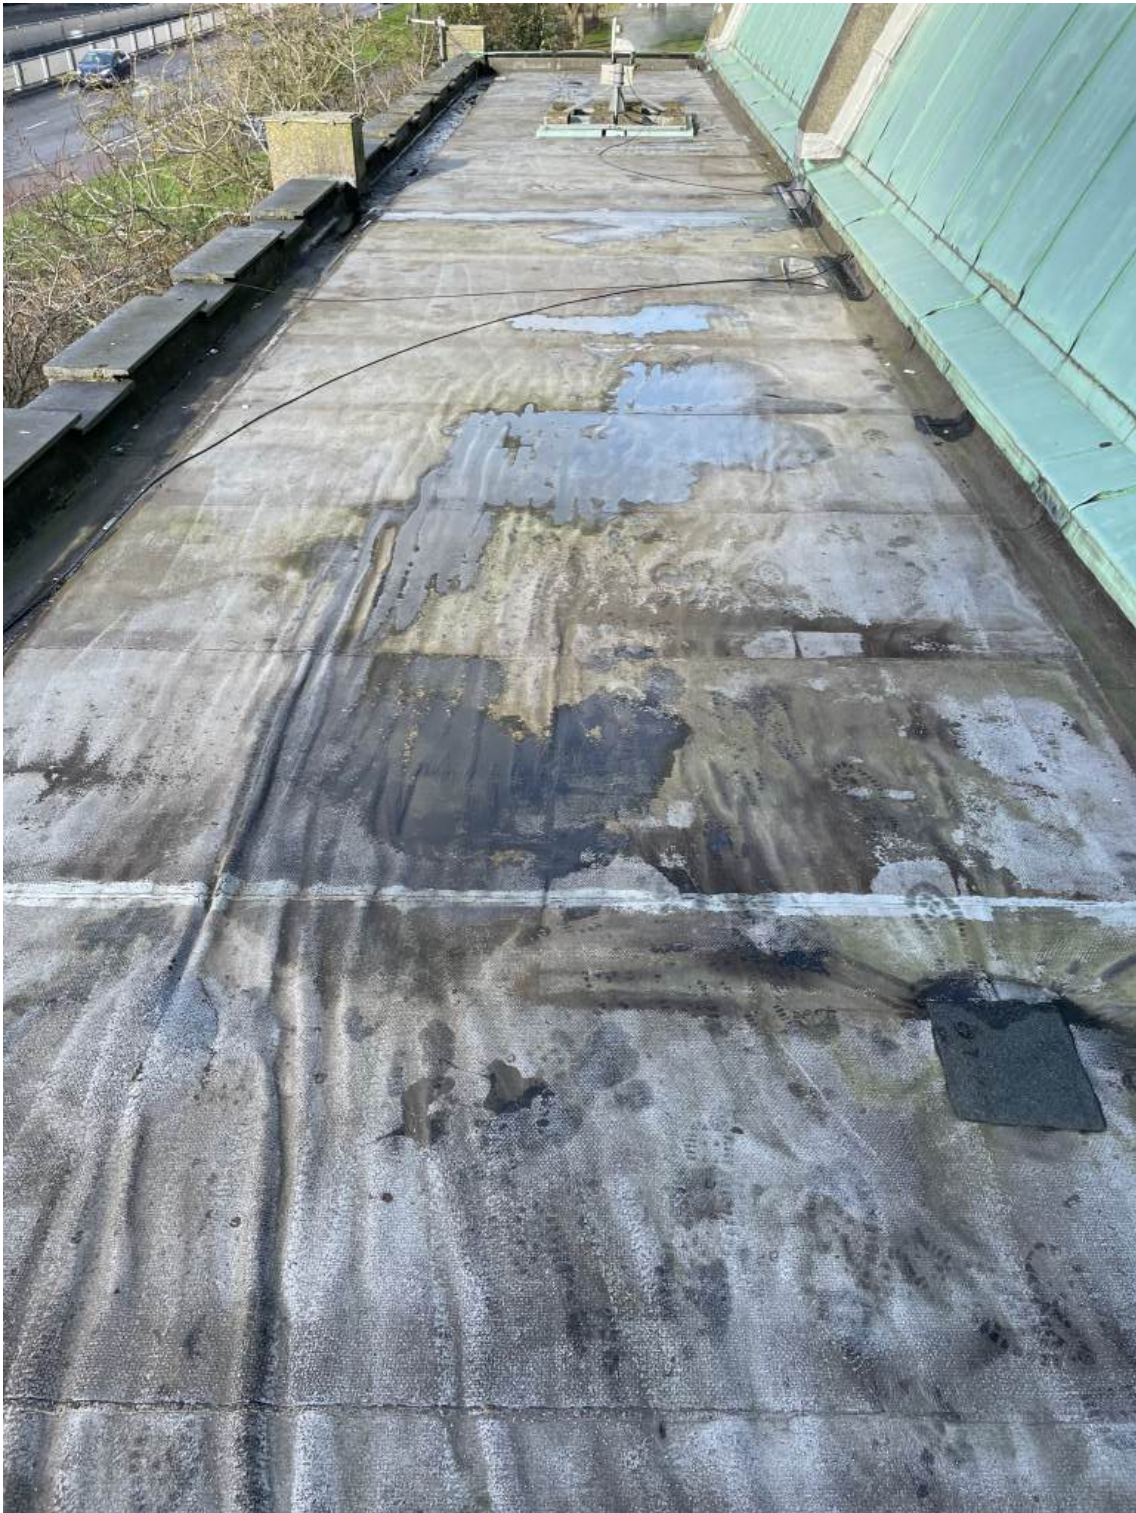
View looking west
South aisle roof
St Andrew and St George

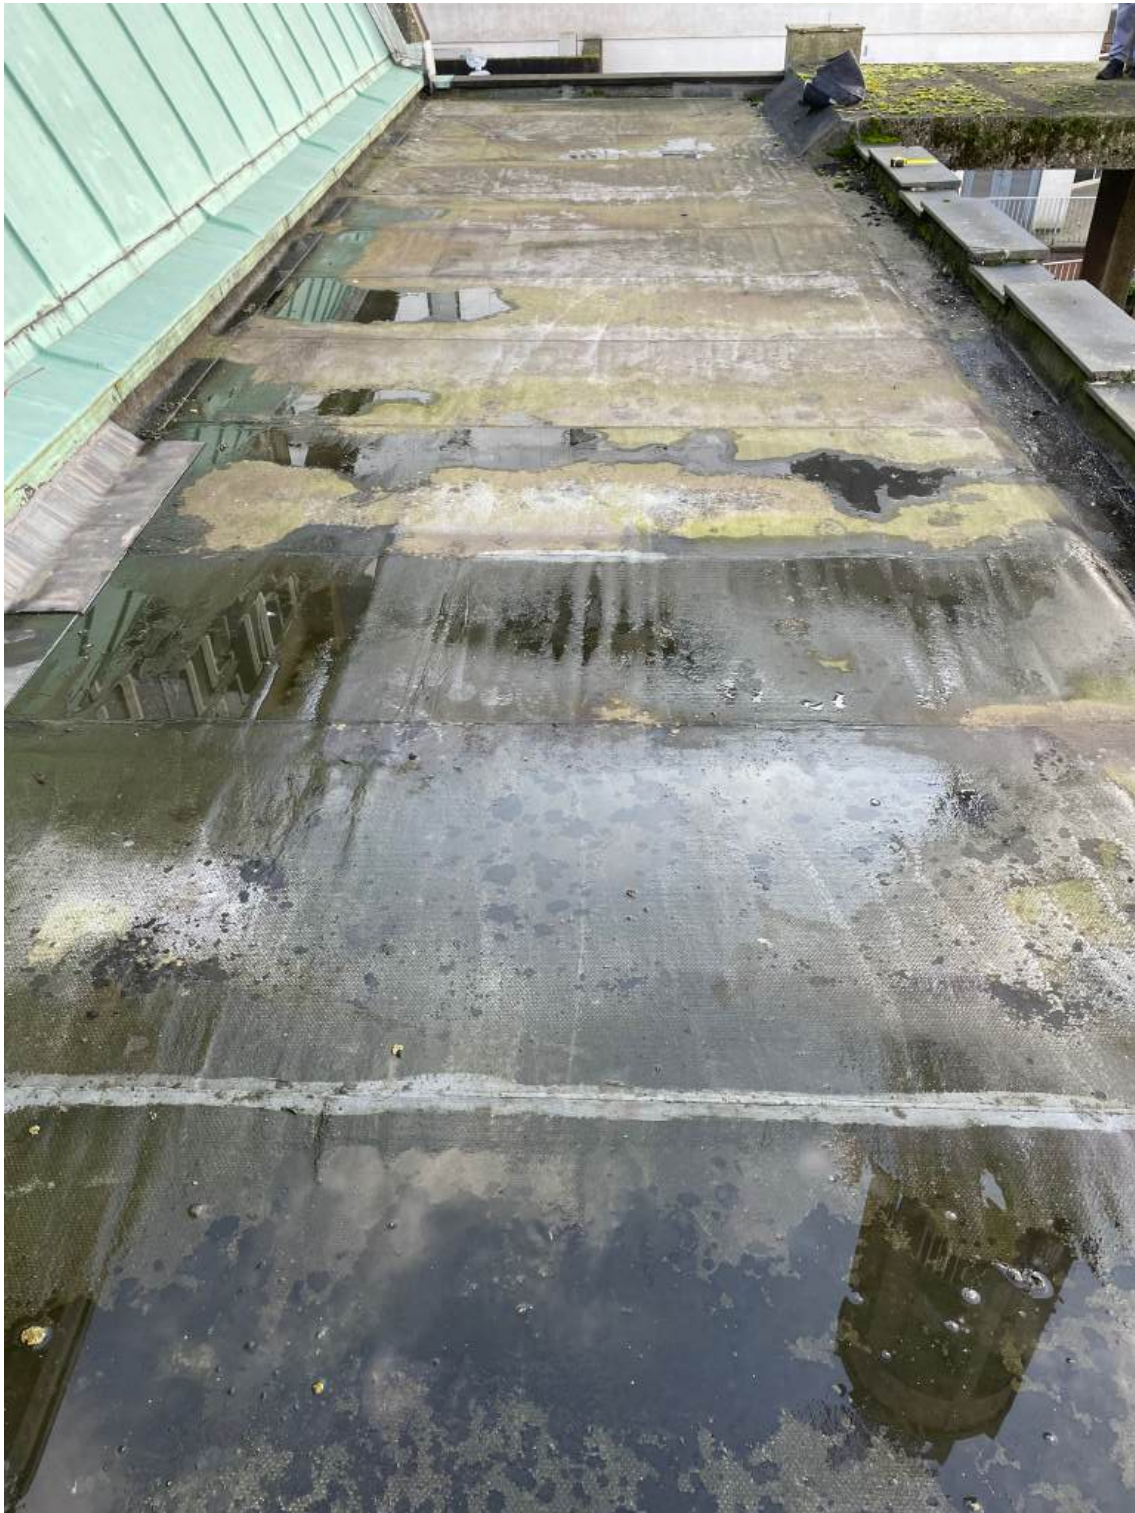
View looking east
South aisle roof
St Andrew and St George

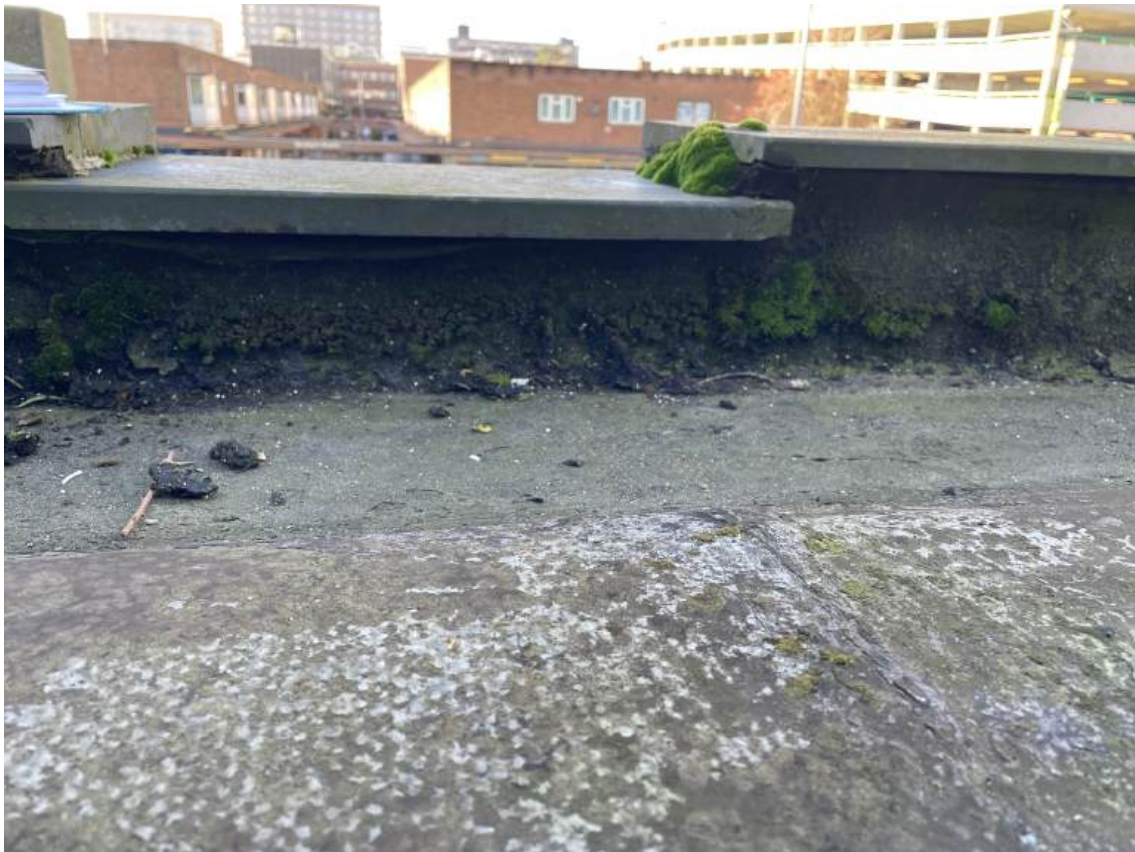
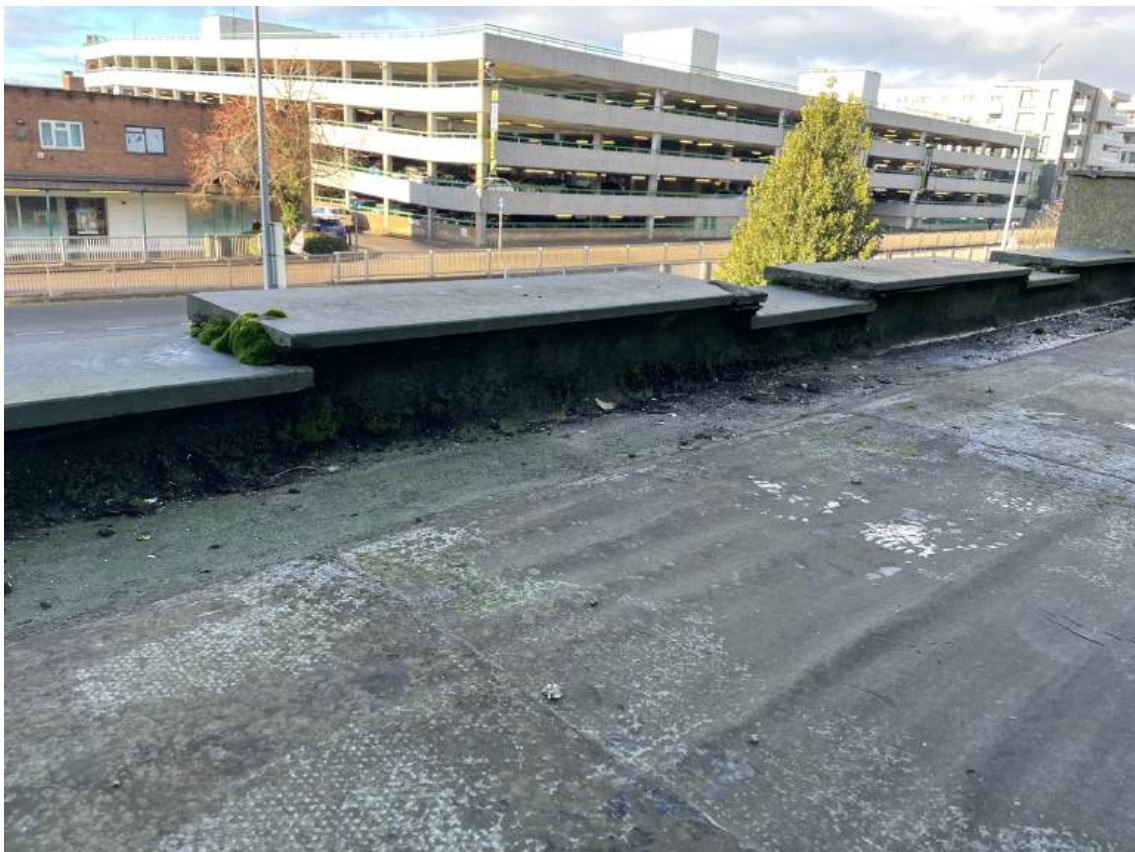
View of parapet with stone capping
South aisle roof
St Andrew and St George

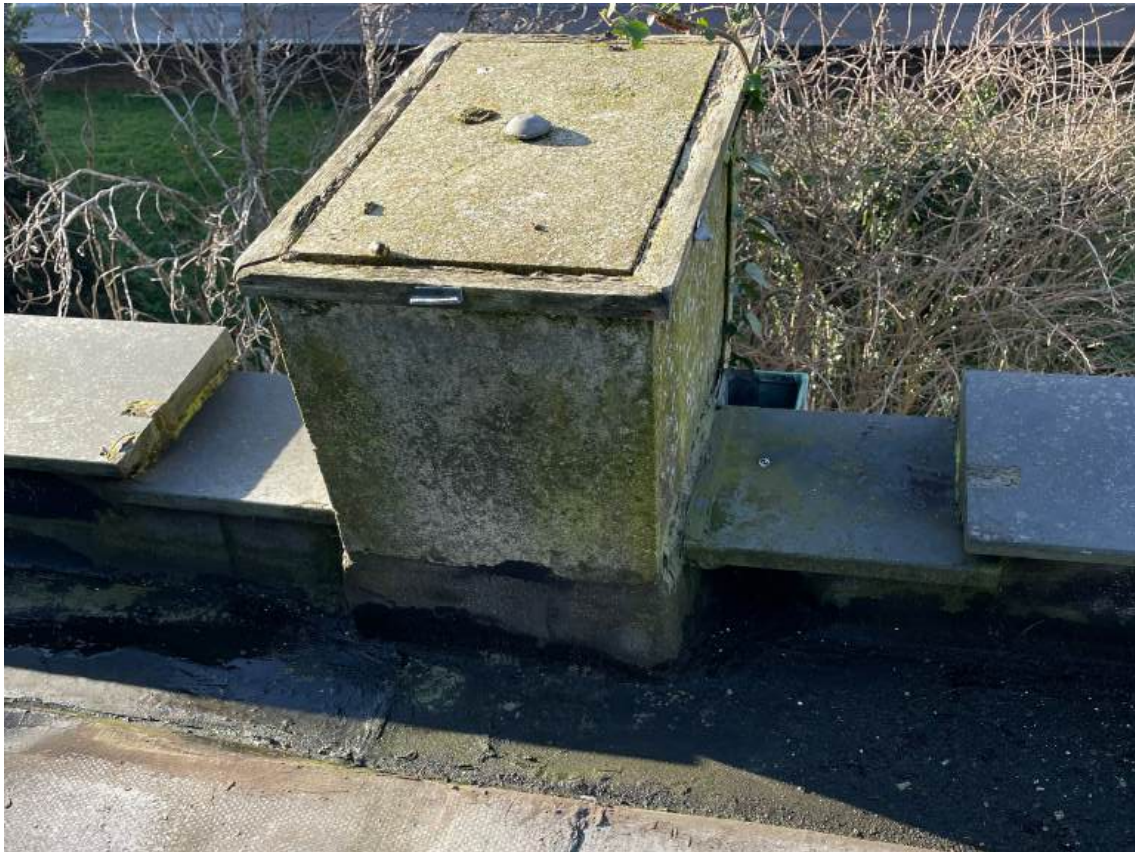
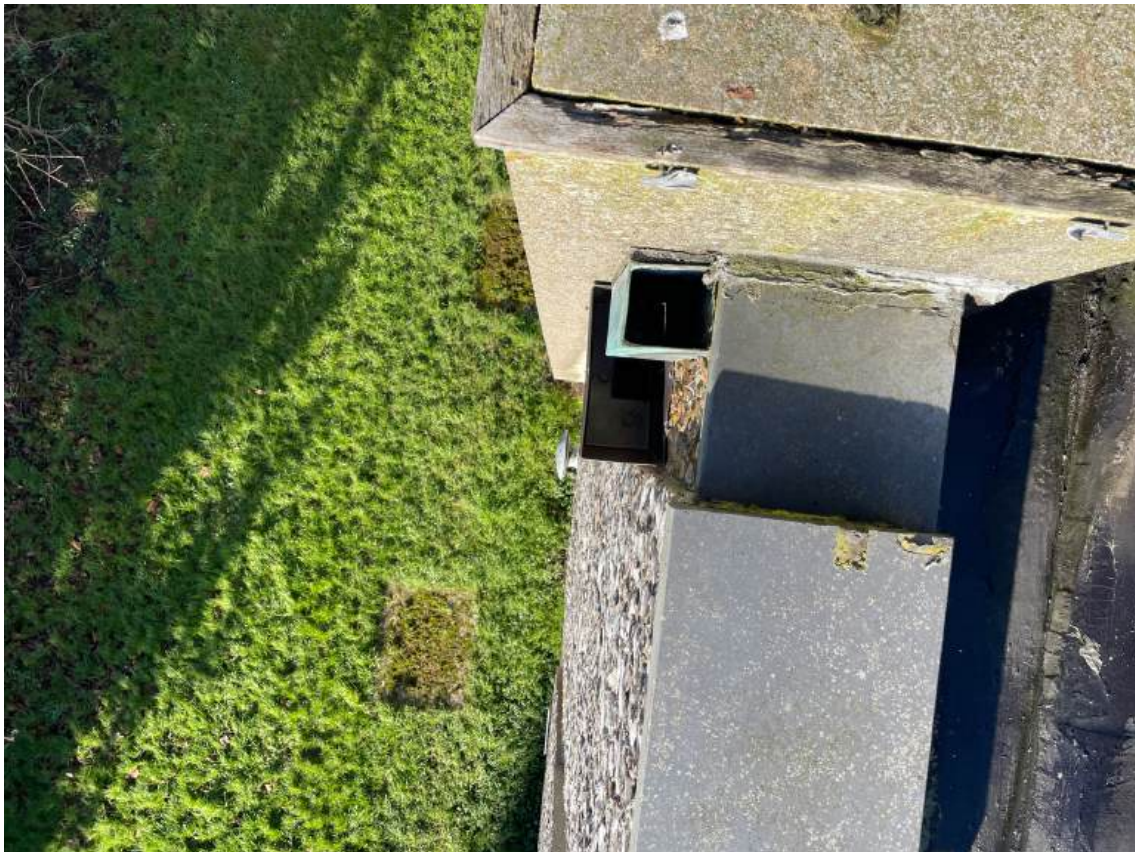
View of pier missing its capping and hopper and downpipe
South aisle roof
St Andrew and St George

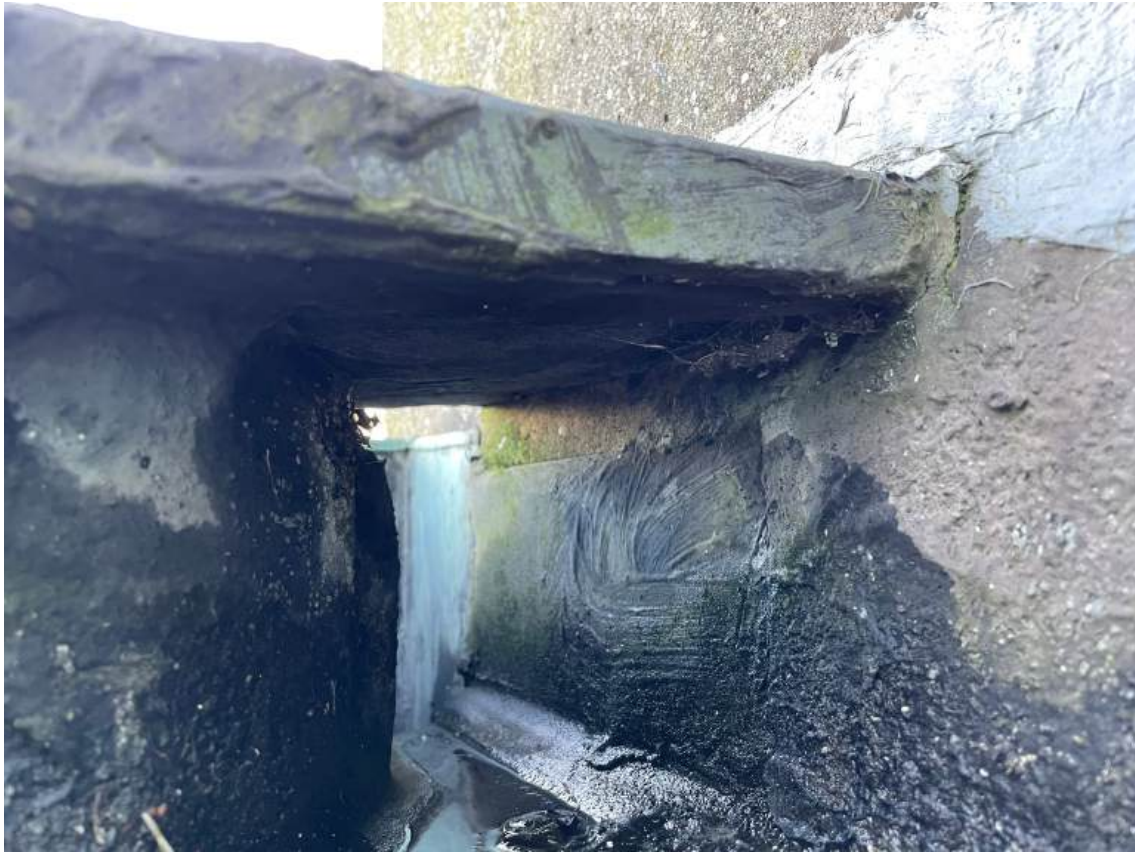
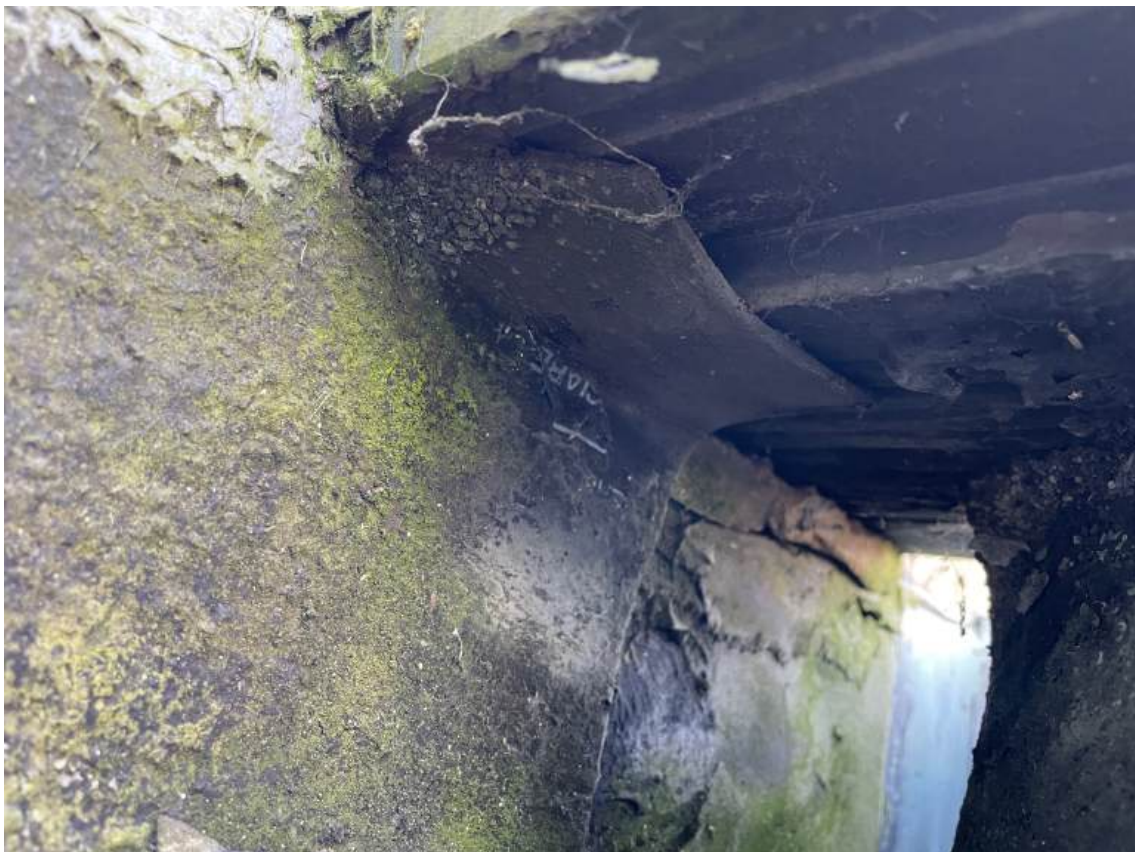
View of scupper through parapet
South aisle roof
St Andrew and St George

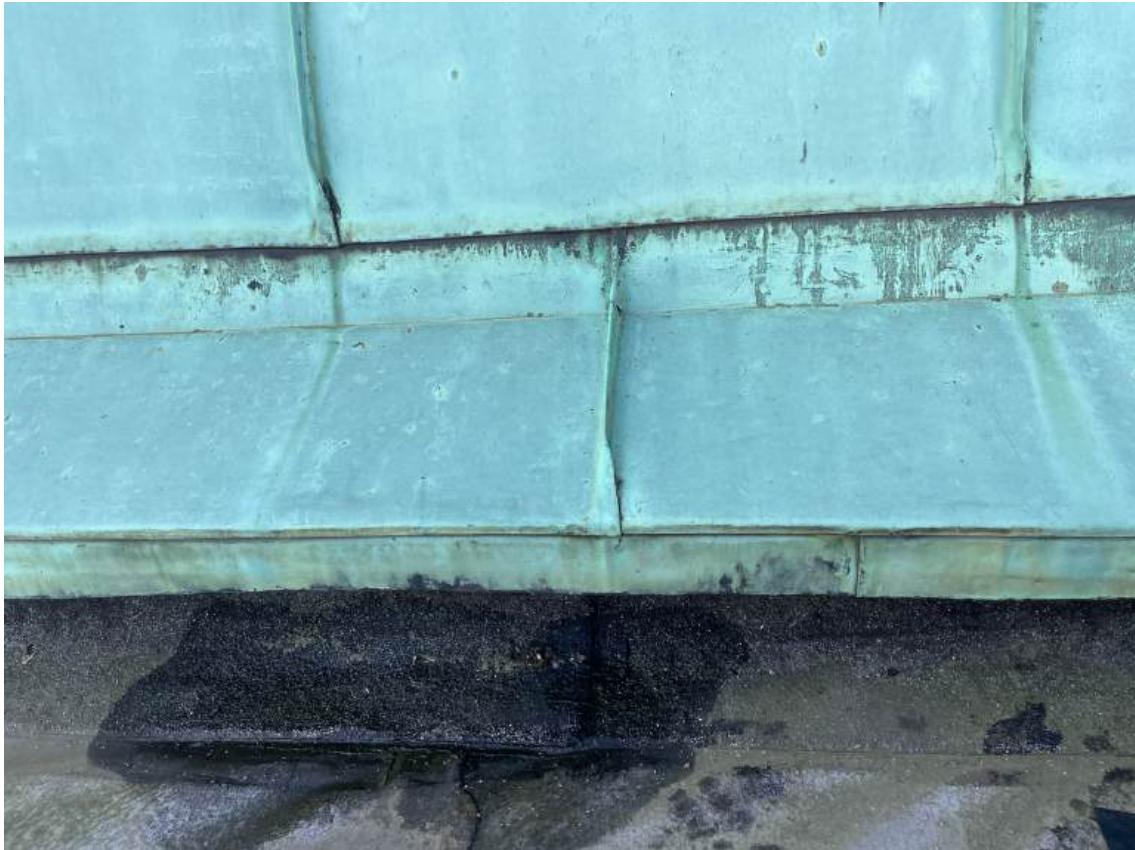
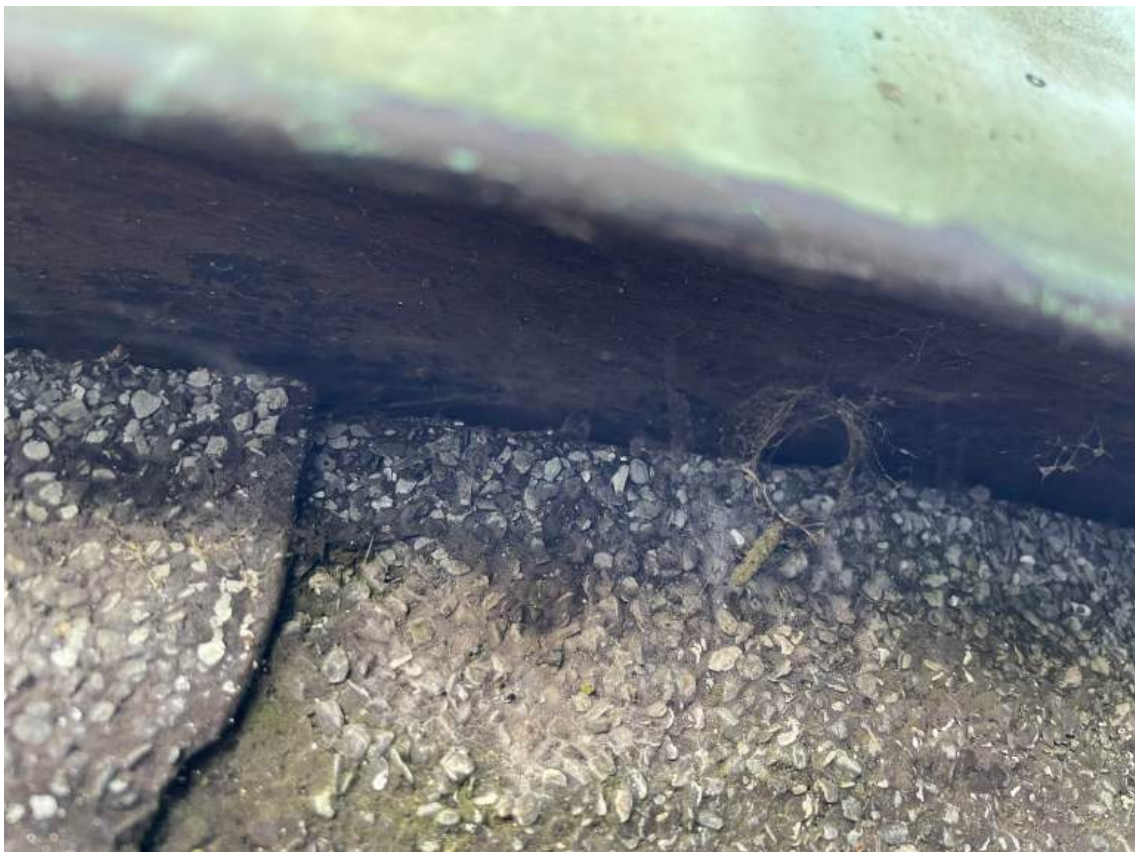
View of upstand and drip flashing to copper half barrel
South aisle roof
St Andrew and St George
