Phase 1 – Main entrance access improvements

Priory Heritage Historic Buildings Consultants

Sharnbrook Church – Internal Access Improvements

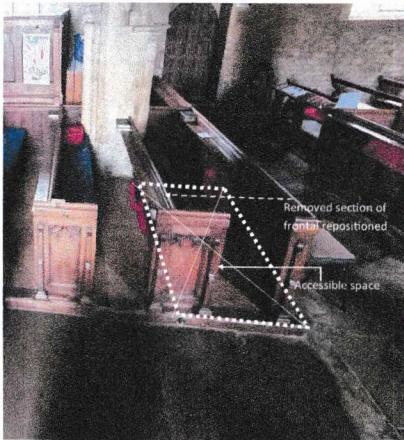
Areas A, B, C, D to have 1No pew removed and frontals relocated to provide space suitable for wheelchair or pram use during services.

Pew base reduced in height. Timber kerbs repositioned around edge of retained plinth and clear area made flush with Nave floor using stone paving to match.

NB, When required loose chairs will be positioned to permit able bodied people to sit alongside those using spaces C + D.

Loose, non original, pews removed and replaced with choir stall pews relocated from Chancel

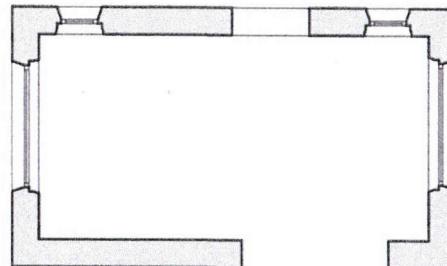
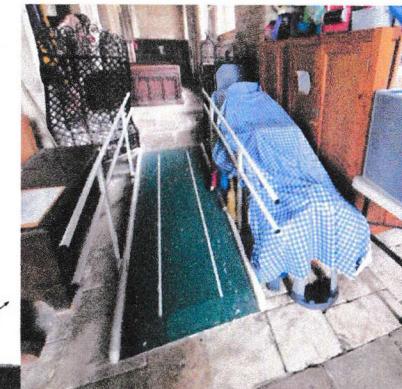
Existing temporary metal ramp replaced with fixed York stone paved ramp constructed over exiting retained floor slabs to apx 3050mm length reducing gradient of current ramp.

New ramp fitted blacksmith made black wrought iron handrail both sides.

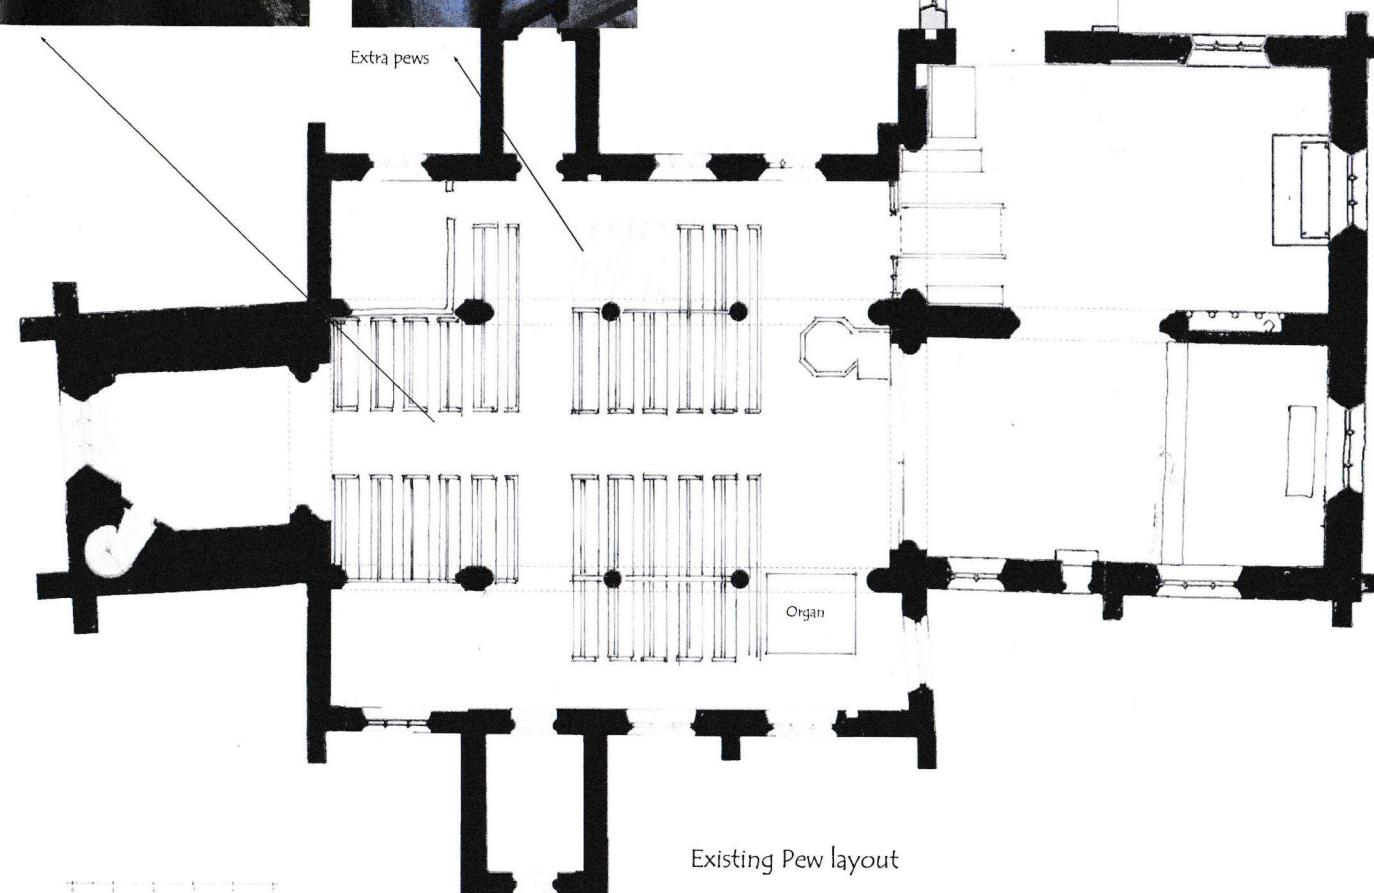
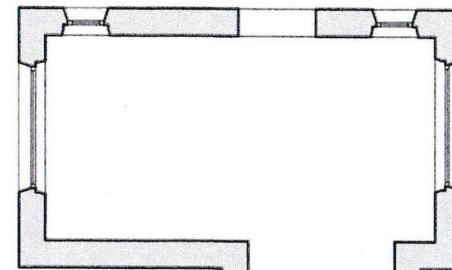
DRG-2416-P2-6

Existing pew configuration

Extra pews
