Priory Heritage Historic Buildings Consultants

Shambrook Church - Internal Access Improvements

DRG-2416-P2-1a

Proposed Chancel Plan

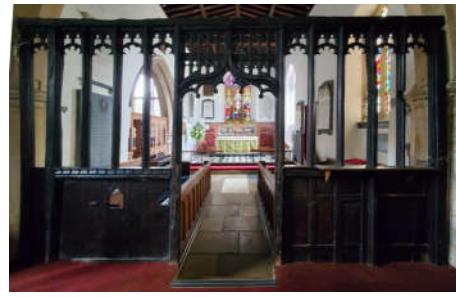
Existing chancel arch screen

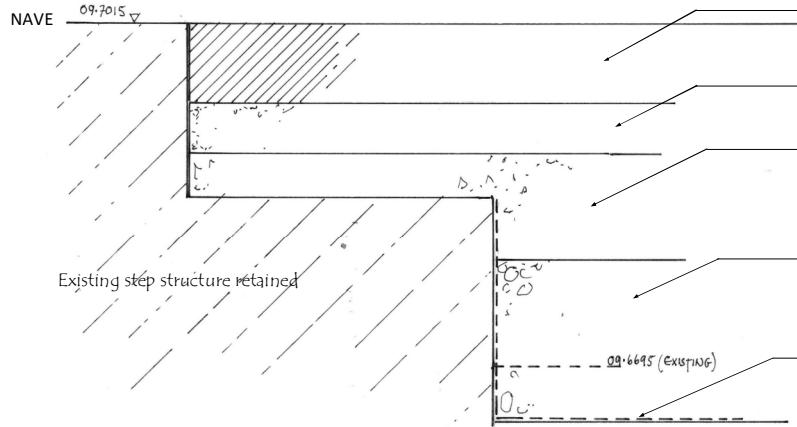
Floor Detail A

Existing step structure retained  
 Relaid paving / memorial slabs  
 Lime screed bedding to set variable slabs to a flush surface evenly between FFL in Nave and at Chancel step  
 Level sub base apx100mm lime concrete  
 Consolidated MOT type 3 crushed limestone or similar to infill after removal of existing floor paving / memorials  
 Geotextile membrane over exposed surface to provide support to any soft areas and isolate new from retained step masonry

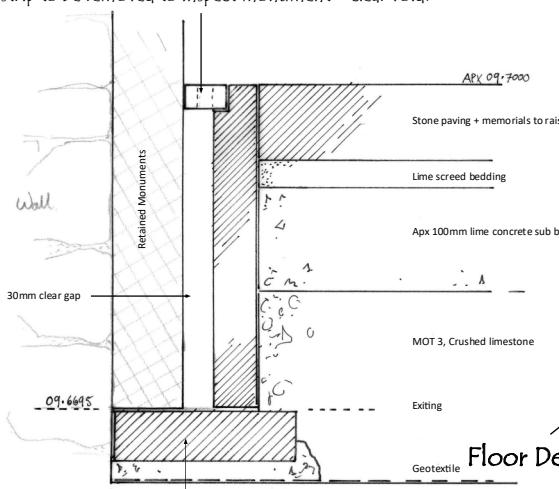
Floor Detail C

Rebed new section stone slab at original level to support monument and form base of vent gap structure

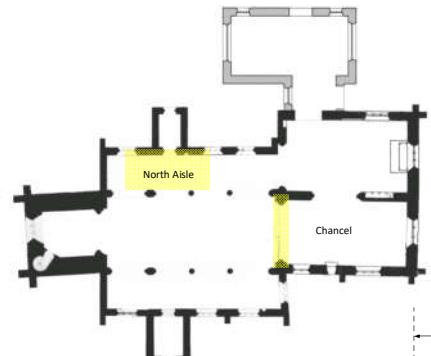
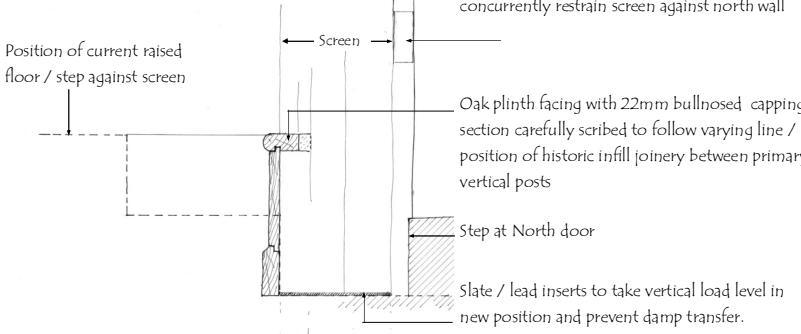
Plinth Facing detail

Nominal post profile, varies to each post + different heights

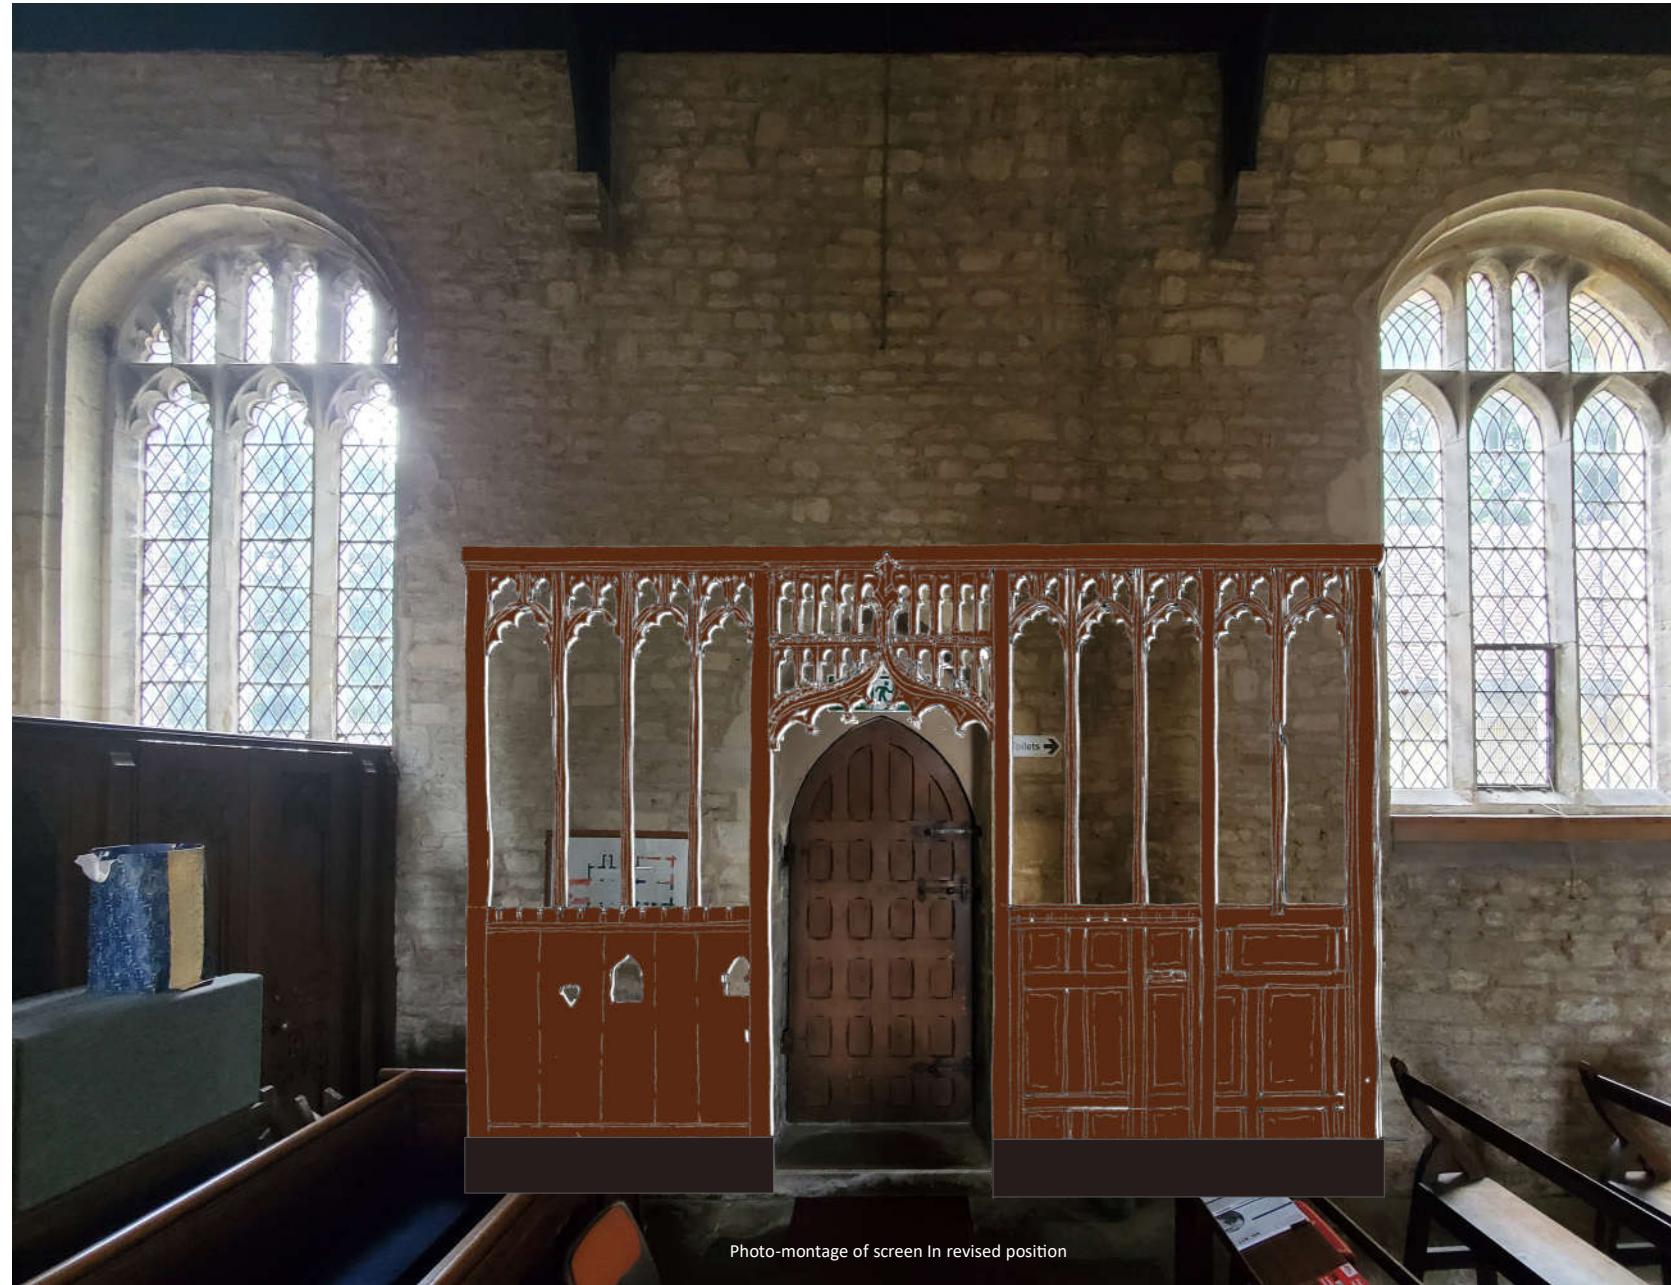
Photo-montage of screen in revised position
