CHURCH OF ST EUSTACE
IBBERTON, DORSET

MONUMENTS & ROYAL ARMS

CONDITION ASSESSMENT
&
CONSERVATION RECOMMENDATIONS

JANUARY 2026

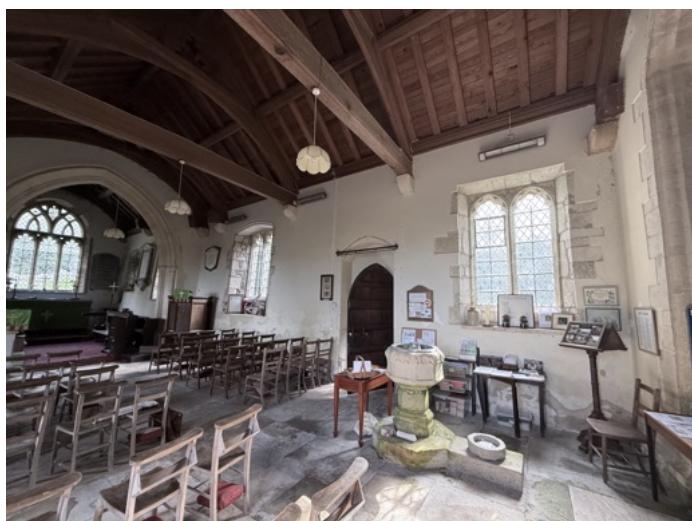
The church has suffered historically from damp and structural issues, and in 2002 works to renew the lead valley roof were completed. Visual evidence of the damp issues may be noted throughout the church. The decalogues on the west elevation of the chancel have suffered the most from the damp and the surrounding walls are in poor condition. The wall upon which the monument to Rev. Richard D'Auberry (005) is fixed, on the north elevation of the chancel, leans outwards and has large cracks across the render and around the monument itself, the stability of which are unknown.

Figure 19 ~ Interior view looking southeast, of the Nave and Chancel.

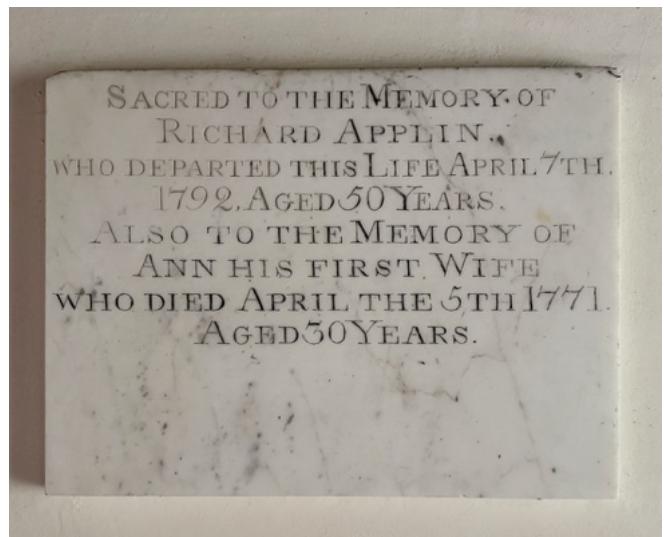
LOSSES ~ None noted, however see note above.

STAINING AND SOILING ~ Surface is soiled.

PAST REPAIRS ~ None noted, although refixed in the past.

LEGIBILITY ~ The lettering is legible but faded, especially towards the top left / dexter of the monument.

Figure 25 ~ Monument 2 to Richard and Ann Applin.

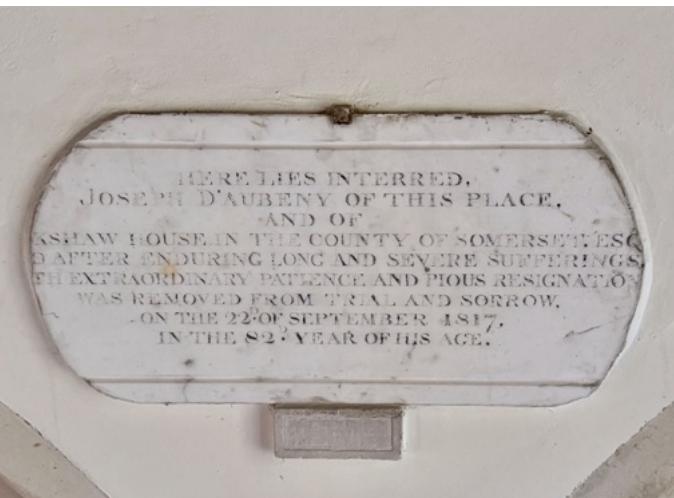
LEGIBILITY ~ The lettering is faded and uneven.

Figure 27 ~ Monument 4 to Joseph D'Aubeny.

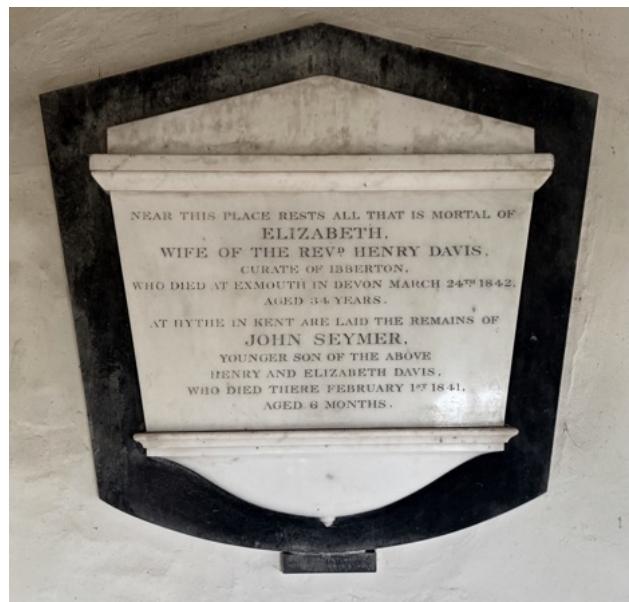
LEGIBILITY ~ polychromy within lettering is slightly faded in the top left / dexter of the inscription but legible.

Figure 36 ~ Monument 6 to Elizabeth Davis and John Seymer.

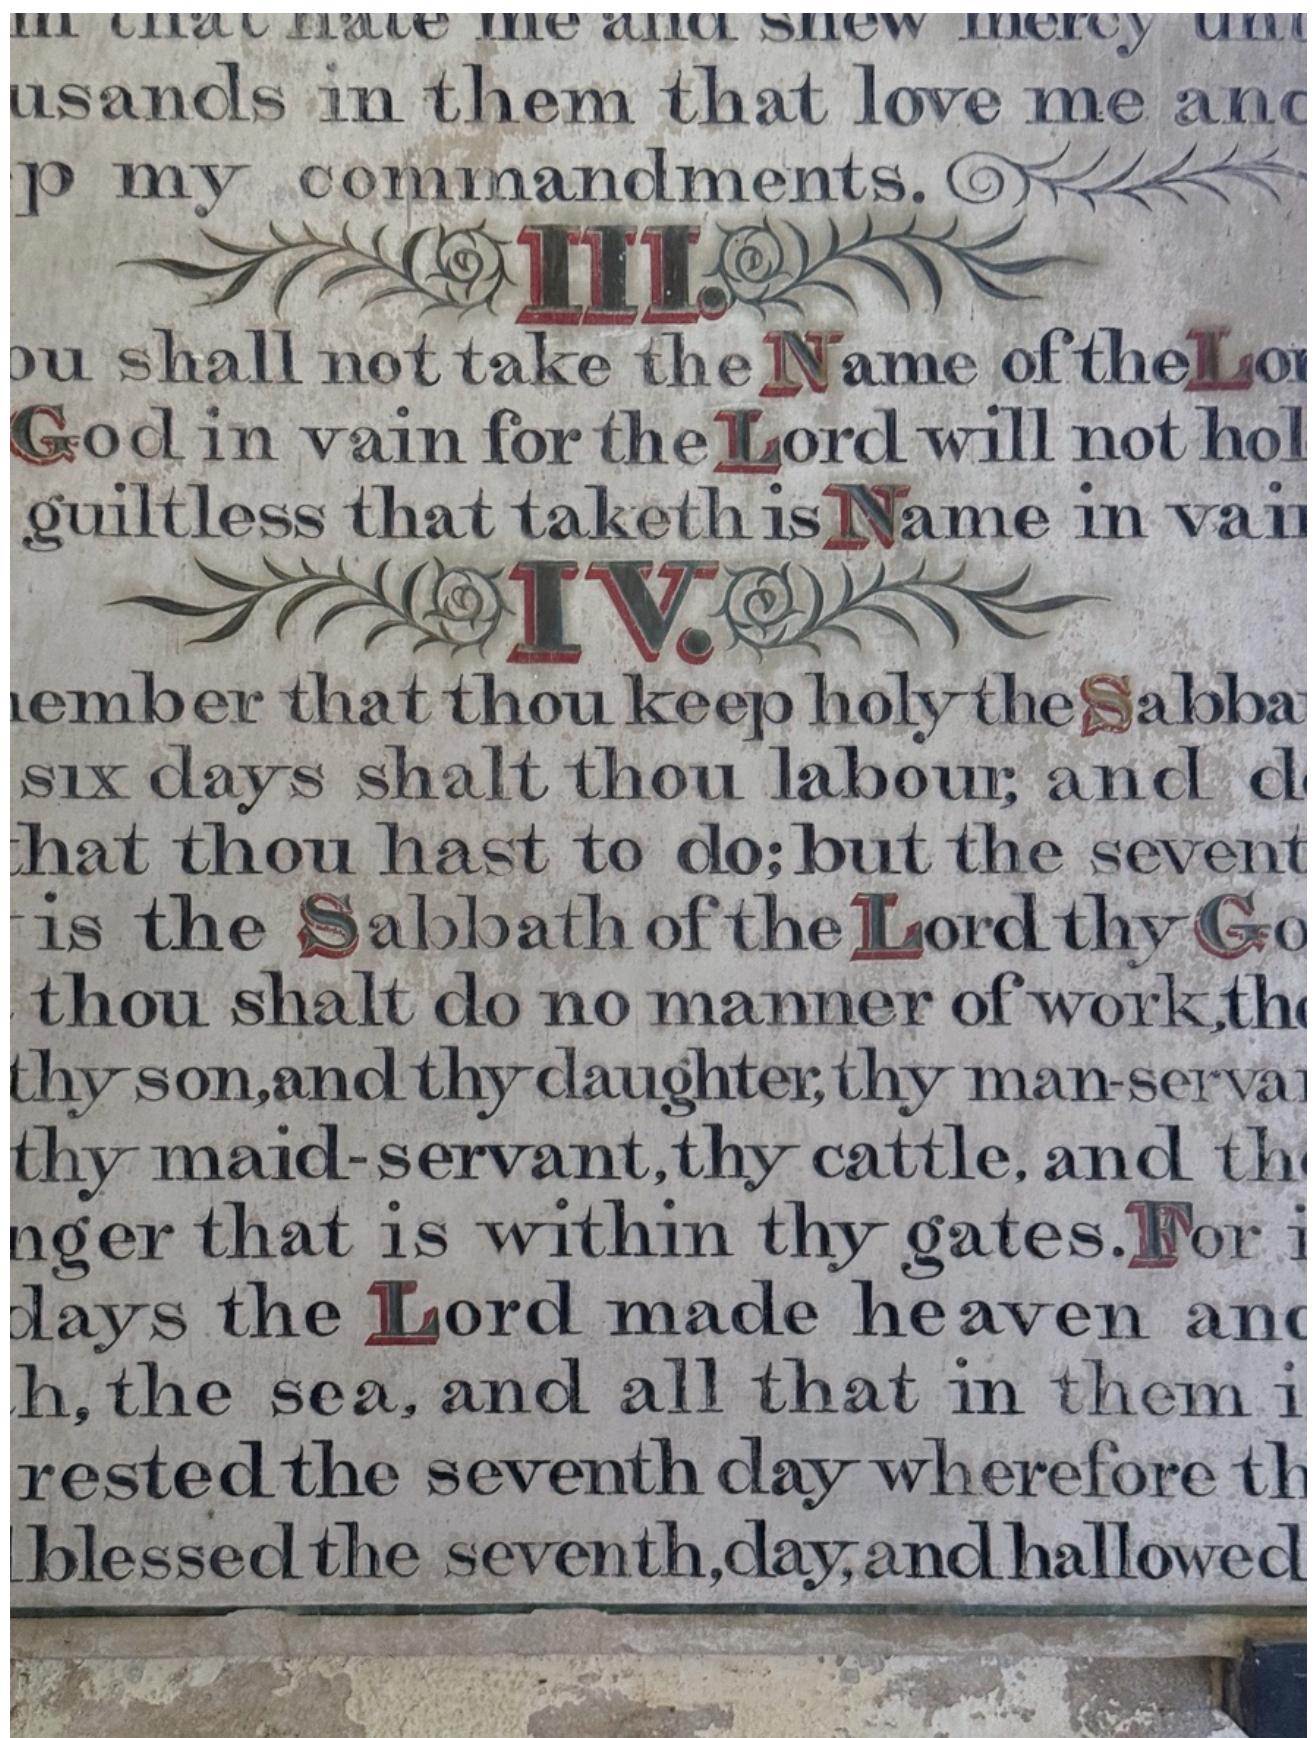
Figure 46 ~ Detail illustrating lettering on Decalogue 1.

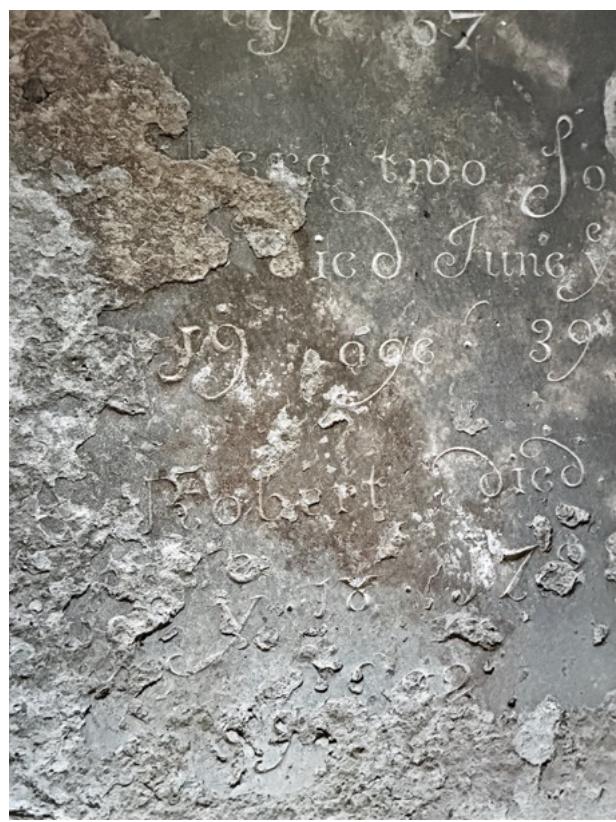
Figure 49 ~ Detail of legible part of inscription of ledger stone 009.

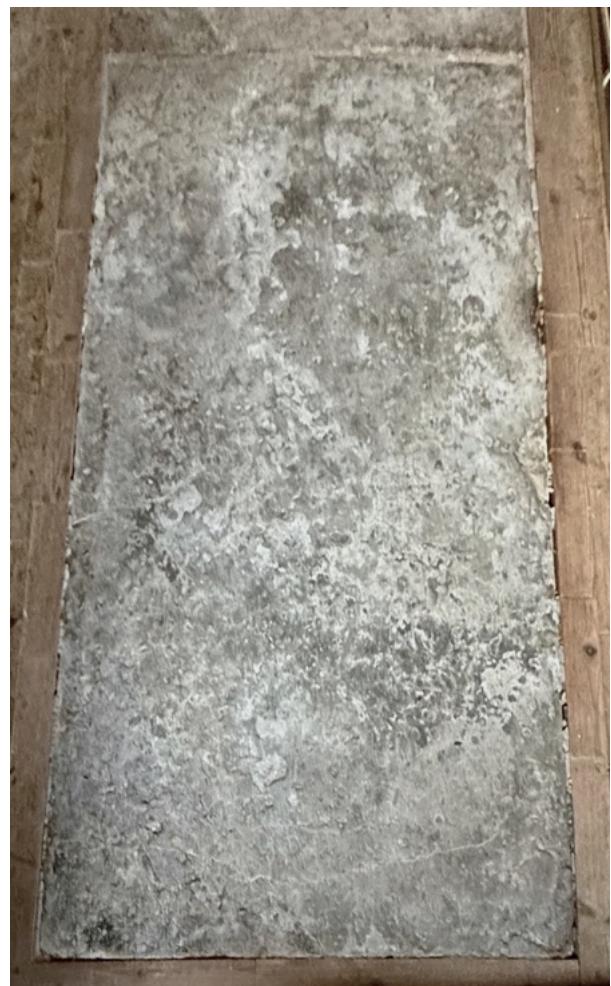
LEGIBILITY ~ Poor. The remaining lettering is extremely vulnerable to further loss.

Figure 50 ~ Ledger stone 010 to Hannah Aplin.

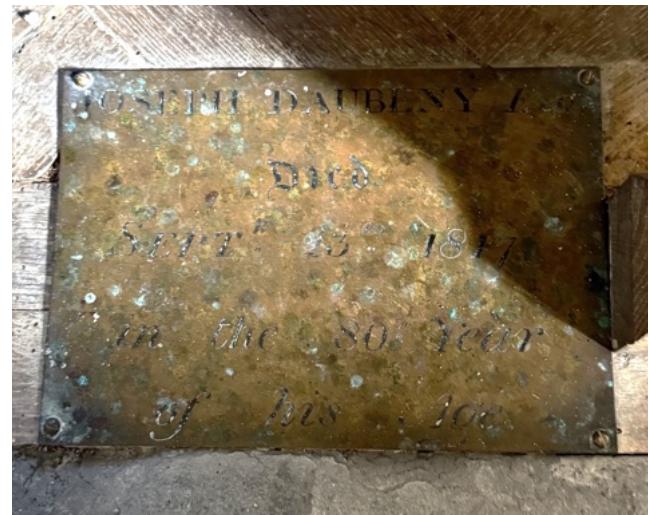
POLYCHROMY & LEGIBILITY ~ Black polychrome inscription is worn, but legible.

Figure 53 ~ Brass coffin plate set in floor.

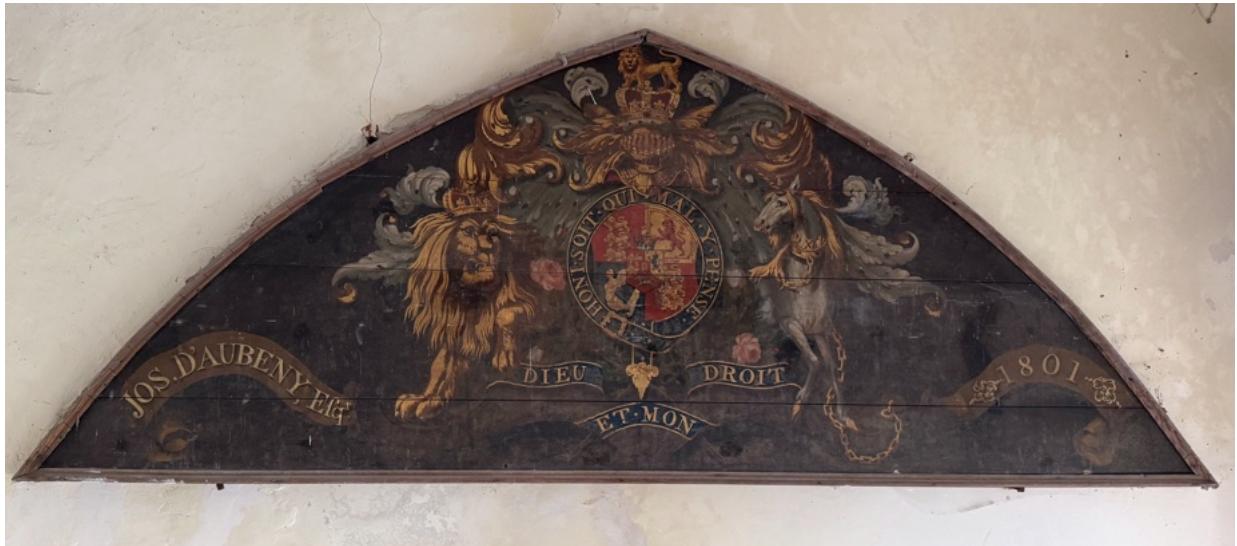
The Royal Arms have been moved over the years and are possibly presented in a replacement frame. Records indicate the arms "used to fill the head of the Tower Arch, above the old gallery." In 1972 the Coat of Arms was cleaned, treated for woodworm and re-assembled. It was at this point it was relocated to the North Aisle. A note in the parish record states that it was painted by a J. (or I) Cunningham. Close inspection will enable a better understanding of the structure, past interventions, repairs and current condition.

Figure 54 ~ Royal Coat of Arms (012) of George III.

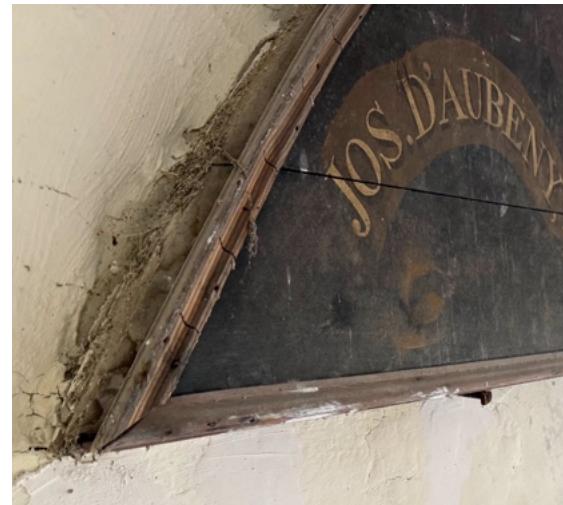
Figure 57 ~ Detail illustrating edge of frame and unpainted wall to rear of Royal Arms.
