# DAN HUMPHRIES STAINED GLASS LTD

## St Eustace Church, Ibberton, Dorset

### Conservator's Report

Windows: Complete Glazing Condition inc. Historic Stained Glass Fragments  
Date: January 2026

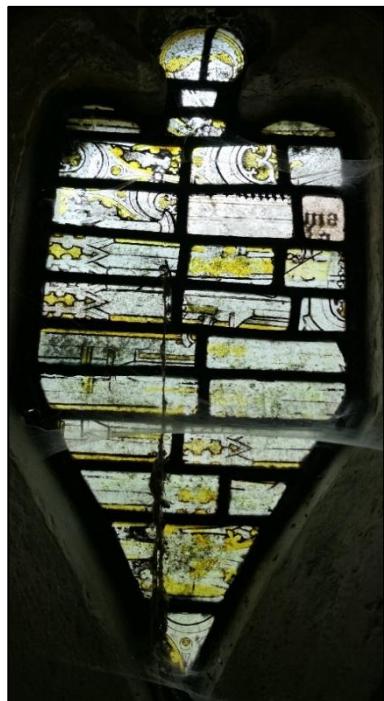
Panel B1 in the tracery is made up of C15th fragments painted and stained with architectural elements, text, and the head of a tonsured monk. In the panels either side are roundels of a sun (C1) and a crowned head of a figure (C2) set into modern quarries. These remains have been amalgamated together to fit the openings (prior to 1902) but are very likely to have come from this location within the church. The glass is crown or broad sheet, painted with dark brown vitreous paint and silver stain applied to the reverse. The lead is 5/16" as in the rest of the window. It is relatively modern flat bead lead folded round, probably from the c.1902 restoration.

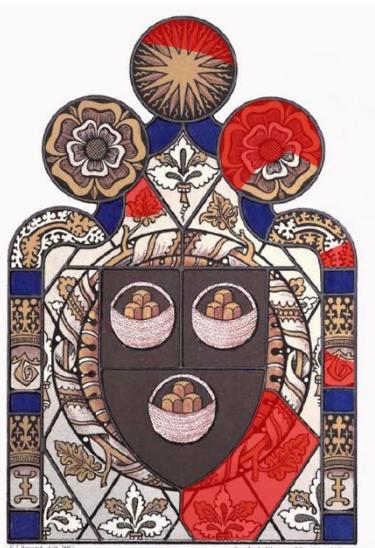
Panel 2b contains C15th stained glass depicting the arms of Milton Abbey. The panel belongs to the window opening and is described as “one of a series of five windows of a similar pattern, design, and proportion” by F.J.Baigent in *Archaeologia Vol. 48 (1884)*.<sup>5</sup> The five windows are sII, sIII, sIV, sV and nVI. Only sV and nVI have any remaining fragments. The glass is medieval crown or broad sheet and blue flashed glass. There are seedy textured antique cylinder glass infills (C20th) where original painted pieces are missing (see fig.8). The detail has been achieved with dark brown and black vitreous paint and silver stain on the reverse. There is also some back painting on the escutcheon.

Fig.8 – Missing historic glass illustrated in red.

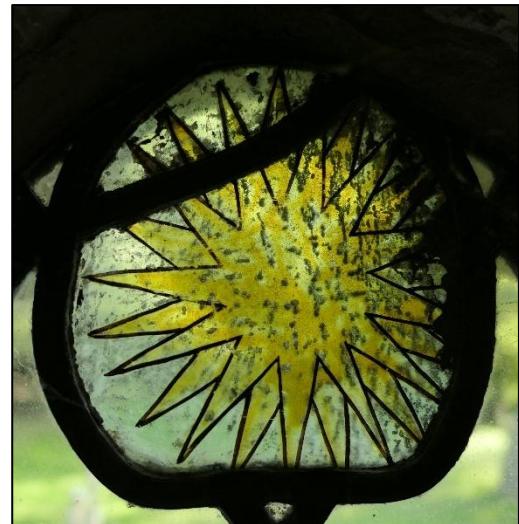
Panel 2b

The painted tracelines remain in very good condition. There is some mild to moderate pitted glass corrosion on the exterior face with some microbial accumulation in the pits. A glass break at the top of the fragment has been repaired with a mending lead during the last re-leading campaign. The lead is in a good stable condition. As in sIII, there are some chalky deposits leached from the leaded-light cement on the inside face.

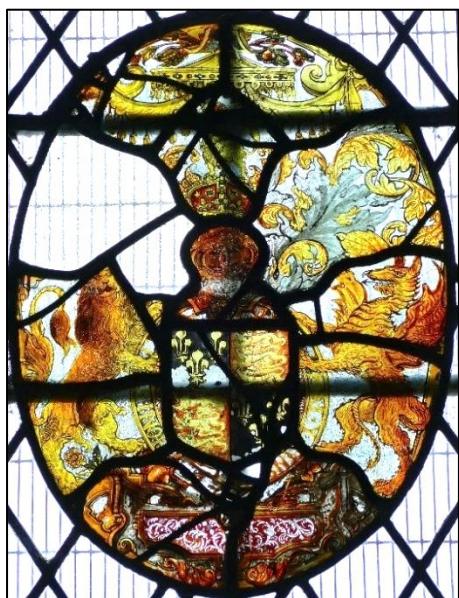
Light a, Panel 1a/2a

Window nIII contains two C16th oval panels set into modern quarries. The larger panel in light a displays the Tudor Royal Arms, and the adjacent panel in light b contains a rose with crown and Royal Cypher E.R. (Elisabeth Regina). The glass is likely crown, with seedy textured antique cylinder glass infills (C20th) where original painted pieces are missing. There is a panel division in both panels at the top lug bar level splitting them into two parts.

The paint is in a deteriorated state. Corrosion pits forming beneath the paint and enamel layers have caused it to flake off in many places. Other areas of enamel failure on the inside face have also shaled off (fig.11), often taking some of the glass surface with it. The field behind the Fleur de Lis in 1a and several parts of the garter and ornament of both panels is painted with blue enamel which has now turned grey through chemical leaching (fig.12). Despite this, both panels are legible and much of the decoration can still be appreciated.

The lead is modern, as in the other windows, and in good condition except for some chalky crusts on the inside face leached from the leaded light cement (fig.13).

The C16th enameling in nIII has deteriorated badly in comparison to the medieval paint and stain in the other windows. Installing a ventilated protective glazing system (EPG) can effectively arrest paint loss and glass corrosion and would be an option to consider for this window given its historical significance and artistic value. EPG is the current best practice for protecting windows with vulnerable paint. It works by preventing condensation from forming on the historic glass and relieving the window of its function as a weather shield. The technical aspects of EPG systems are complex, and exact specifications vary taking into account the size of the window, location within the church and potential visual changes to the elevation. We recommend that EPG is considered by the PCC for window nIII. An estimated cost is provided on pg. 30, however, a more detailed specification should be designed should the PCC wish to proceed with further discussion.

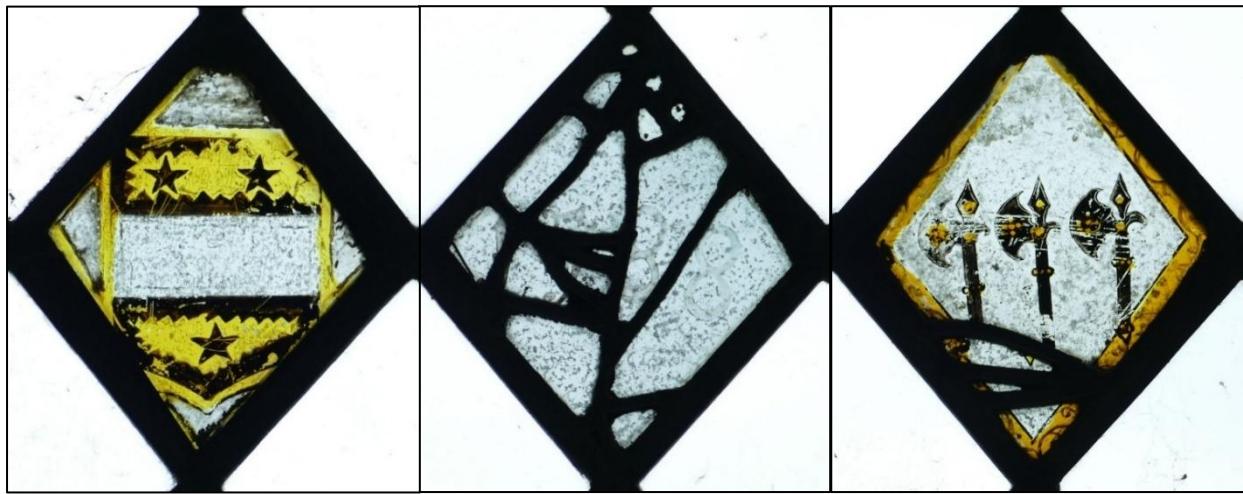
Each light in nV contains a single stained glass quarry set into the clear modern glazing. 1a and 1c are decorated with armorial shields and devices, and light b bears the date 1588. According to Baigent in *Archaeologia Vol. 48*, the quarry dated 1588 belongs with the Tudor Royal Arms in nIII, the armorials in lights a and c are C17th additions to the church.<sup>6</sup> The arms in 1c are identified by Baigent as Gibbs of South Perot, but later as Leweston of Dorset by the Rev. L.S. Ploughman.<sup>7</sup> The arms in 1a are unknown; the mullets (stars) may relate to the Mullett family of Ibberton.<sup>8</sup>

The lead appears to be from a different, probably earlier re-leading campaign than the others in the church. There is some reddish lead corrosion on the exterior of the glazing (fig.16), but it remains in a stable condition.

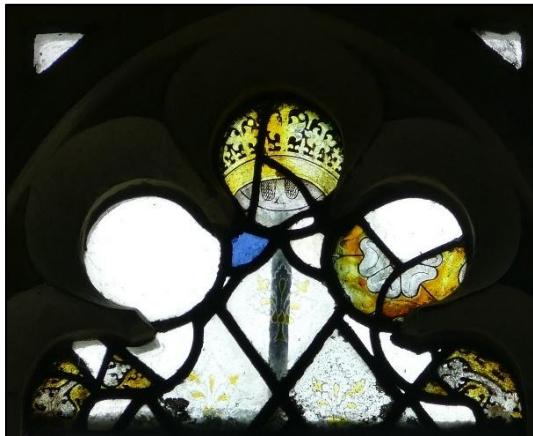
Panel 2a

The panel heads contain C15th ornamental quarries with crowns and roses in the lobes. The similar borders and quarries suggest they belong to the same scheme as the armorial in sIII and the remains in sV. It is likely that they are also in their original positions and have not been relocated. The glass is crown or broad sheet with blue and ruby flashed glass. As in I, sIII, and nIII, there are seedy textured antique cylinder glass infills (C20th) where original painted pieces are missing. The glass is painted with dark brown vitreous paint and silver stain on the reverse. The lead is C20th, 5/16" flat bead folded round with 1/4" mending leads.

The paint is in fairly good condition at the borders and lobes, with only a small amount of loss despite some glass corrosion on the inside face and areas thick with algae. Conversely, the paint has faded almost entirely from the ornamental quarries in both panels (fig. 18). This extensive loss of paint is likely the result of combined factors, such as inadequate firing and repeated washing of the surface during condensation cycles.

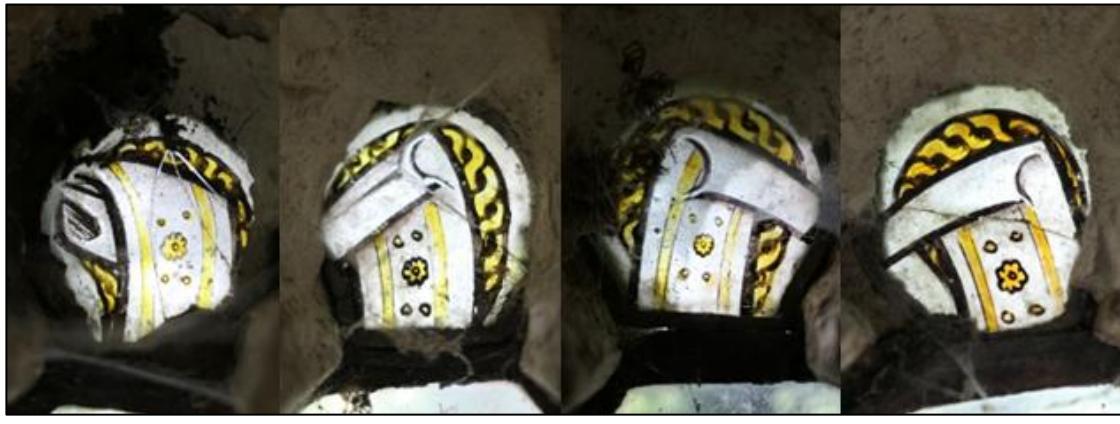
The heads of each of the four perpendicular tracery panels in wI contain C15th stained glass depicting the ends of scrolls. According to Baigent, in 1844 there were remains of a winged lion and a scroll of St Mark in this window,<sup>9</sup> but this glass is not there today.

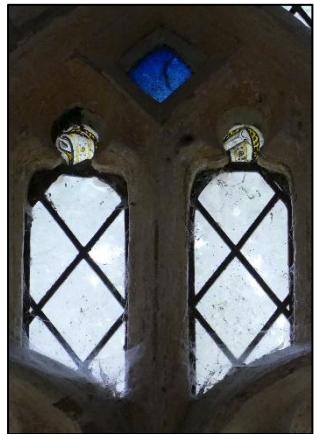
Panel B1

There is a large piece of unpainted medieval blue glass filling B1 which also remains from the C15th scheme. The glass in the heads of row A is crown or broad sheet with dark brown vitreous paint and silver stain on the reverse. The glass in B1 is unpainted blue flashed glass.

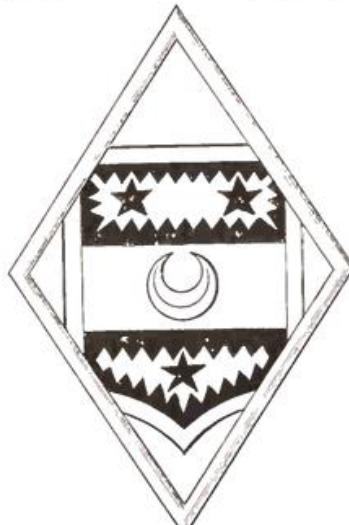
Fig. 2.

that the lead-work follows its original dimensions, but in the other (Fig. 2) the piece of glass has been cut away to fit the shape and size of the lead-work arrangement of the window, and it is placed in a reversed position, the pointed end of the shield being uppermost. I have not succeeded in identifying the coat of arms on the latter quarry. In Hutchins's *History of Dorset* (first edition, 1774) it is blazoned inaccurately as *Or, a fess sable between three mullets in a border engrailed argent, a crescent or.* In the last edition (1871) it is given as *Or, a fess argent between three mullets in a border engrailed sable, a crescent gules.* The crescent retains not the slightest trace of colouring. This piece of glass may be Dutch or German, the shape, bordure, and charges of the shield not resembling English heraldry.
