Bianca Madden MSc ACR  
Conservator of Wall Painting and Polychromy  
The Garden Flat 5 Rawlinson Road Oxford OX2 6UE  
07789067364/01865 513144 bianca@biancamadden.com  
www.biancamadden.com

Conservation Condition Assessment and Proposed Treatment Strategy  
12 Apostle Wall Paintings, St Paul's Church, Whiteshill, Stroud, Glos

March 2026

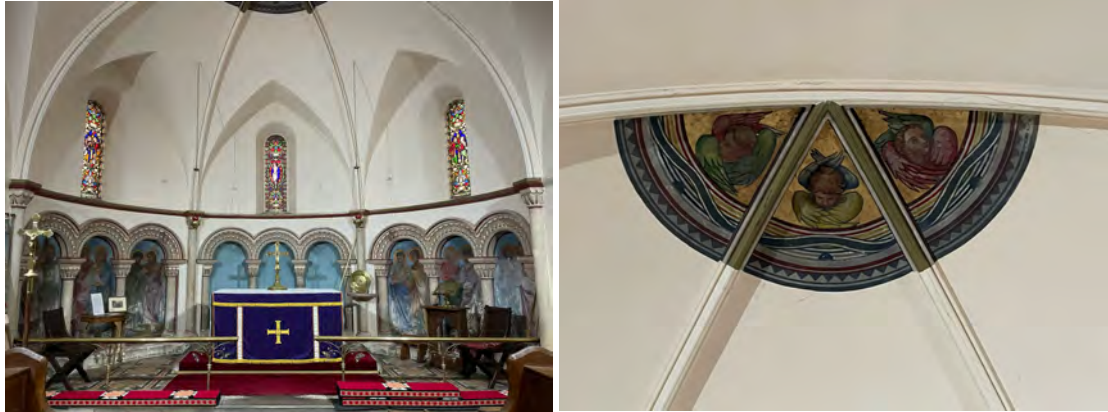
The 12 Apostle wall paintings date from 1872–1905 and were painted in a Pre-Raphaelite style by the local sisters Rose Emily and Emily Rose Stanton. On casual viewing, the figures, iconography, and overall colour scheme of the wall paintings remain legible, despite evidence of water-related damage and a whitish bloom across the surfaces. Another surviving area of painting, by the sisters, is visible on the ceiling of the apse, with part of an associated polychrome scheme retained on the adjacent ceiling ribs.

*The 12 Apostle wall paintings, in their setting in the apse, as it appears now, left. Right, the surviving painting on the apse ceiling*

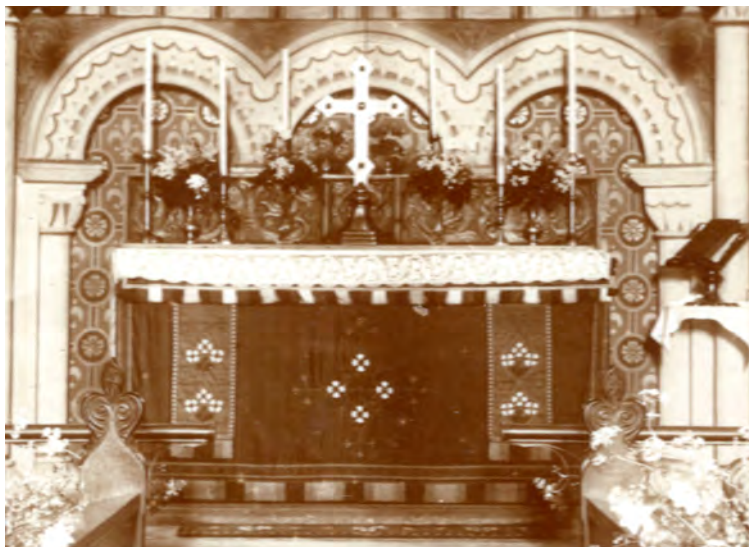
High-resolution scans of a c.1910 photograph of the church interior, provided to inform this assessment and research, and confirm that the decorative scheme in the apse was formerly much more extensive than is now visible. The image clearly shows decorative (non-figurative) painted ornament in the three panels behind the altar. The photograph also shows a painted text band beneath the string course of the apse, as well as, seemingly, decorative painting within the spandrels between the stone hood moulding of the arches (see page 4). These elements appear still to be present at the time of the 1930s watercolour of the interior.

*A detail of the panels behind the altar, taken from the c.1910 photo of the chancel/apse*

While the simplification or overpainting of Victorian decorative schemes of this kind was not uncommon in later phases of church redecoration, the three central panels appear to have been painted blue prior to being boarded.<sup>2</sup> By 2011 the central panels were covered by boarding, painted cream to match the surrounding interior photograph of the church interior.<sup>3</sup> The blue overpainting may have been undertaken due to already active deterioration of the painted decoration (which seems likely, particularly as it appears it may have been undertaken at the time of the retouching on the other

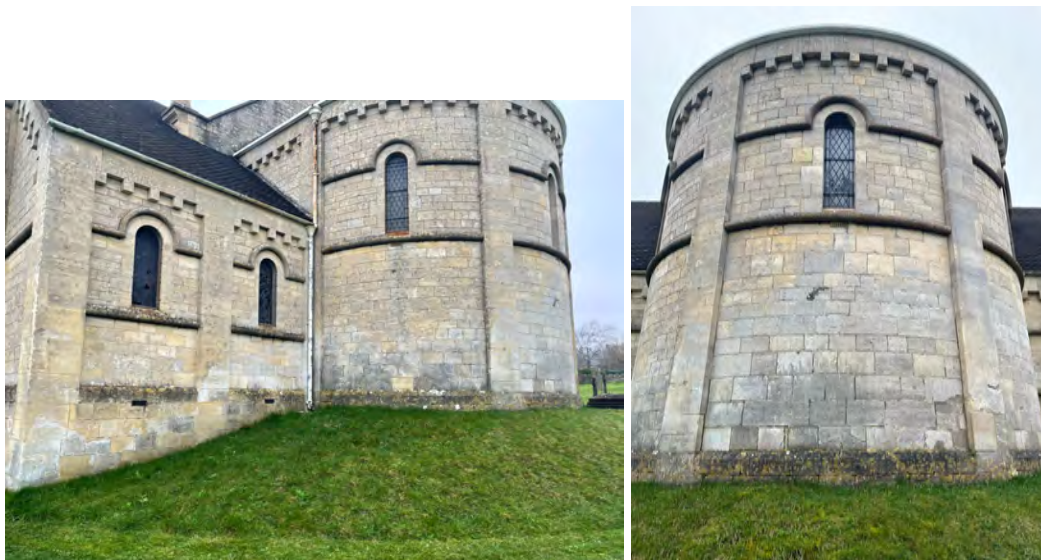
The architect's Quinquennial Inspection of August 2021 describes the building's overall condition as fair. It notes blocked gullies below downpipes that require clearing and emphasises the need for regular maintenance of the rainwater system, including parapet gutters, gutters, hoppers, downpipes, and gullies. Some missing pointing to the chancel and evidence of previous repairs are also recorded. On inspection of the exterior, during the present assessment, in particular of the apsidal end of the chancel where the wall paintings are located, there is little external evidence to explain the extent of water ingress indicated by the current internal condition of the paintings. The rainwater goods appear to be functioning, and there is no cement render or other impermeable coating on the exterior wall.

*External view of the apse, from the south, left, the east wall from the outside, right*

Ongoing maintenance of the building fabric, particularly the rainwater disposal system, remains key. The architect's Quinquennial Inspection (2021) highlights the importance of regular clearing and maintenance of gutters, downpipes, hoppers, and gullies, and attention to areas of missing or eroded pointing. Adherence to these maintenance measures will help reduce the risk of water ingress and should form part of the overall strategy for managing moisture within the building.

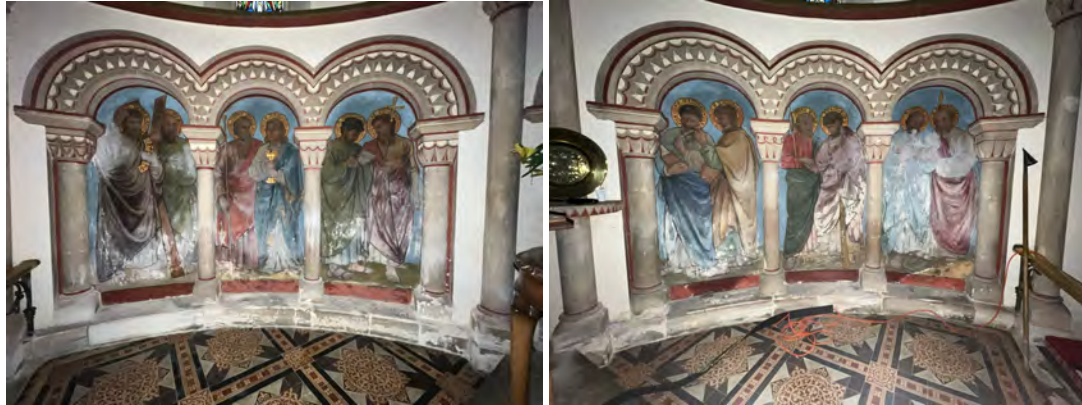
Internally, the wall paintings show clear evidence of water-related deterioration, indicating ongoing moisture movement within the masonry and possible condensation. The lower sections of the paintings are the most affected, although the precise source of moisture is not immediately apparent. While the pattern of damage could suggest rising damp, the chancel and apsidal end are on raised ground, with no visible earth banked against the walls and surrounding land sloping away, which should provide reasonable drainage.

*Overall views of the wall paintings, to the north/left of the altar, left, and to the south/right, right. Images provided by church architect, Toby Falconer*

As noted in **6.1 The Building**, further investigation of the building's environmental performance is recommended to identify the sources and pathways of moisture affecting the chancel/apse and the wall paintings. This should include a specialist environmental assessment of the interaction between the building fabric, internal climate, and patterns of moisture movement within the masonry and at the surface where condensation may occur. Advice from Tobit Curteis, Tobit Curteis Associates, is therefore recommended as the first step in developing an appropriate strategy for the long-term preservation of the paintings and the building as a whole.
