## Danby Wiske - Diocese of Leeds

### Recently revealed wall paintings – Preliminary report

Peter Martindale – 6 May 2026

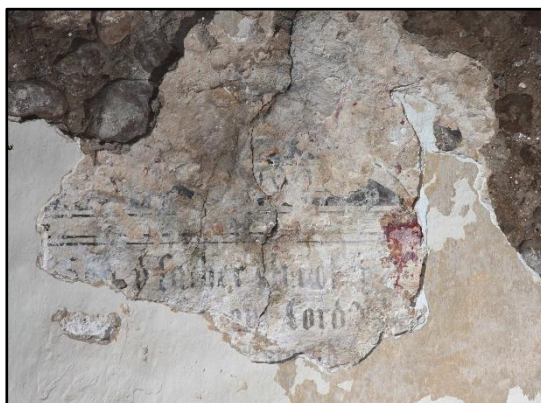
*Example of recently revealed wall painting, nave south wall*

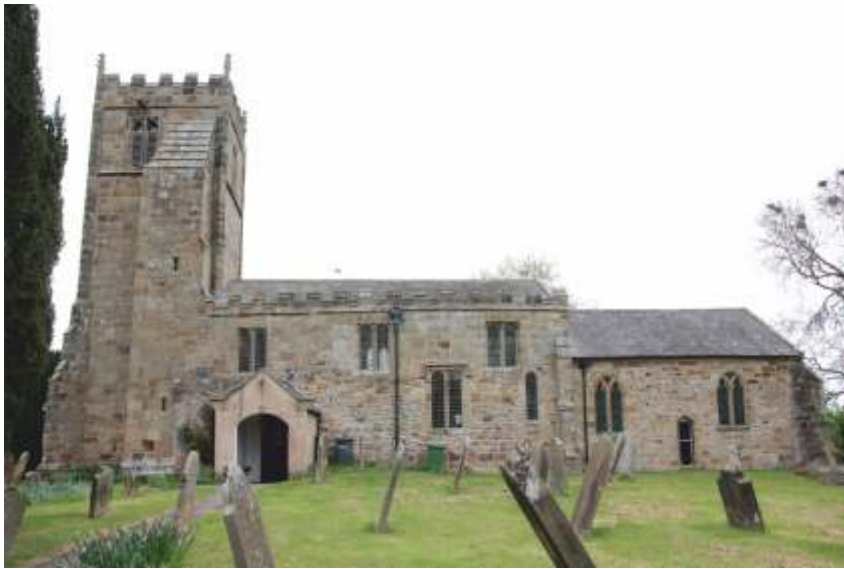
1 - Left - Danby Wiske church looking north.

2 - Below - South nave wall looking west. Areas of wall painting studied in this report identified as follows - green rectangle area 'a' - orange rectangle area 'b'.
