STAINED GLASS CONSERVATION REPORT

Following a condition survey Holy Well Glass was asked to carry out conservation works at St. Thomas of Canterbury Church, Birtsmorton. Works comprised of removal from site of all panels in Window sII; a two-light window (main lights 12 ½ x 53") with a single kite shaped tracery element, and of single tracery lights from Windows sV, sVI, sVII, nIII, nV, nVI, nVII, and panel 2b from WI. Conservation work was carried out in the workshop before panels were re-fitted. Additionally a bespoke internally ventilated protective glazing system (EPG) has been designed, manufactured, and fitted. Repairs were also carried out to the surrounding stonework by HWG masons. The relevant windows and panels can be seen on the diagram and photos below.

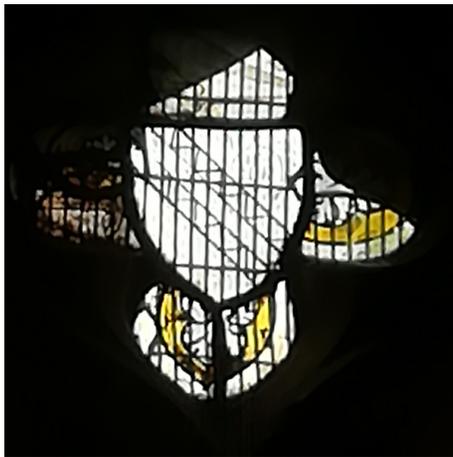
sV tracery - A single quatrefoil tracery dating from the late 14thC. The lower and right hand cusps have in-situ painted detail in glass paint and silver stain which accurately follows the form of the stonework. The other two lobes have fragments of 14th C glass including robe from a larger scale figure and canopy work. The central heraldic motif has simplified 14thC arms of Ruyhale.

sV
in-situ, before conservation

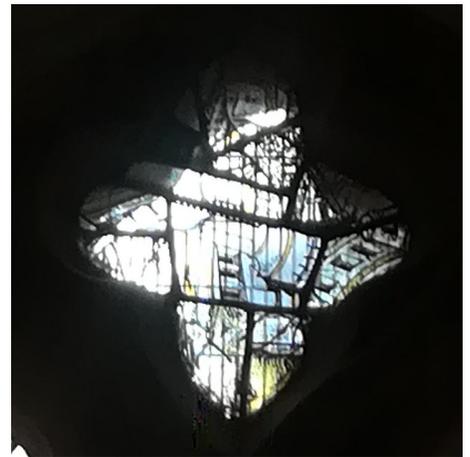
sVII tracery- A single quatrefoil tracery dating from the late 14thC. A collage of fragments including the head of the Virgin - probably from a Coronation of the Virgin.

sVII
in-situ, before conservation

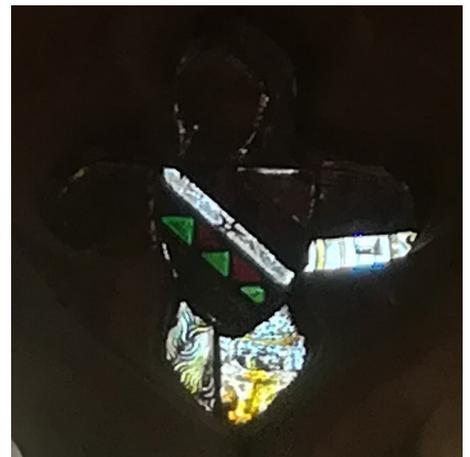
nVI tracery- A single quatrefoil tracery dating from the late 14thC. The centre, left hand, and part right hand cusps have in-situ foliate painted detail which accurately follows the form of the stonework. The other two lobes have fragments of 14Th C glass including robe from a larger scale figure and canopy

nVI
in-situ, before conservation

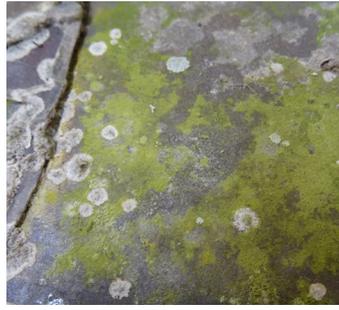
In all panels the glass showed a mixture of broad glass and crown glass, both early forest glass types. The glass condition was poor, with extensive corrosion and lichen infestation on the external face. The internal face showed slight surface pitting. A number of cracks in the glass were located in tracery panels in sVI, nV, nIII, panel 2b from WI, and the main lights in sII, and a hole was found in the shield section of nV tracery. There were a number of pieces from nIII, sVII, sV, nVI, and WI 2b panels that were inserted in reverse historically; the painted side exposed externally to the elements, instead of internally. The painted detail in general was well fired, although there was slight loss of painted detail caused by surface abrasion over the centuries and the action of wetting cycles of condensation. In Window sII the lead structure (1/4" & 5/16" Round sections) was sound. In the tracery panels sVII had survived best, and

Lichen, external surface

Cleaning methods for algae and lichen first involved examination under digital microscope. An initial application of 50% solution in deionised water was used, but proved ineffective. Therefore, treatment was employed by spraying the surface with undiluted ethanol solution employing a small nebulizer (Pari Boy Mobile). The spray solution was applied twice with a 24-hour delay between applications. The surface was allowed to dry, and then cleaned with deionised water on cotton wool swabs.

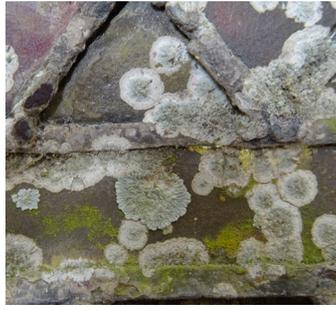
Algae & lichen, external surface

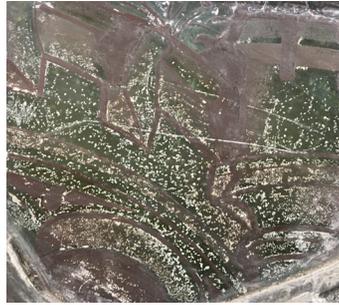
Moderate pitting internal surface

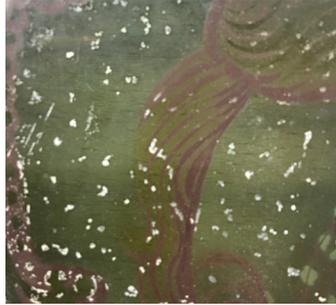
Light pitting, internal surface

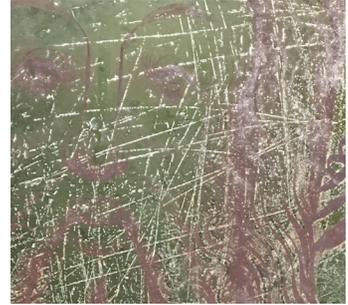
Scratches, internal surface

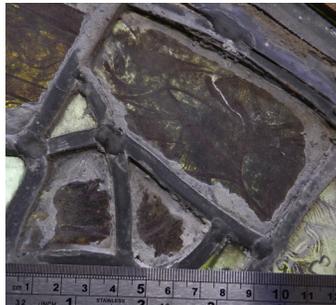
Cement build up, internal surface

Other areas not affected by lichen acid accretions were also cleaned. The painted surface of the glass was monitored with a binocular microscope. Each piece of glass was cleaned using a 50/50 mixture of ethanol and de-ionised water on cotton buds and soft brushes. Leaded light cement was removed with a scalpel. Panels not dismantled were also cleaned, as above, but within the lead matrix.

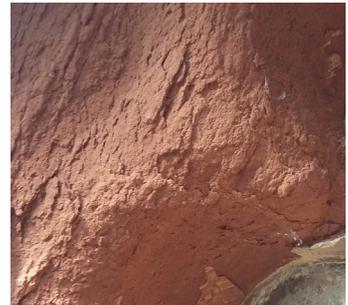
Friable red sandstone

was in reasonable condition. The remainder were dilapidated but intact, and still had remains of ancient cast lead cames. In general, the surrounding stonework was reasonable, although friable on the external surface. The central mullion to Window sII had two splits and vertical hairline cracks, and the cusps eroded significantly. The medieval stone mullion in Window nIII was heavily eroded. The structure of the stone was very friable, and there was a major crack at the top of the mullion. Perimeter mortar was hard Portland cement overlying lime mortar. All the medieval glass had stainless steel wire guards fitted, prior to conservation works. The ferramenta for the main lights in Window sII consisted of 4no. internal ferrous tie bars (1/2" Round). They were rusted slightly, but did not seem to have affected the stonework through expansion. The copper ties were well fixed.

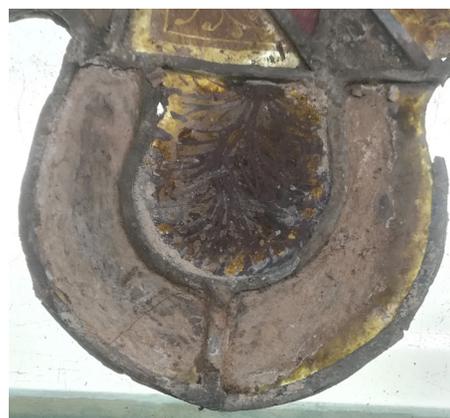
nVI tracery panel section, before cleaning

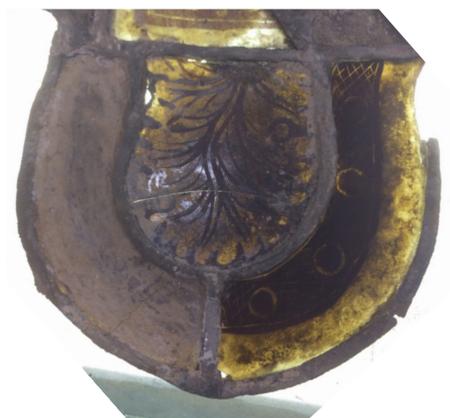
nVI tracery panel section, left, before cleaning, right, after cleaning

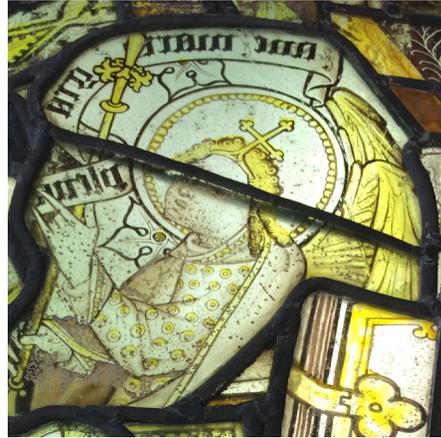
sV panel 1b break across face, strapped externally, before conservation, external view

Impact breaks, single/double breaks and small gaps repaired using Araldite 20:20; a conservation grade two-part epoxy resin. In sII panel 1b the disfiguring historic repair lead across the large central figure was removed, and the broken sections edge-bonded, thus making the iconography much clearer. The shield section of nV tracery required a resin fill to mend the hole in the glass.

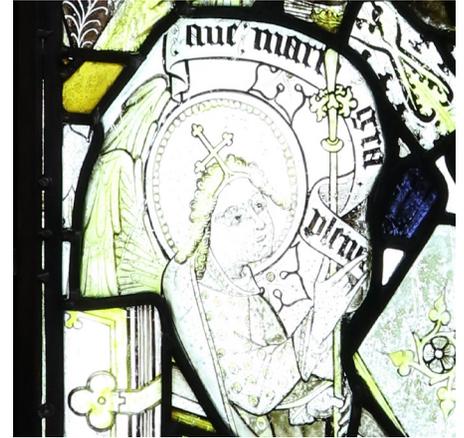
sV panel 1b break across face, after edge-bonding, internal view

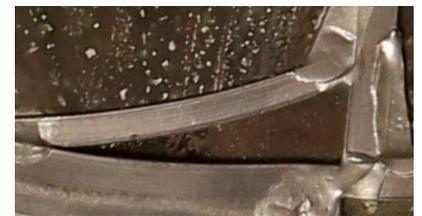
sV detail, HWG painted replacement, reflected light, internal

A small number of newly painted kiln-fired inserts pieces have been produced to fill gaps in the design, or replace ill-fitting stop-gaps. Glass matched from stock of handmade tints (Lamberts Restoration Glass), and paint and stain tests conducted to achieve correct match. Detail repainted using evidence within panel. All new insertions clearly date marked with kiln-fired glass paint.

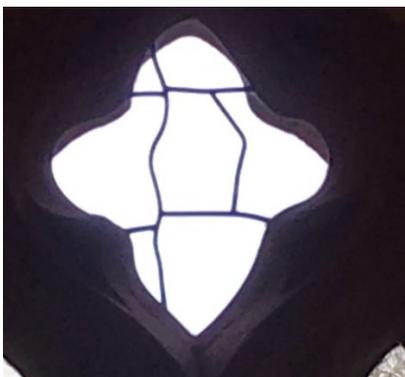
Window nVII protective glazing panel in position, prior to fitting of historic glass

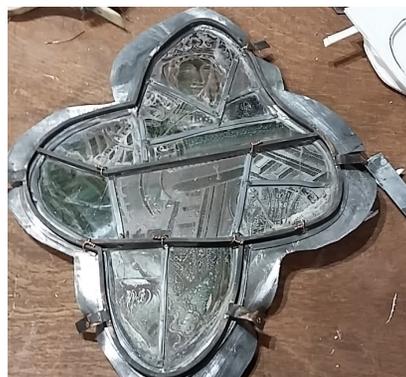
Window sVII panel, on-site, after perimeter lead skirt fitted

Windows sV, sVI, sVII, nIII, nV, nVI, nVII tracery, and WI 2b re-fit for traditional stained glass panels. Panel perimeters fitted on-site with lead skirts, to prevent light halation. Panels mounted internally with shaped bronze bar supporting framework, accurately fitting the stonework. Frames secured and supported with bronze fixing tabs with Rawl plugs and non-ferrous fixings. Frames are set back from the original groove to allow space for ventilation.

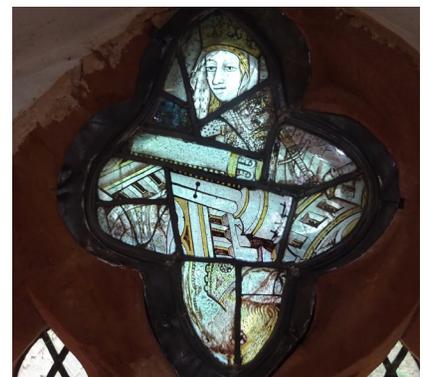
Window sVII panel, fitted in-situ, after conservation

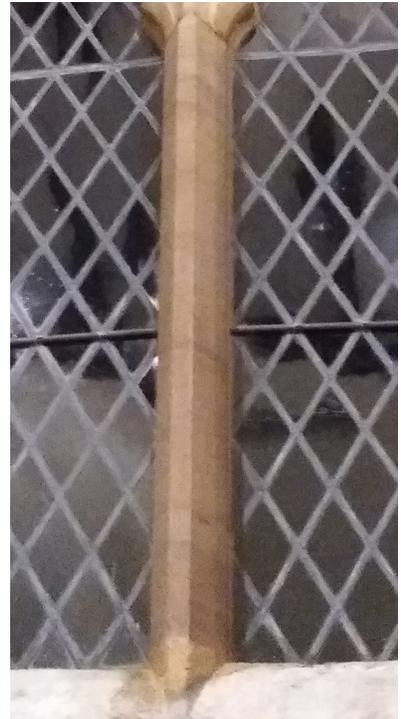
nIII after stonework repair, internal elevation

nIII sandstone mullion fully replaced like-for-like. To enable this, nIII leaded light panels removed. Labelled prior to removal and surrounding historic fabric protected. Perimeter mortar chipped out by hand using dummy & tungsten-tipped chisels. Leaded lights eased from openings and removed. Window nIII propped and existing mullion removed. Replaced old stone for new, pre-worked (including glazing groove) and cut to size. Removed old copper ties from nIII leaded lights and replaced for new. Re-fitted leaded lights and pointed in lime mortar (1:3 - St Astier NHL 3.5: Whiteball Red Sand).

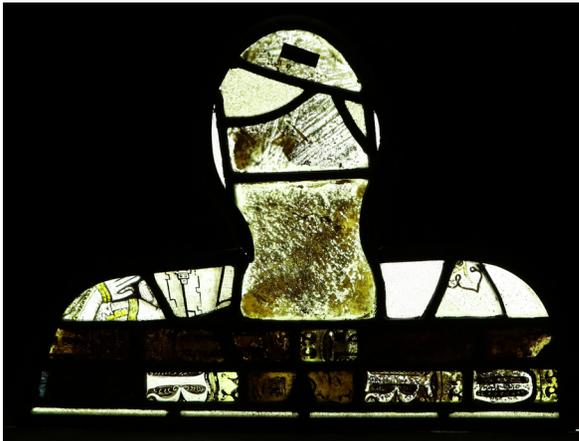
Window WI panel 2b, after conservation, transmitted light, internal

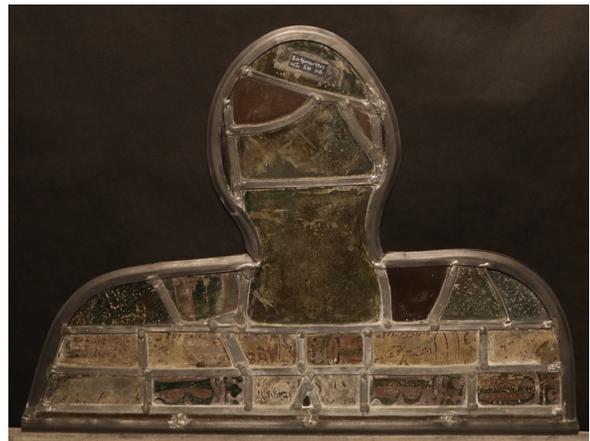
Window WI panel 2b, after conservation, reflected light, internal

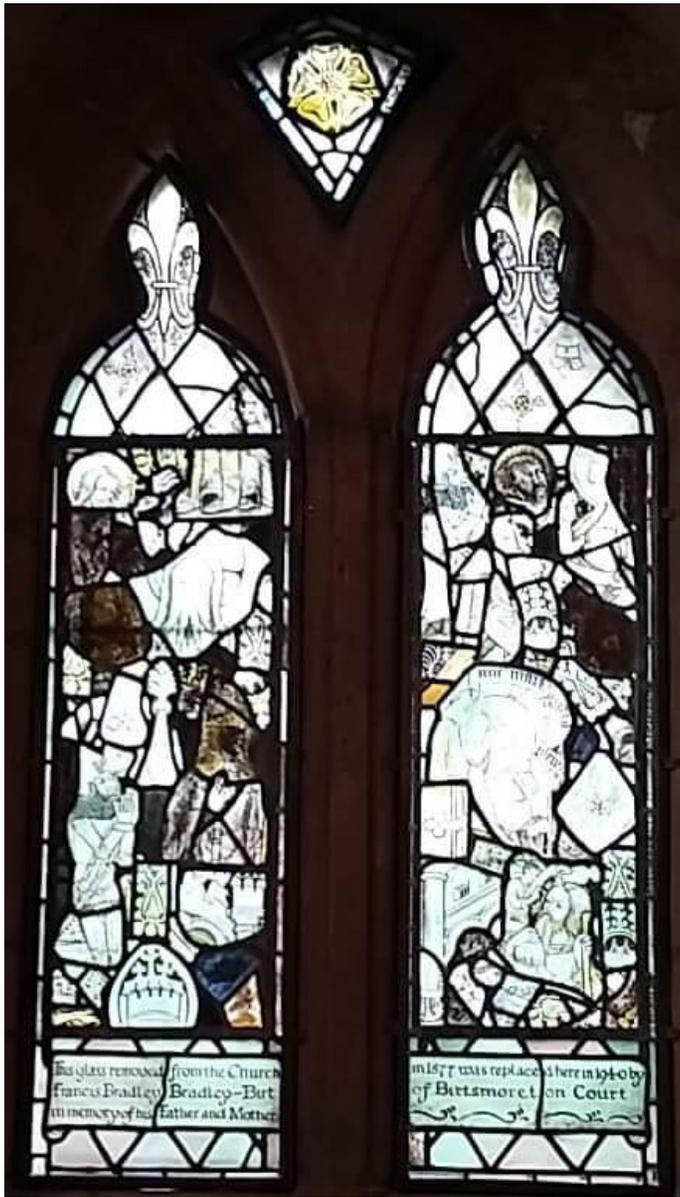
Window sII after conservation and site refit, internal view

Upon return to site, ancient panels refitted within new bronze frames, set slightly inside the building. Stained glass frames are secured and supported with bronze fixing tabs with Rawl plugs and non-ferrous fixings. Frames are set forward from the original groove to allow space for ventilation. Compriband foam used to create a seal between frames and the stonework when fixing.

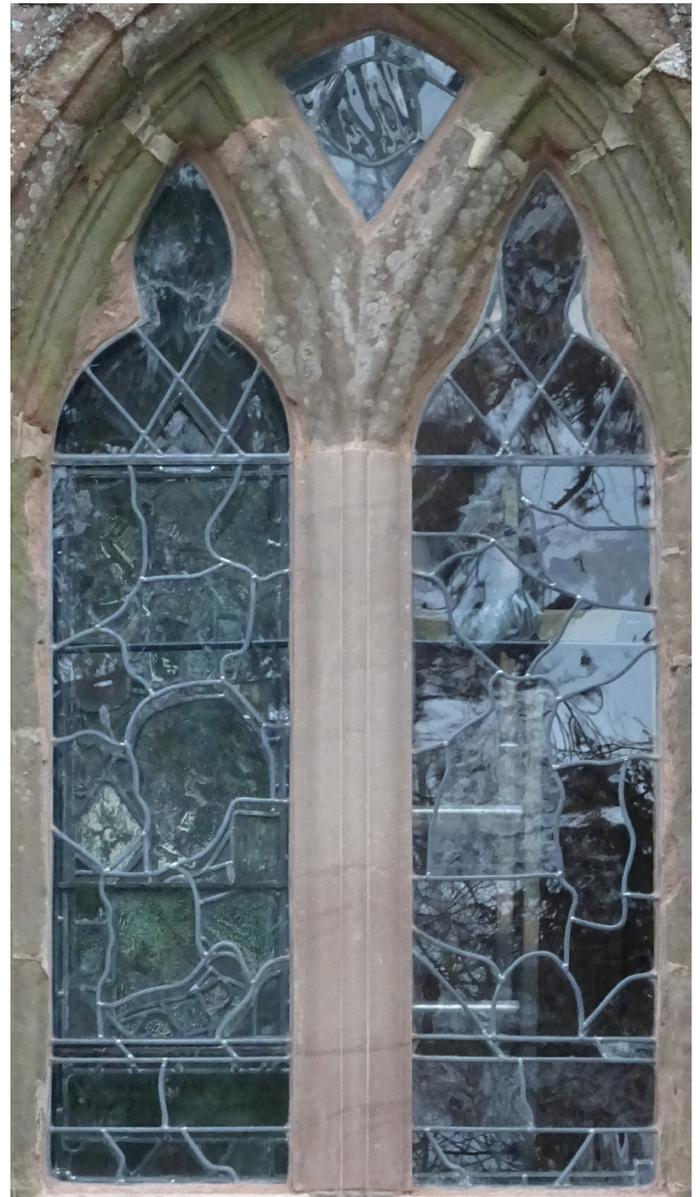
Window sII after conservation and site refit, external view

sII stone mullion cut back to the glazing line externally, new half stone replacement cut, and fitted using stainless steel dowels to pin in place, which were coated in a stone resin to prevent future rusting.

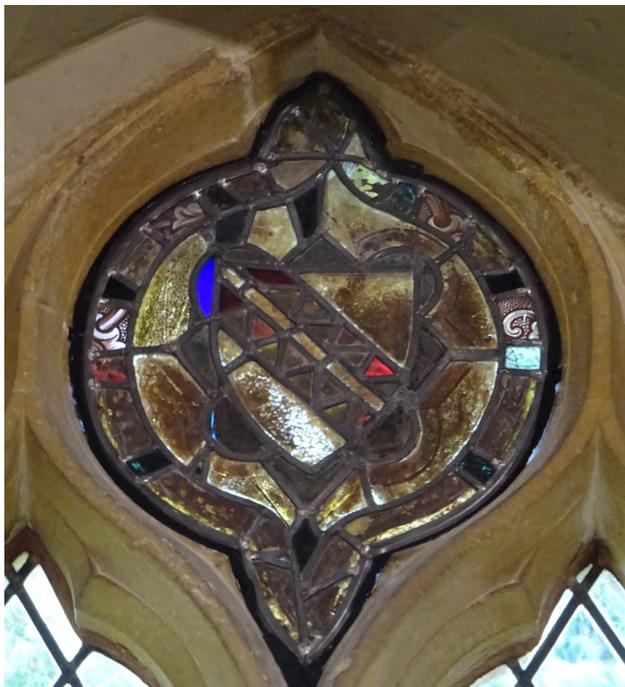
Window nIII after conservation and site refit, internal view

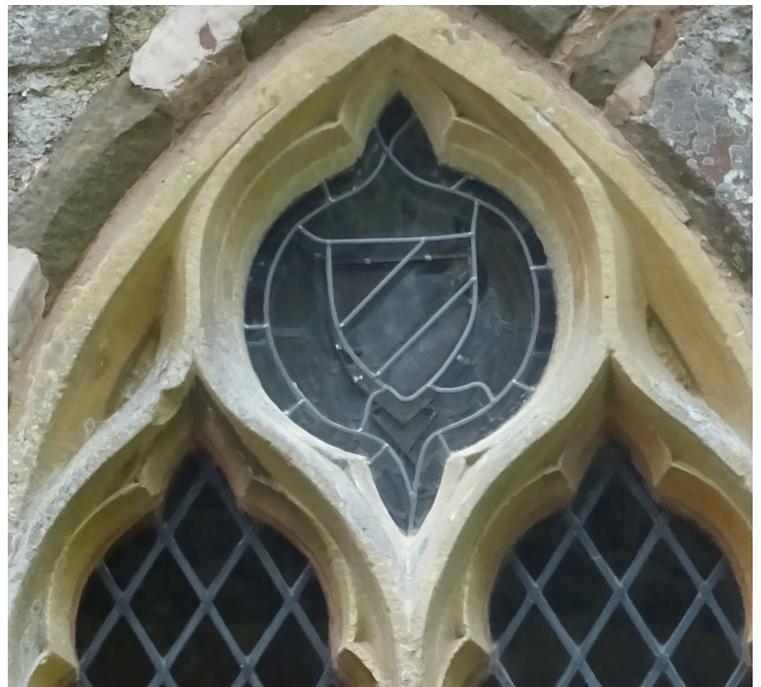
Window nIII after conservation and site refit, external view

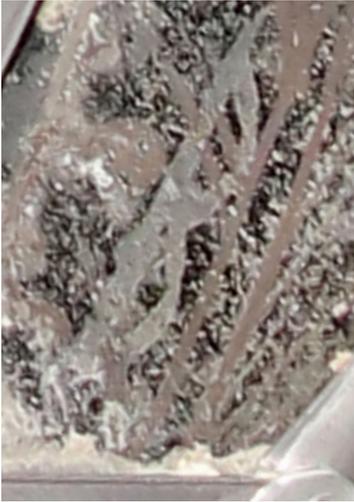
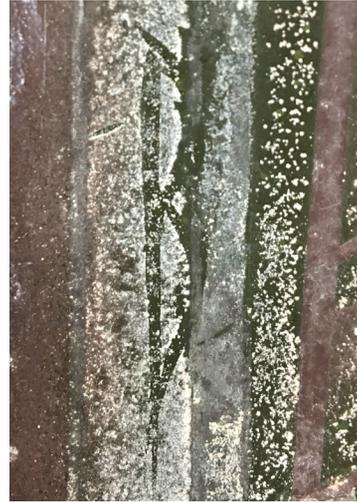
Window nVII panel, left, Window sII panel 1b, right, - medieval glaziers marks on internal surface.
Is is a letter 'B' or a medieval archers bow?

N.B. nVII glaziers mark, left, is only visible today because the glass has corroded to its shape, whilst sII glaziers mark is only visible today because its shape has resisted corrosion

Interestingly, two very clear medieval glazier's marks have been located showing the letter 'B', on the internal surface of panel 1b in sII, and the tracery panel in nVII. In this case they have only become apparent through the corrosion on the glass surface. General thinking suggests they were meant to be temporary painters' marks, helping to identify the positions of the glass during manufacture, and then wiped away once the panels were made, although there is still no certainty for this.
