**Condition survey of the wall paintings within the Chantry
Chapel, Church of St Michael and All Angels**

Skelbrooke, Diocese of Sheffield

January 2017

**SKELBROOKE
SOUTH YORKSHIRE**

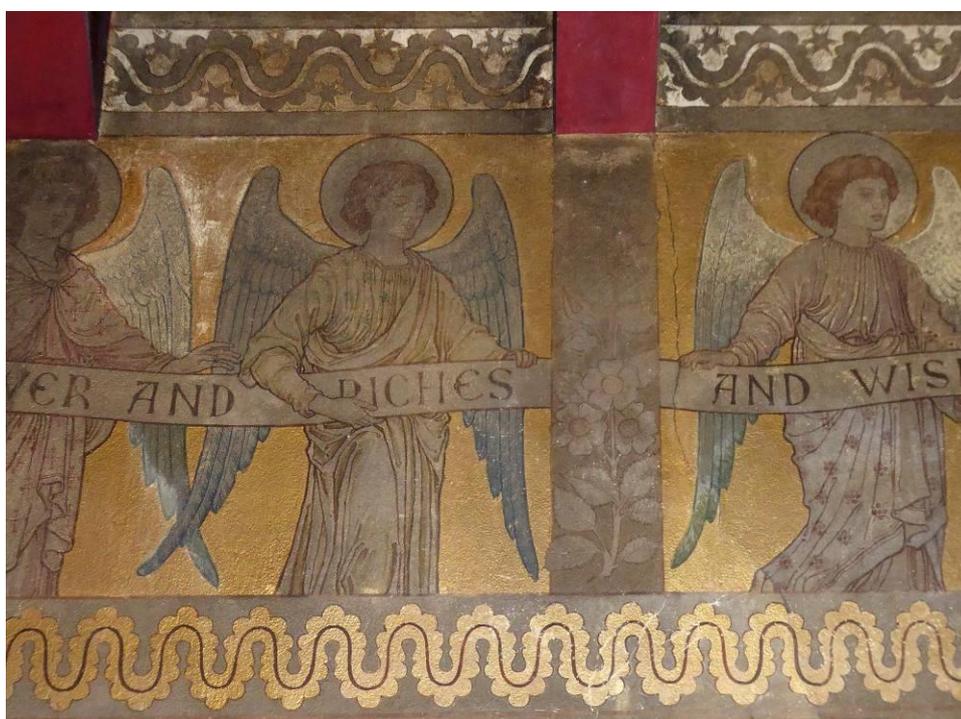
Figure 18: Detail of the north wall painting

Finely detailed wall paintings are present above the dado on all four elevations of the Chantry Chapel, see figure 18, with polychrome stencil decoration and applied gilded stars found to the roof timbers.

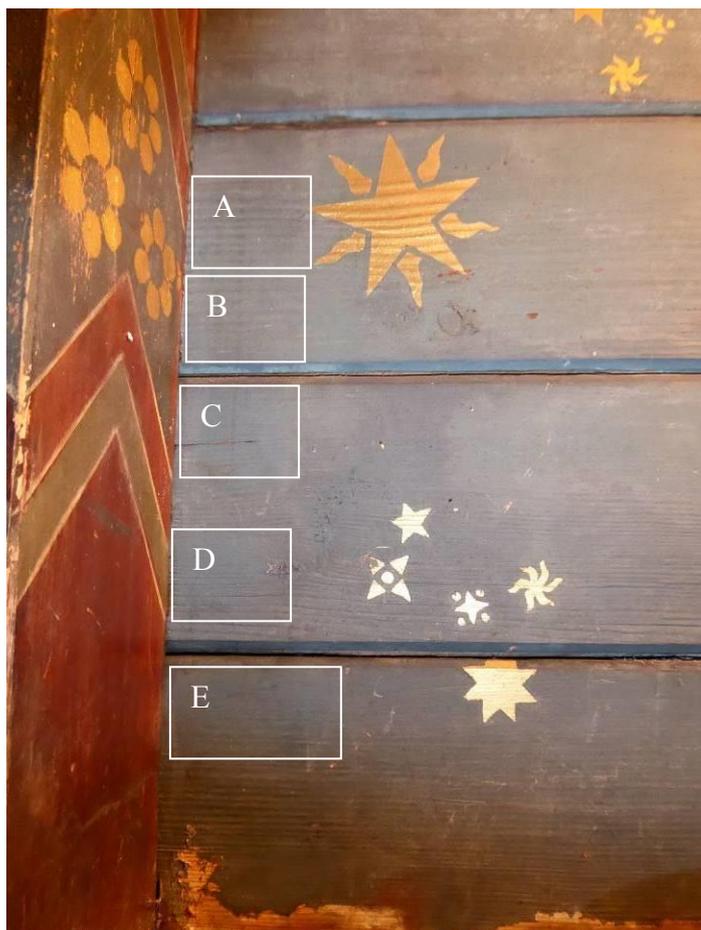
A = white spirit applied with cotton wool

B = soft latex sponge (wishab)

D = deionised water applied with cotton wool swab

E = deionised water applied with sponge

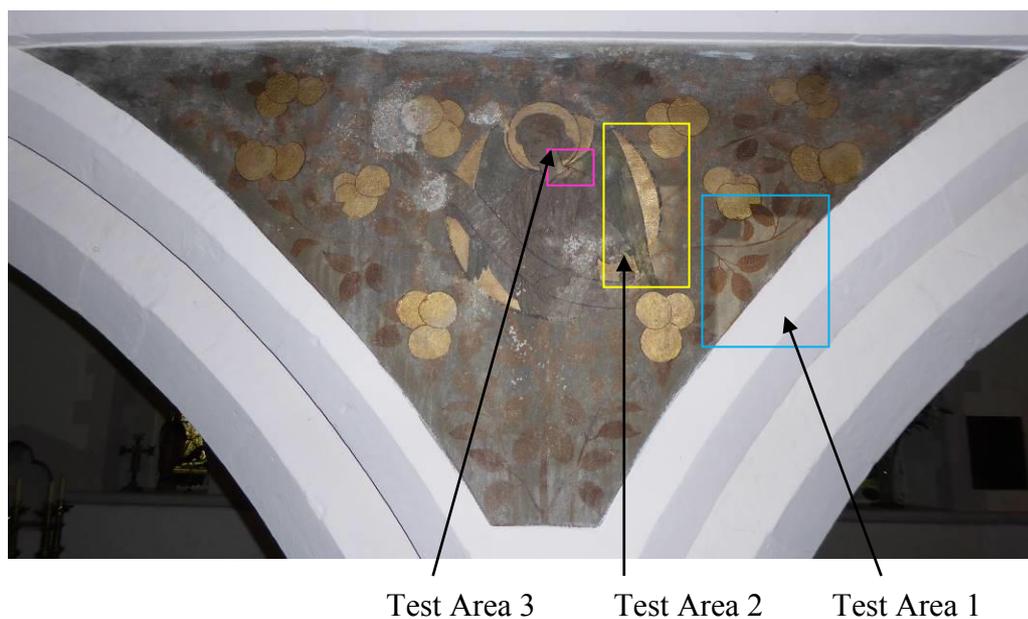
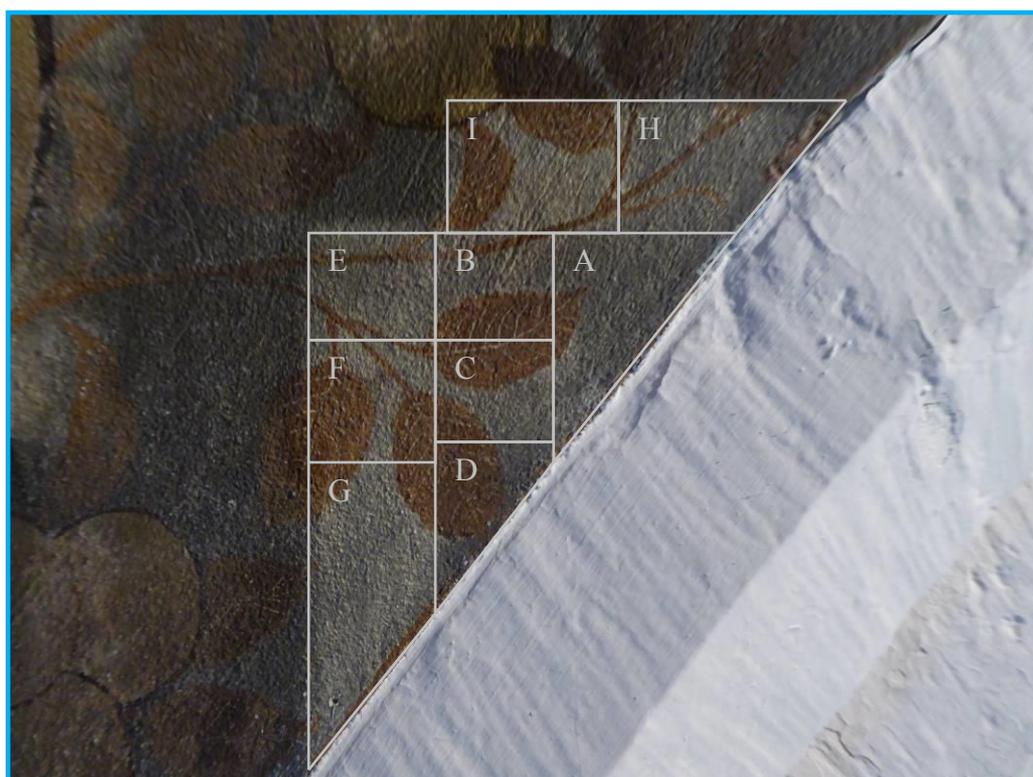
- A = soft latex sponge
- B = deionised water applied with cotton wool swab
- C = deionised water and sponge
- D = IMS applied with cotton wool swab
- E = white spirit applied with cotton wool swab
- F = weak solution of non ionic detergent in deionised water applied with cotton wool swab, cleared with deionised water
- G = 3% tri-ammonium citrate solution applied with cotton wool swab, cleared with deionised water
- H = V&A mix applied with cotton wool swab, cleared with deionised water and white spirit
- I = weak solution of ammonium hydroxide applied with cotton wool swab

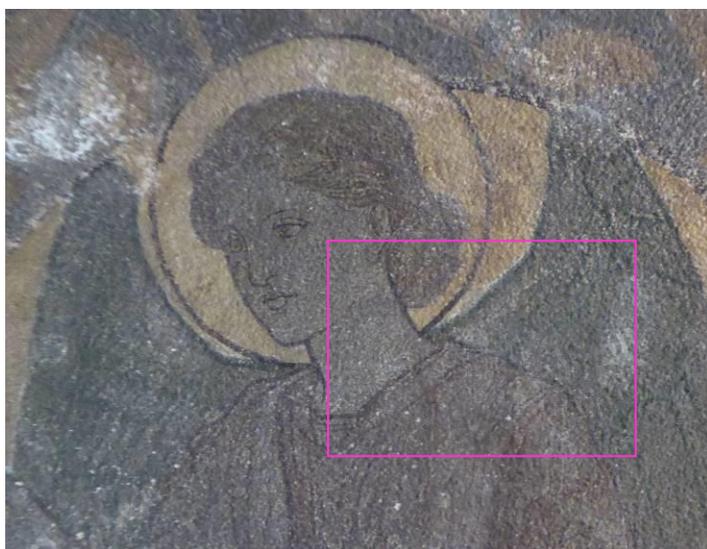
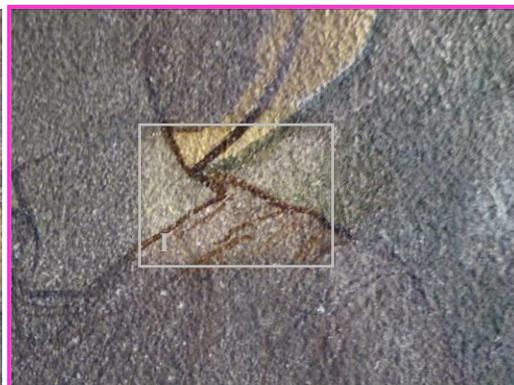
- I = weak solution of ammonium hydroxide applied with cotton wool swab

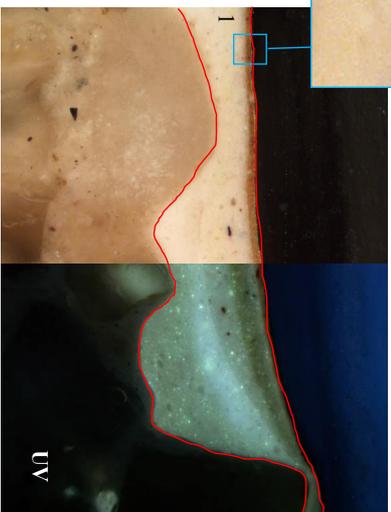
Sample 5 – North wall (same stratigraphy as sample 3)

Samples 3, 5 and 6 contain only the original decorative scheme. Samples 3 and 5, taken from areas of gilding on the east and north walls consist of the same stratigraphy, namely white zinc oil primer/undercoats, followed by an ochre coloured oil size and a layer of gold leaf. Zinc paint is indicated by the characteristic 'sparkles' visible in uv light, and was confirmed with a positive stain test using dithionite. The presence of oil is indicated by fluorescence in uv light and confirmed with a stain test using Rhodamine B. Sample 6, taken from the west wall painting, also contains the same zinc oil primer/undercoats followed by an ochre/sienna top coat.

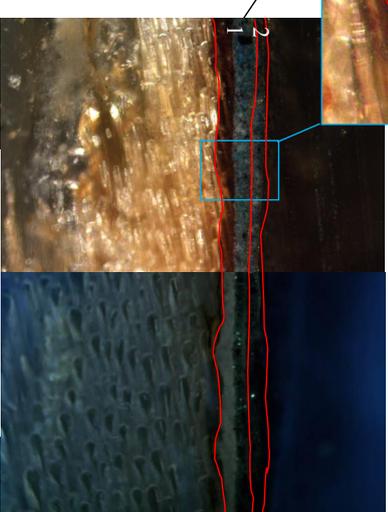
Sample 7 – Roof timber

Sample 7, taken from a painted roof timber, consists of two schemes of gold leaf on a blue zinc oil paint, on top of an oil stain to the timber. The two schemes can clearly be seen in the photograph above, with the upper gilded flowers being slightly off-set to the earlier scheme. The paint characteristics appear to be the same or very similar, and no dirt layer is evident between the schemes so they may have been painted within a short space of time. Further investigations and sampling would need to be undertaken to confirm whether the two schemes are present throughout the ceiling, or whether this is just a localised issue, possibly to adjust the layout slightly.

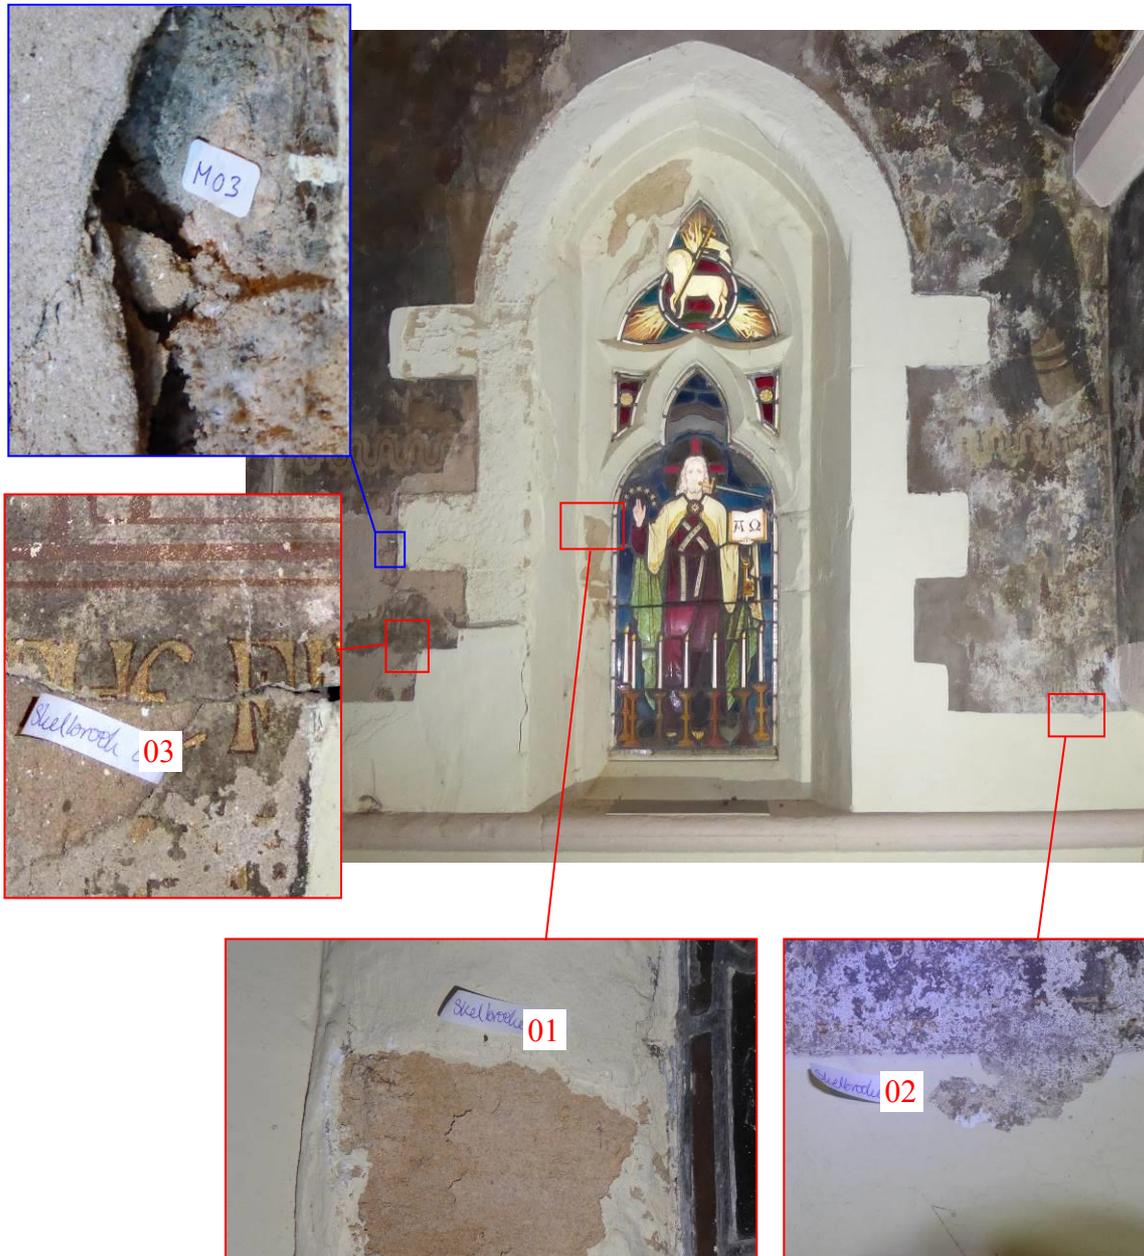
East Wall:

Paint samples: 01, 02 and 03, Mortar sample: M03

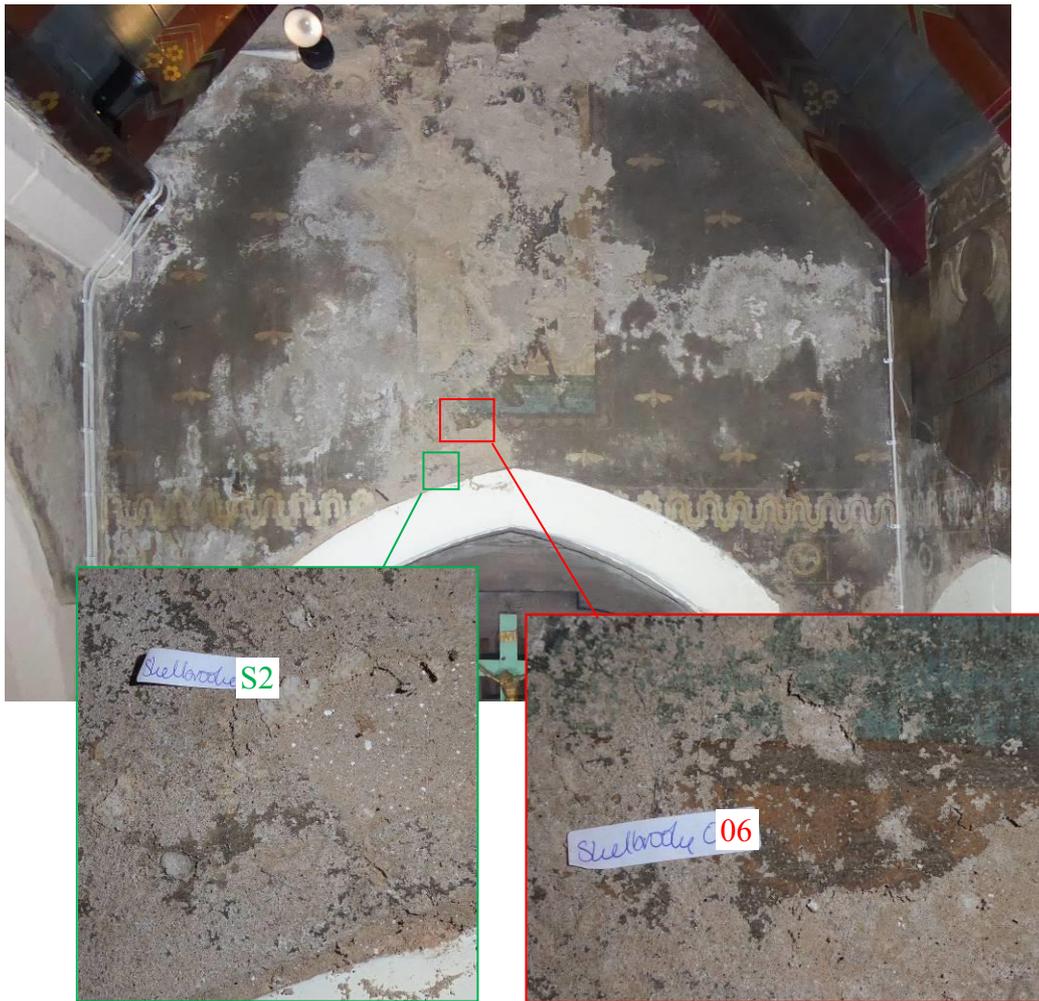
West wall:

Paint sample: 06, Salt sample: S2

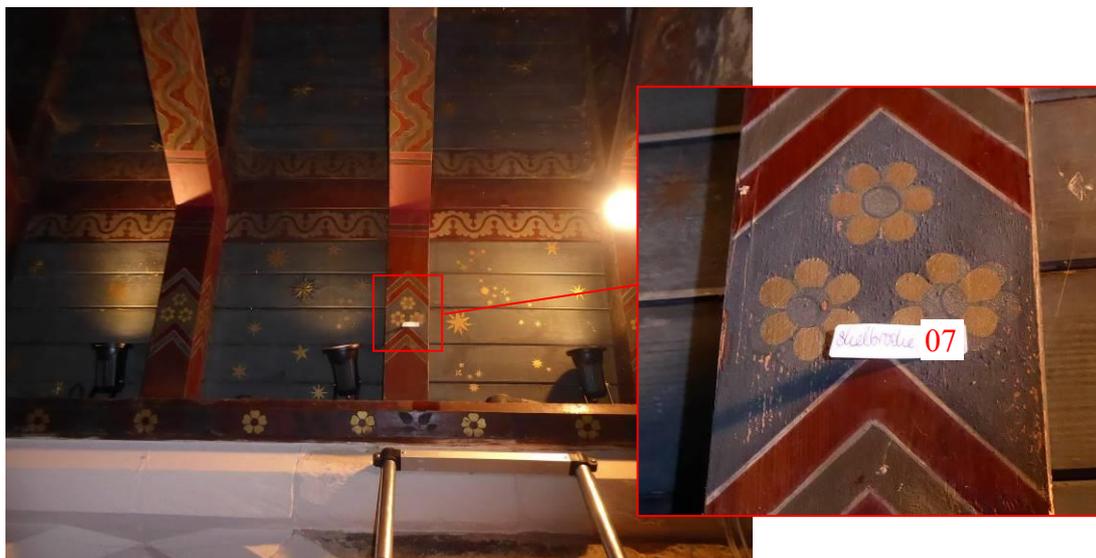
Roof timbers:

Paint sample: 07

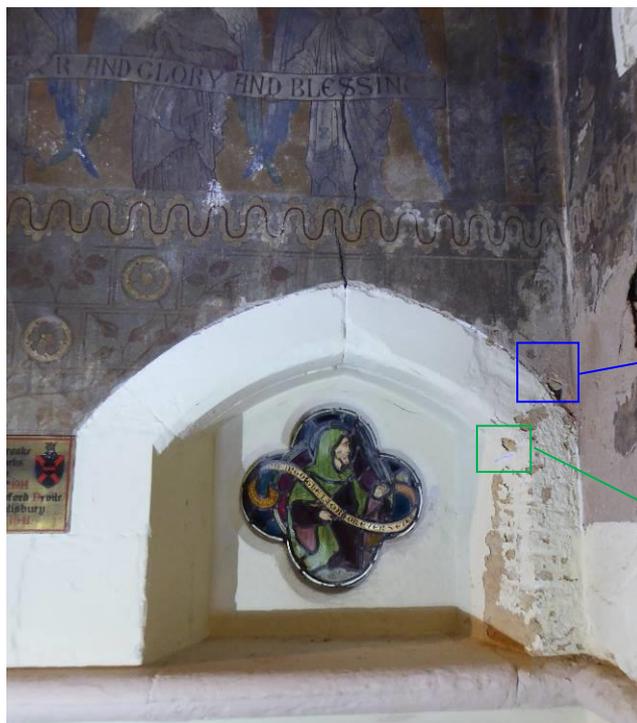
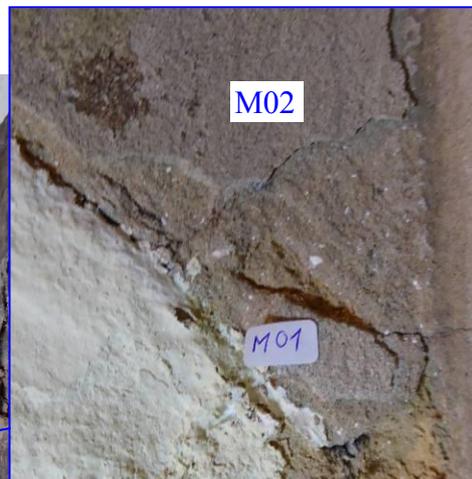
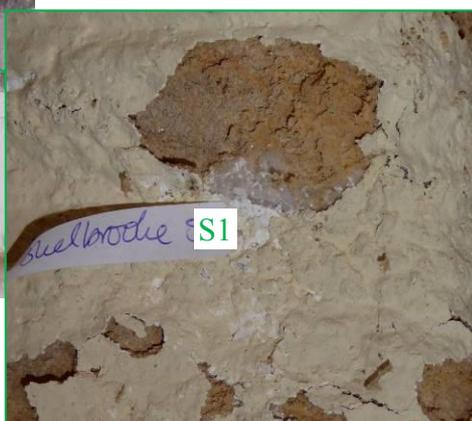
North wall:

Paint samples: 04 & 05
Mortar samples: M01 & M02
Salt sample: S1

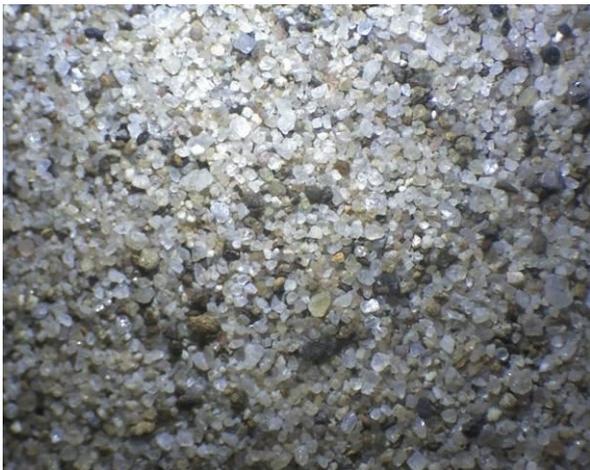
<p>Summary of Results and Comments:</p>	<p>The aggregate: is a fine-grained grey-buff coloured sharp silica sand, similar to that found in the top coat:</p> <div style="text-align: center;">

</div> <p style="text-align: center;">Aggregate Base coat, mag.x 10</p> <p>The Binder: is a non or slightly hydraulic (very feebly hydraulic – NHL1) dolomitic lime.</p> <p>The Mortar: has a mix ratio by volume of 1.5 : 1 Aggregate : Binder</p>
--	--

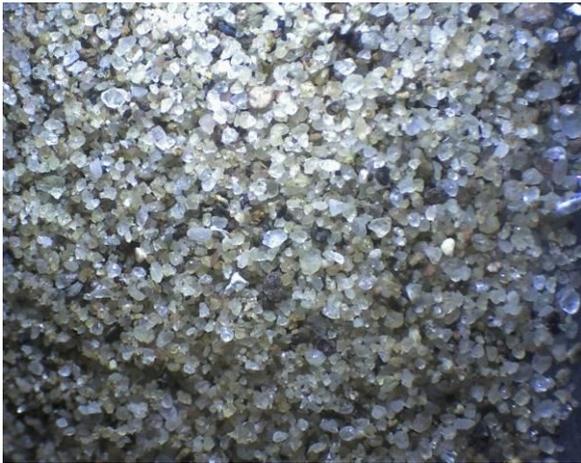
<p>Summary of Results and Comments:</p>	<p>The aggregate: is a fine grained, grey-buff coloured sharp silica sand, similar to that found in the base coat:</p>

<p style="text-align: center;">Aggregate mag.x 10</p> <p>The Binder: is a non-hydraulic dolomitic lime.</p> <p>The Mortar: has a mix ratio by volume of 0.9 – 1 : 1 Aggregate : Binder.</p>
--	---

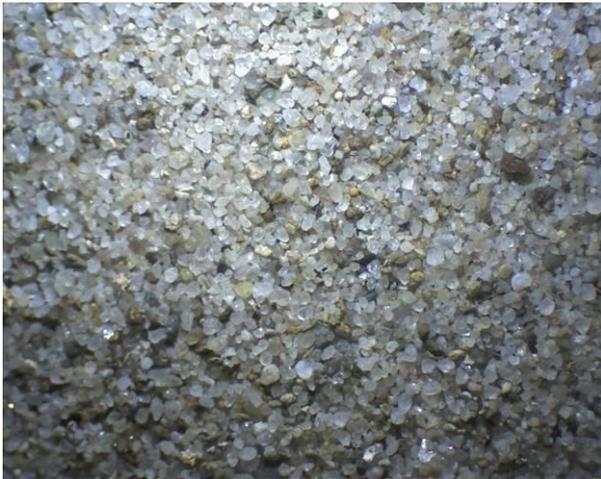
<p>Summary of Results and Comments:</p>	<p>The aggregate: is a grey-buff coloured, fine grained, sharp silca sand similar to that found in samples MO1 base and top coat:</p>

<p style="text-align: center;">Aggregate mag.x 10</p> <p>The Binder: is a dolomitic lime.</p> <p>The Mortar: has a mix ratio by volume of 0.9 : 1 Aggregate : Binder</p>
--	---
