## **Draft Statement of Needs Revision B**

# St Peter's Sharnbrook – Draft Statement of Significance

Proj: 24-20: Assessment of Significance – Chancel Screen

Sharnbrook Church - Internal Access Improvements

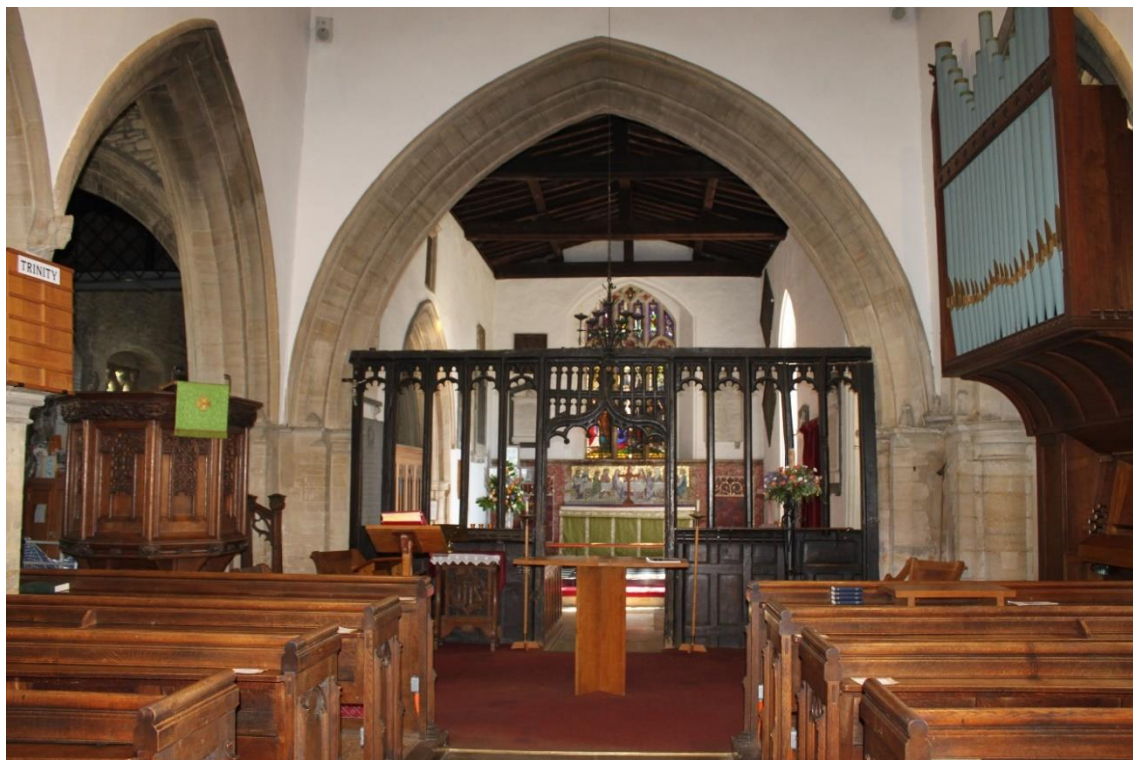
Plate 1: View to the nave facing side of the screen and the chancel from the nave, looking east (Credit: Esther Robinson Wild)

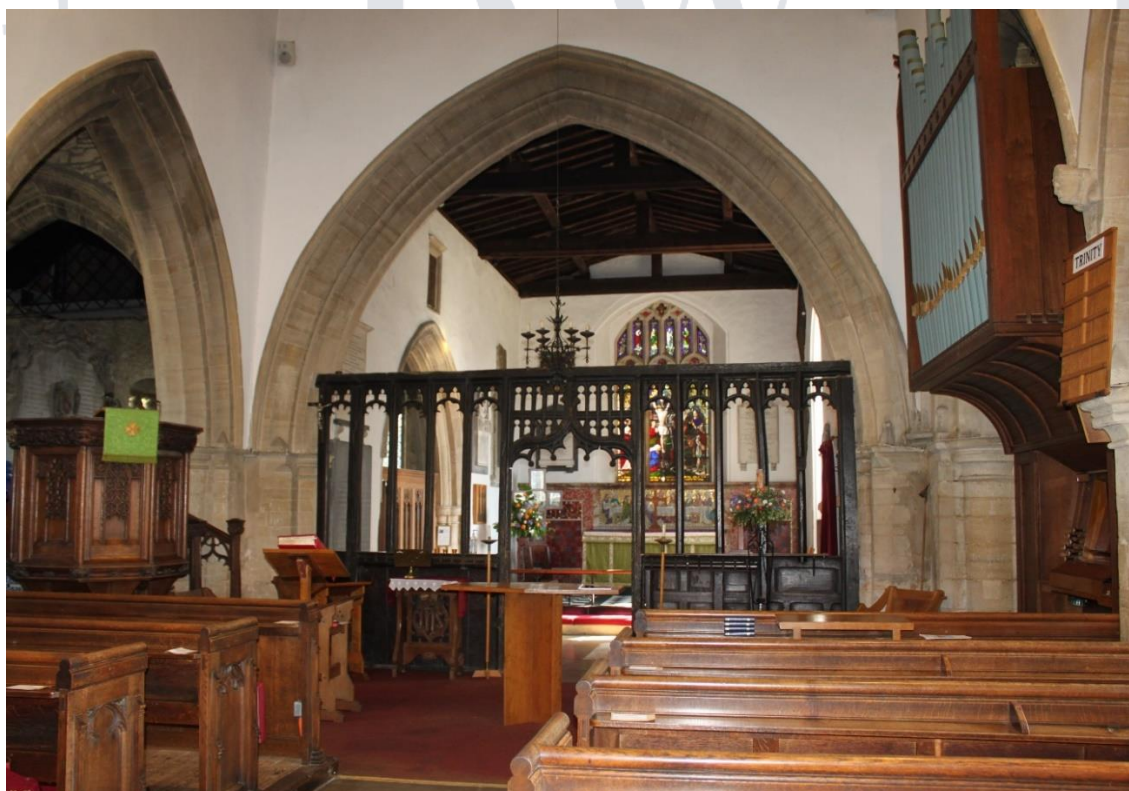
Plate 2: View to the nave facing side of the screen and the chancel from the nave, looking east (Credit: Esther Robinson Wild)

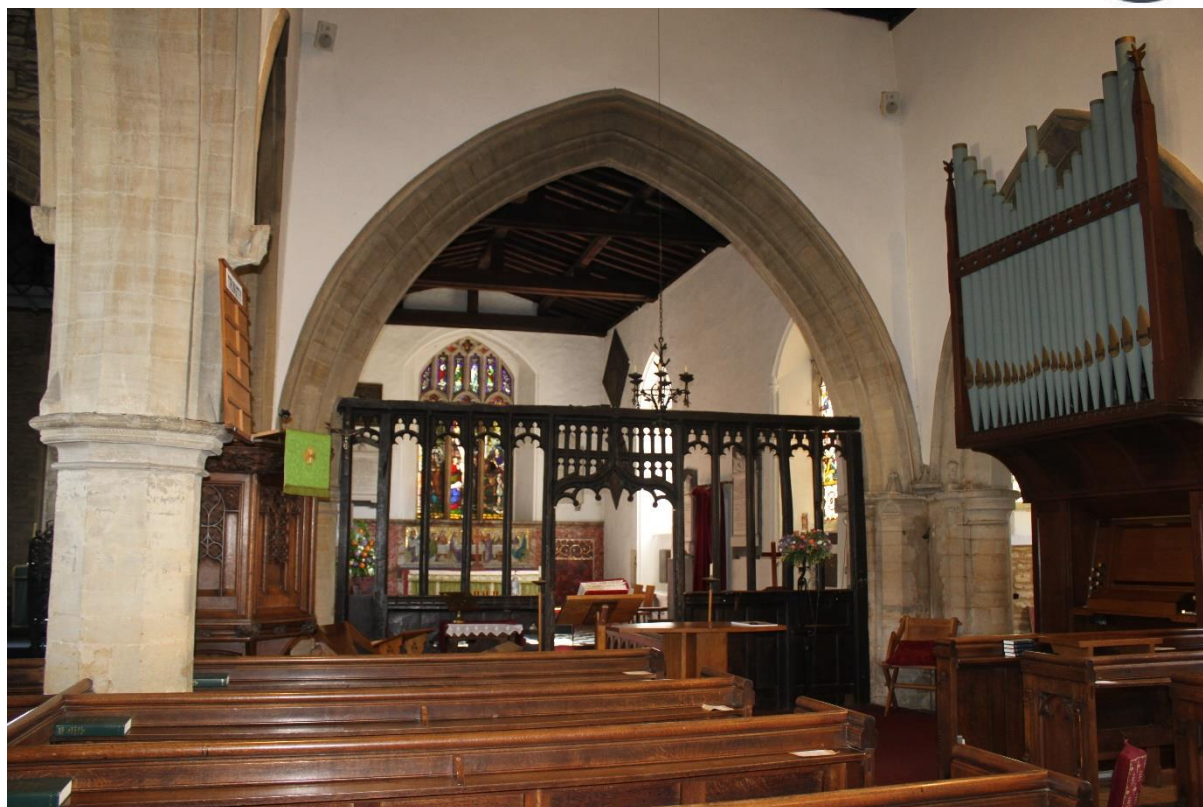
Plate 3: View to the nave facing side of the screen and the chancel from the nave, looking southeast (Credit: Esther Robinson Wild)

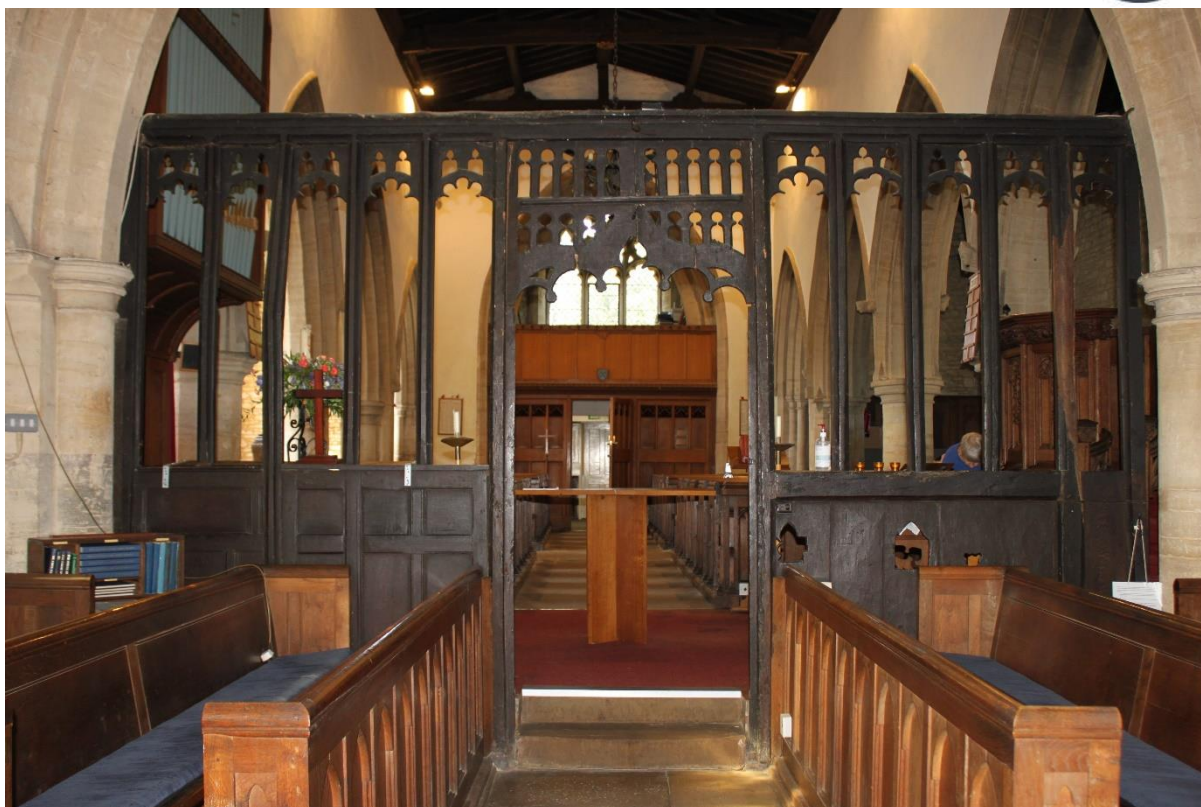
Plate 5: View to the chancel facing side of the screen and the nave from the chancel, looking west (Credit: Esther Robinson Wild)

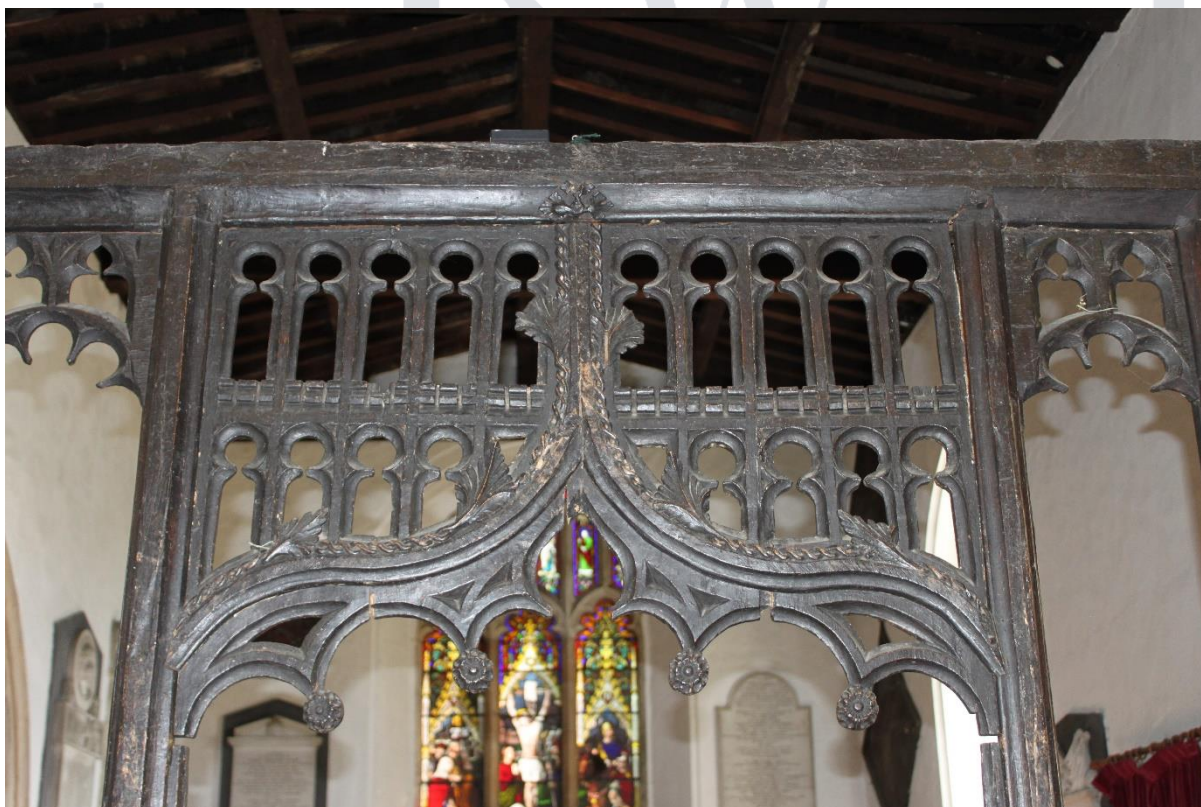
Plate 6: View to the decorative central arch of the screen from the nave, looking east (Credit: Esther Robinson Wild)

32. Each window light is headed by open tracery (Plates 8 – 9; 12 – 13; 15; 19) with two forms of trefoil arches. The central ogee arch decorated with a vine trail has drop tracery and openwork tracery in the spandrels (Plate 6). Overall, the design of the chancel screen is rather simple with the decoration restricted to the nave facing side (Plate 7 shows the plain chancel facing side of the central ogee arch). The restriction of the decoration to the nave facing side of the chancel screen is seen elsewhere and has been considered by some to indicate that because the parishioners paid for the work in many cases, and these same parishioners were not allowed into the chancel, then they were not especially concerned – if at all – with the eastern face of the screen in all its elements (Williams, 2008, pp. 148 – 149).

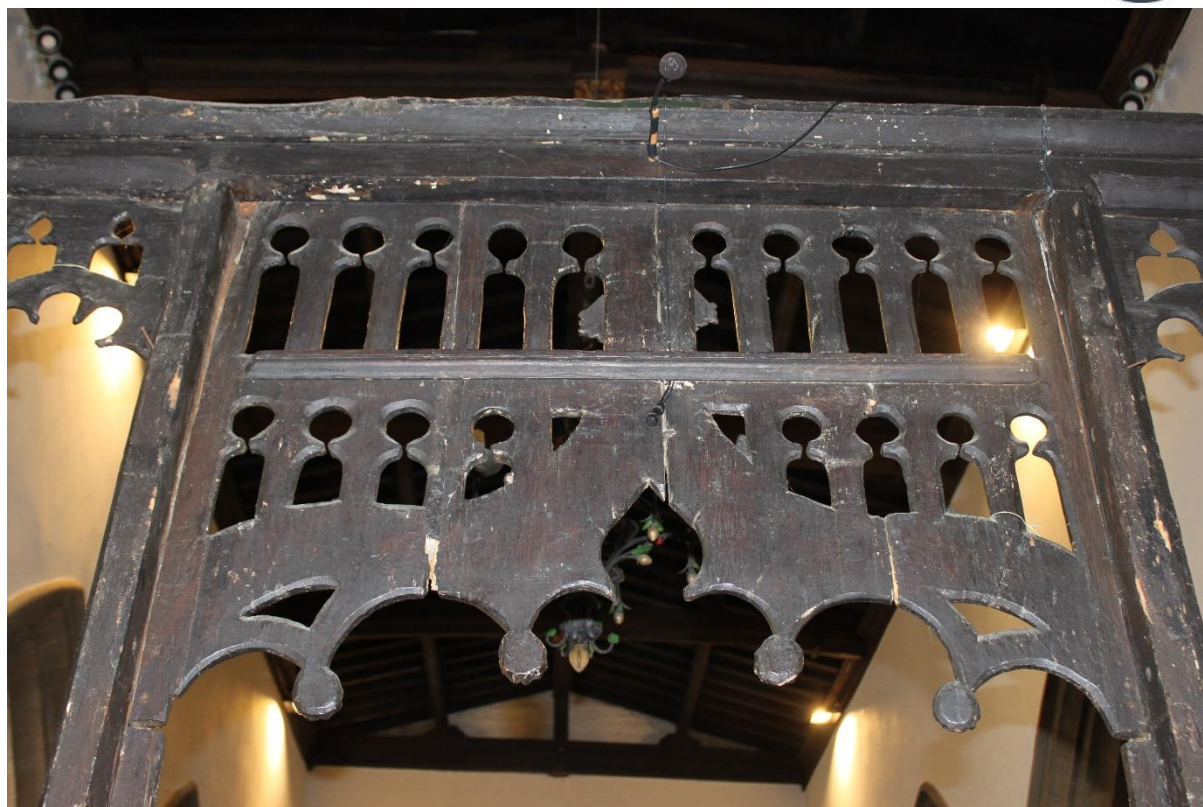
Plate 7: View to the chancel facing side of the decorative central arch of the screen from the chancel, looking west (Credit: Esther Robinson Wild)

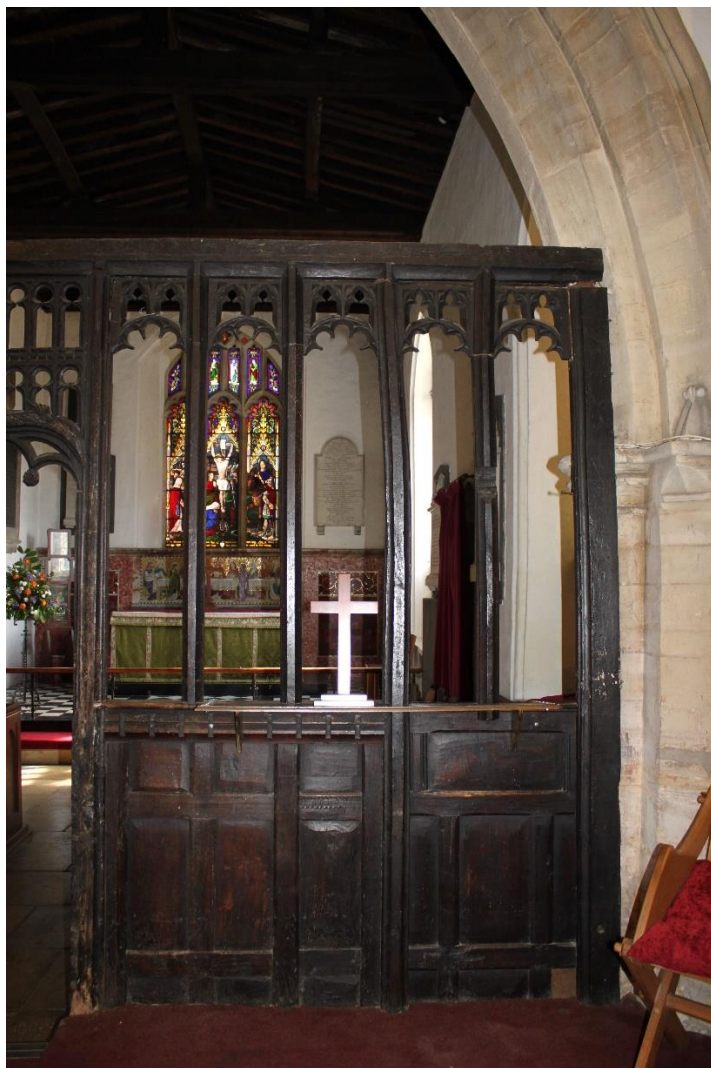
Plate 8: View to the south side of the nave facing side of the screen and the chancel from the nave, looking east (Credit: Esther Robinson Wild)

29. There is no uniformity to the dado. On the south side (Plates 8; 10 – 11) it is comprised of raised panelling with boards of varied sizes and differing sections of limited decoration. As noted above, some of this panelling was taken from the 1636 pulpit. The dado on the north side (Plate 16; 20) is uniform and comprises five plain boards with squint holes of varying size within three of them. In the History, the north side dado is attributed to the sixteenth century.

31. The stanchions to the window lights (fenestration) have moulding profiles with some variety displayed on the south side (Plate 8). These evidence repair and the reuse of timbers. The stanchions on the north side (Plate 19) have a consistent moulding profile. An analysis of woodworking technique can assist in dating chancel screens. Specifically, an analysis of the jointing of the junction between the transom rail and the stanchion. Research (Wrapson, 2020,

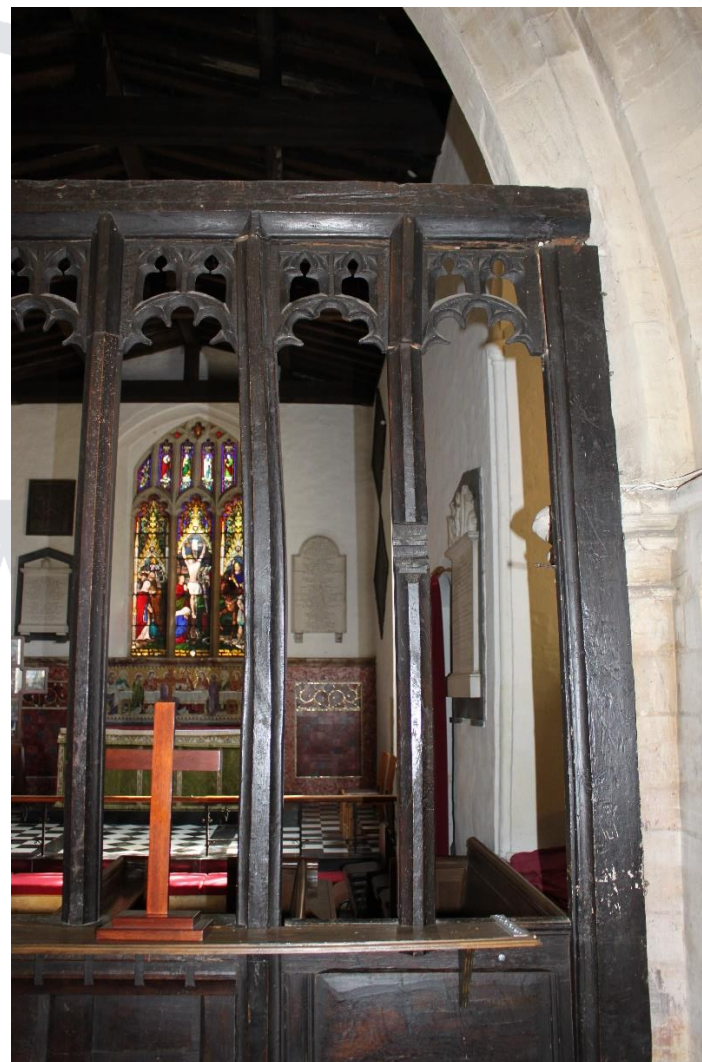
Plate 9: View to the window lights of the nave facing side of the south side of the screen and the chancel from the nave, looking east (Credit: Esther Robinson Wild)

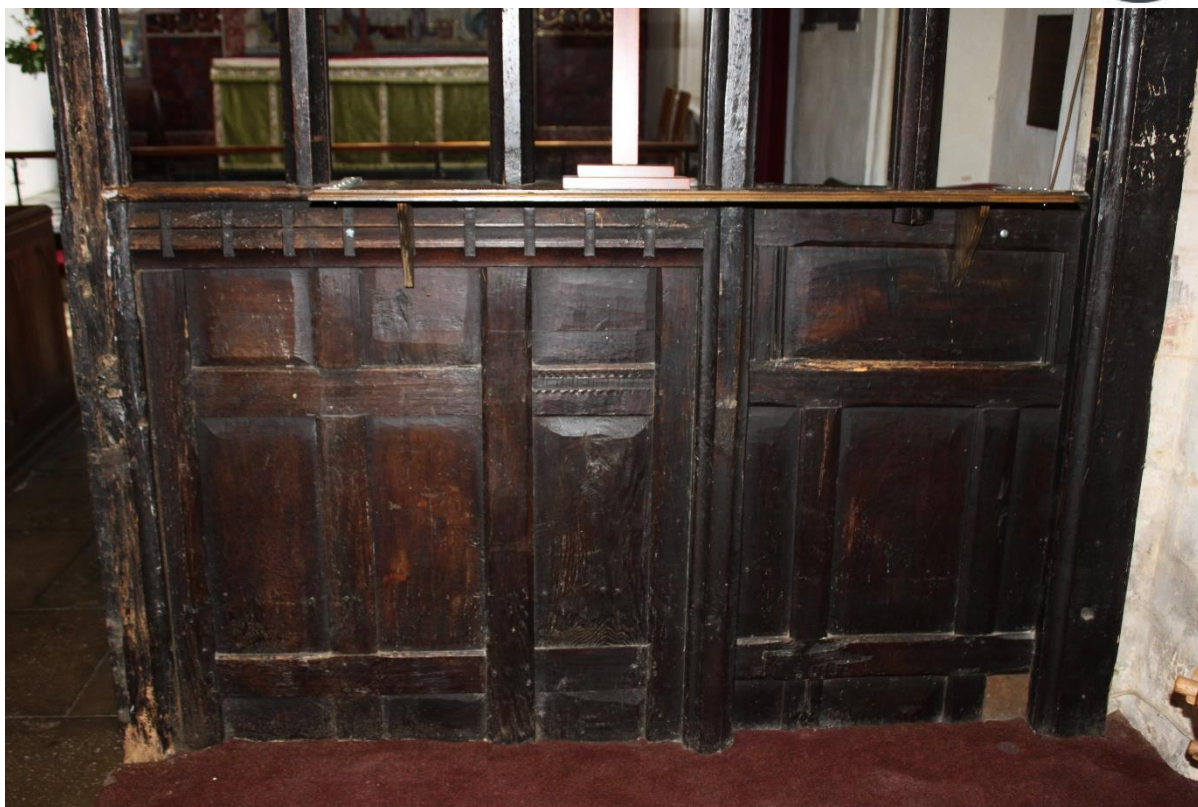
Plate 10: View to the dado of the south side of the screen from the nave, looking east (Credit: Esther Robinson Wild)

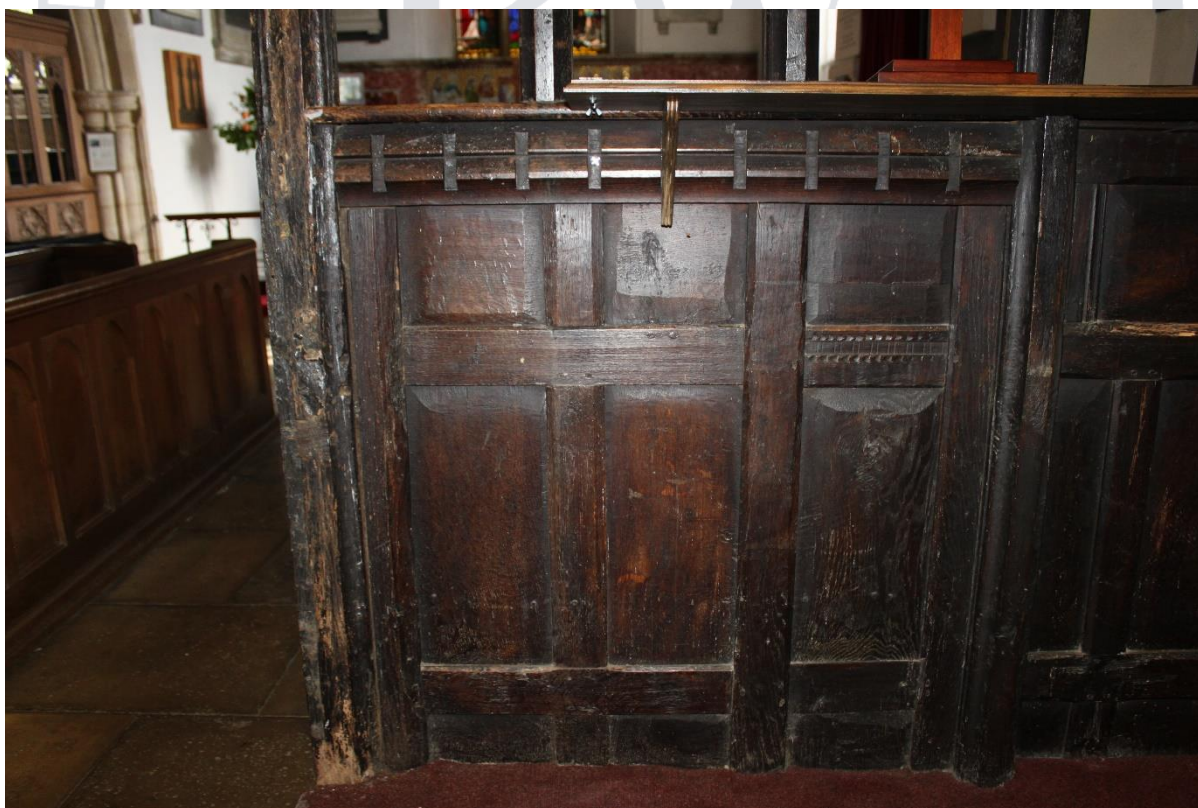
Plate 11: View to the dado of the south side of the screen from the nave, looking east (Credit: Esther Robinson Wild)

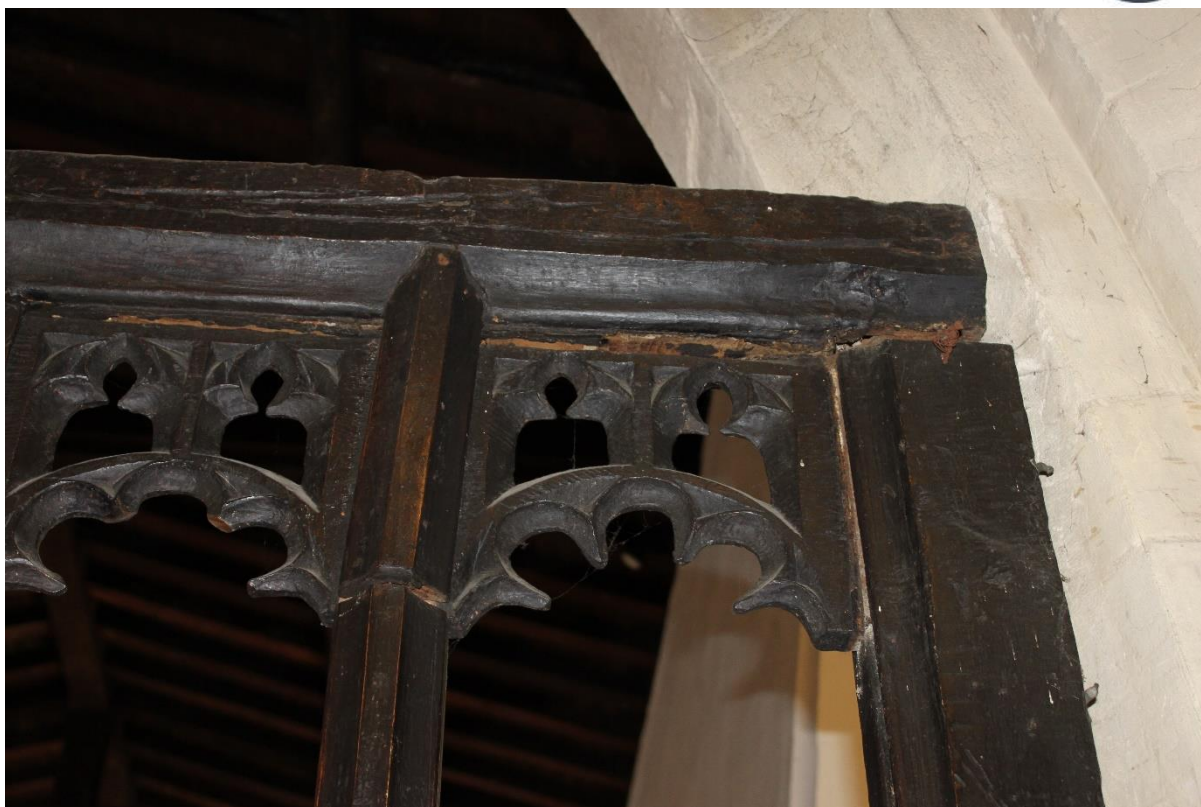
Plate 12: View to top of the window lights of the south side of the screen from the nave, looking east (Credit: Esther Robinson Wild)

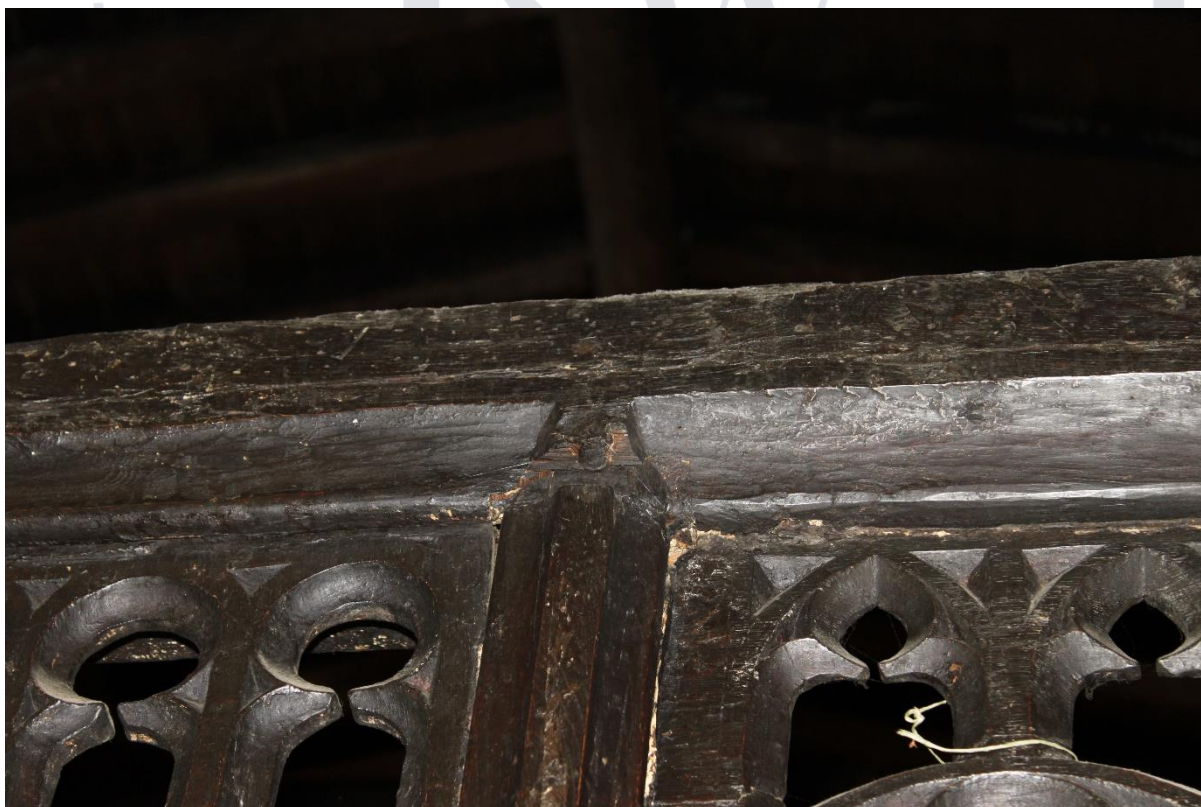
Plate 13: View to the top of the window lights (and metal nail) of the south side of the screen from the nave, looking east (Credit: Esther Robinson Wild)

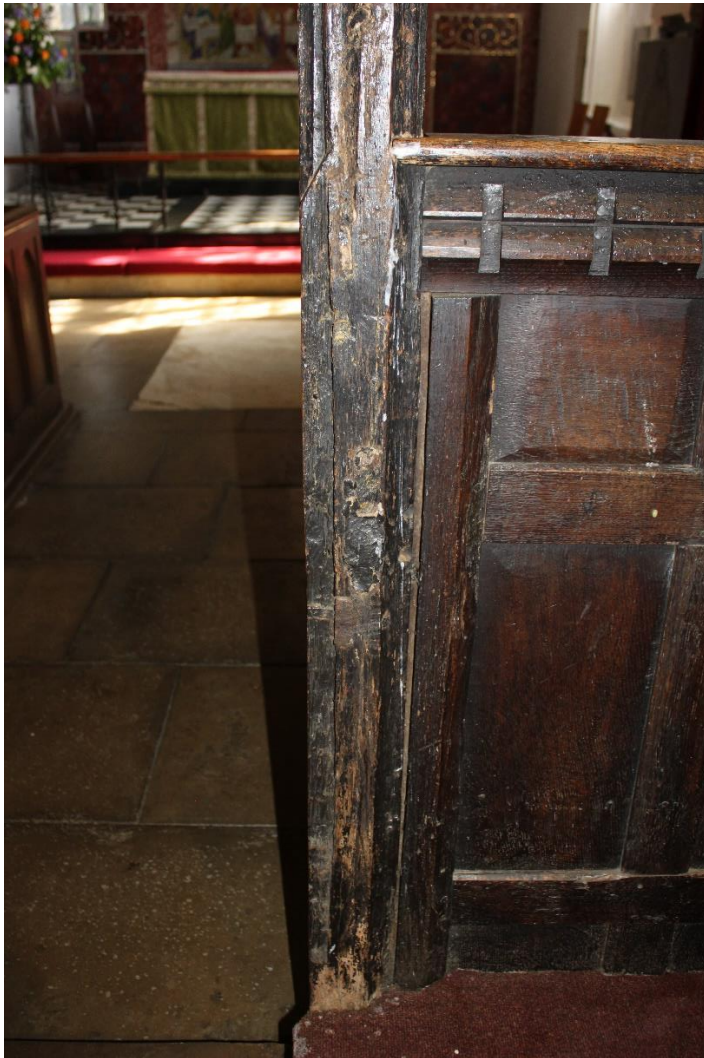
Plate 14: View to the post of the south side of the screen from the nave, looking east  
(Credit: Esther Robinson Wild)

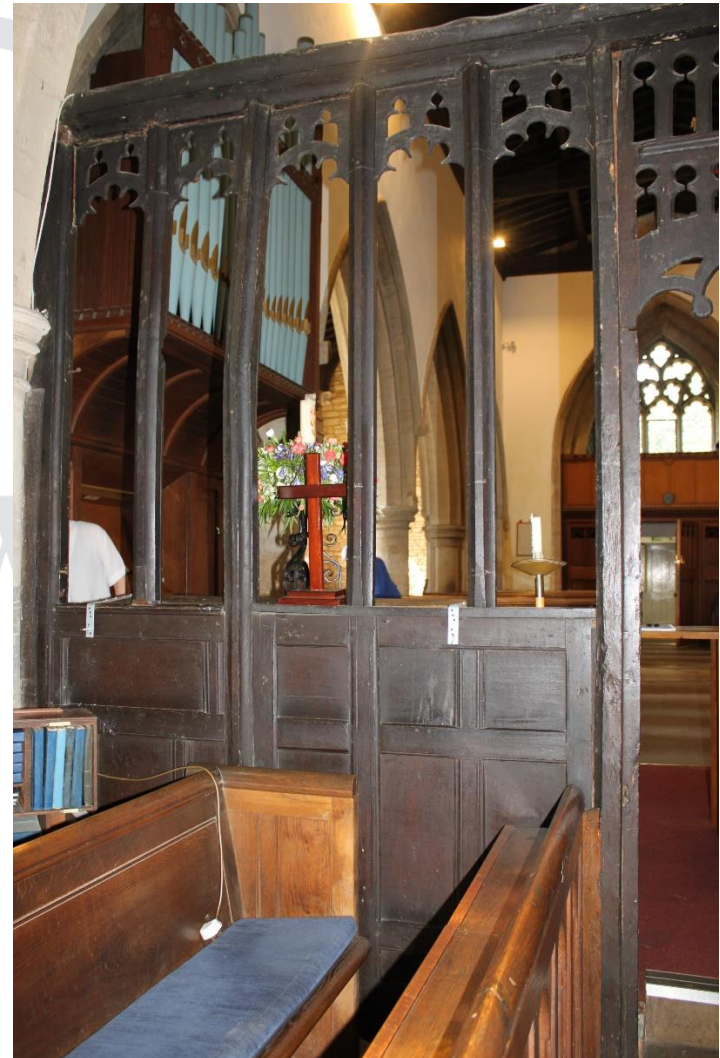
Plate 15: View to the chancel facing side of the dado of the south side of the screen from the chancel, looking west (Credit: Esther Robinson Wild)

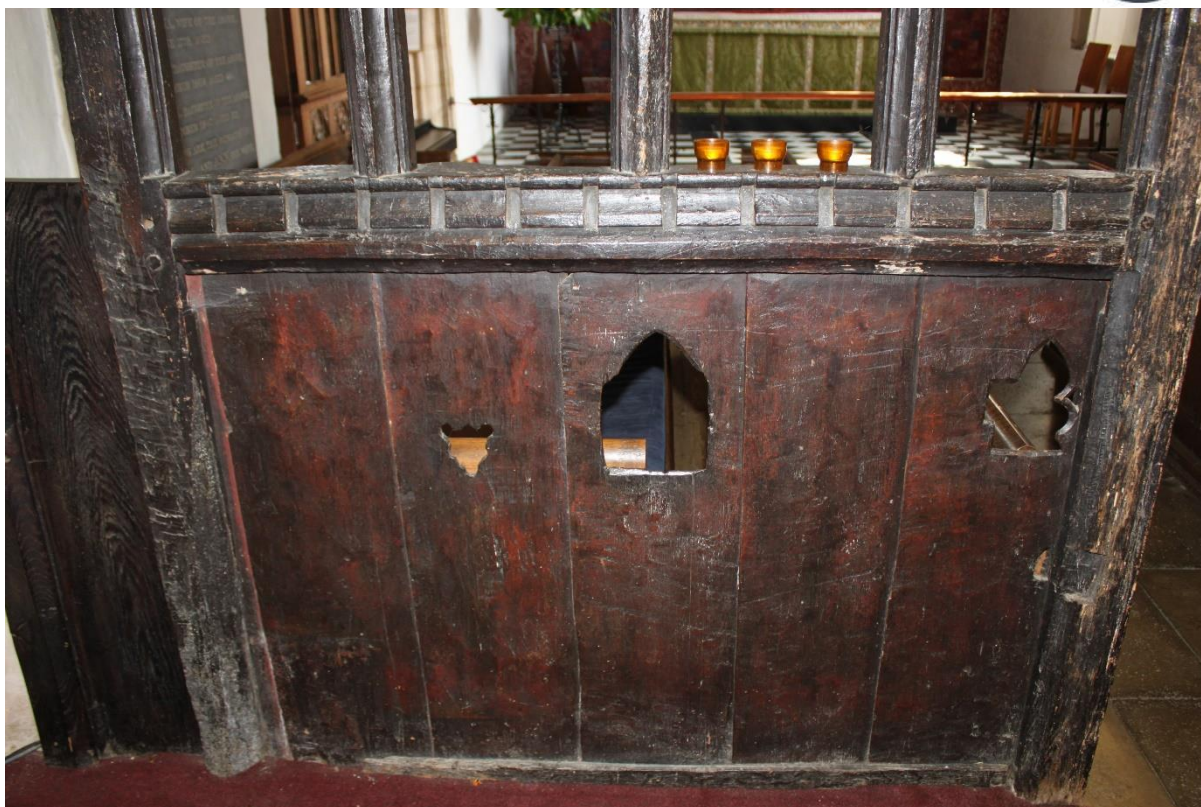
Plate 16: View to the dado of the north side of the screen from the nave, looking east (Credit: Esther Robinson Wild)

28. The oak chancel screen is comprised a central ogee arch flanked by a bay either side. Each bay has five window lights, the tall and narrow profile of which is a characteristic of the Perpendicular style. A sill is visible only in part on the north side (Plates 16; 23). This is due to the variegated floor level between the nave and the chancel, the latter being at a lower level and accessed via two steps (Plate 5). The sill is a strong horizontal timber that serves as a foundation for the chancel screen. As a rule the sill would run end to end doors and panelling alike but it would not be fixed to the floor.

30. The transom rails across both sides also lack uniformity with a consistent dentil decoration to that on the north side (Plates 16 – 18), and a section of the south side having notches which were likely designed (rather crudely) to give a dentil effect. The decoration is restricted to the nave facing side of the chancel screen.

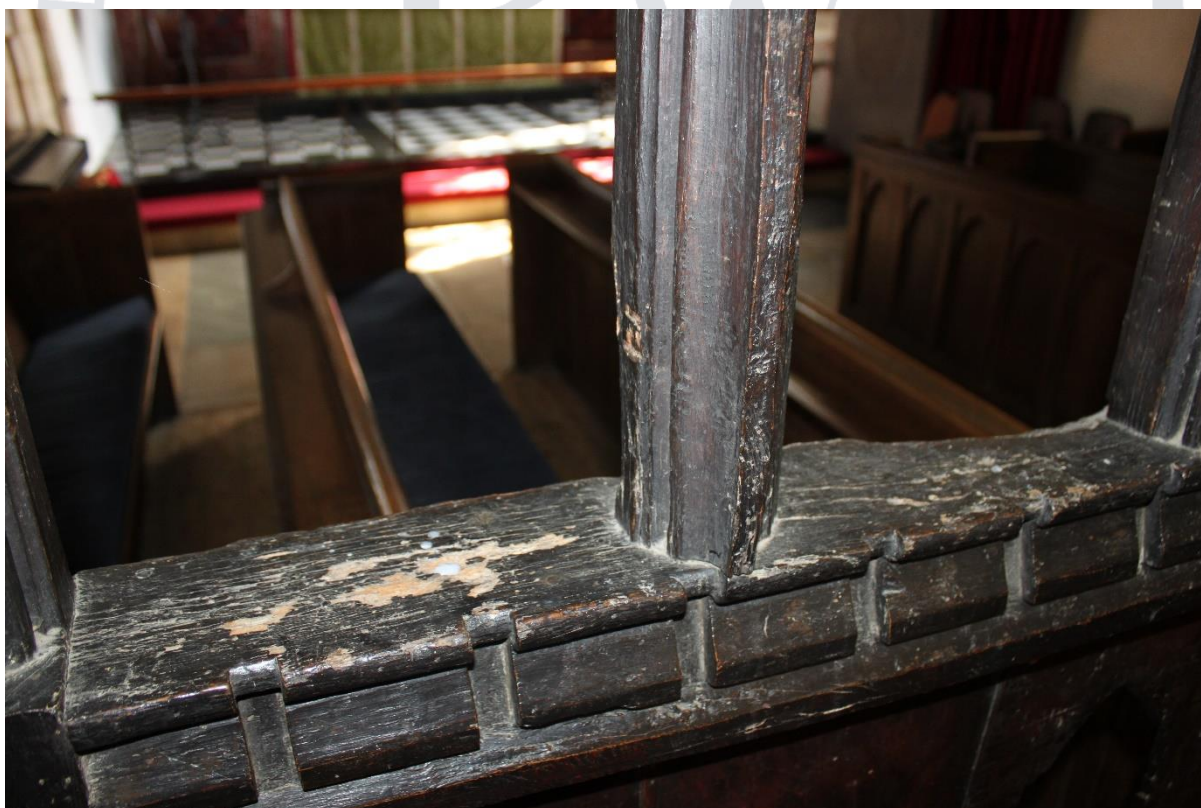
Plate 17: View to a section of the transom rail above the dado of the north side of the screen from the nave, looking east (Credit: Esther Robinson Wild)

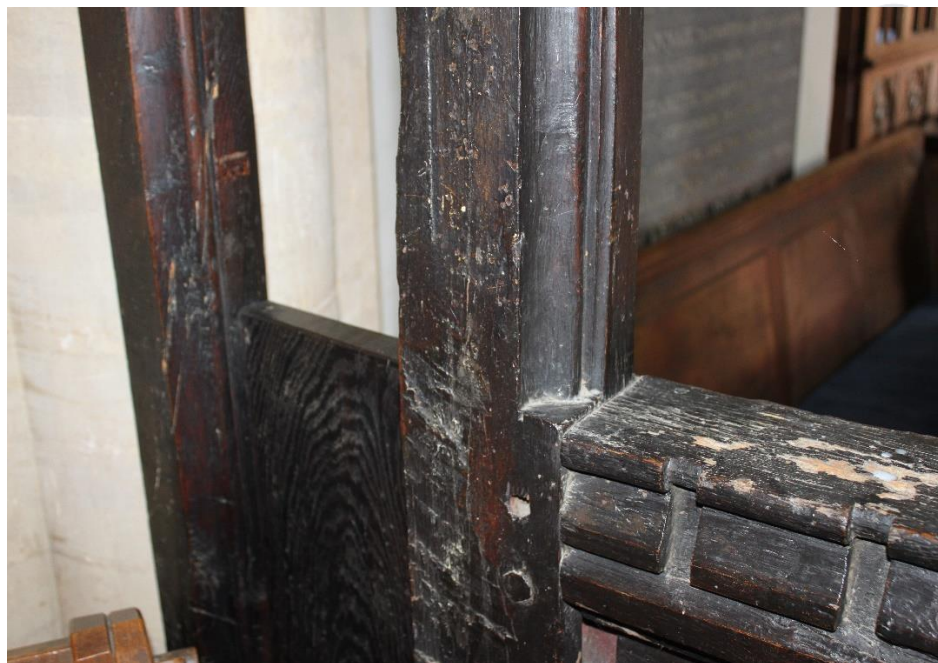
Plate 18: View to a section of dado and transom rail of the north side of the screen from the nave, looking east (Credit: Esther Robinson Wild)

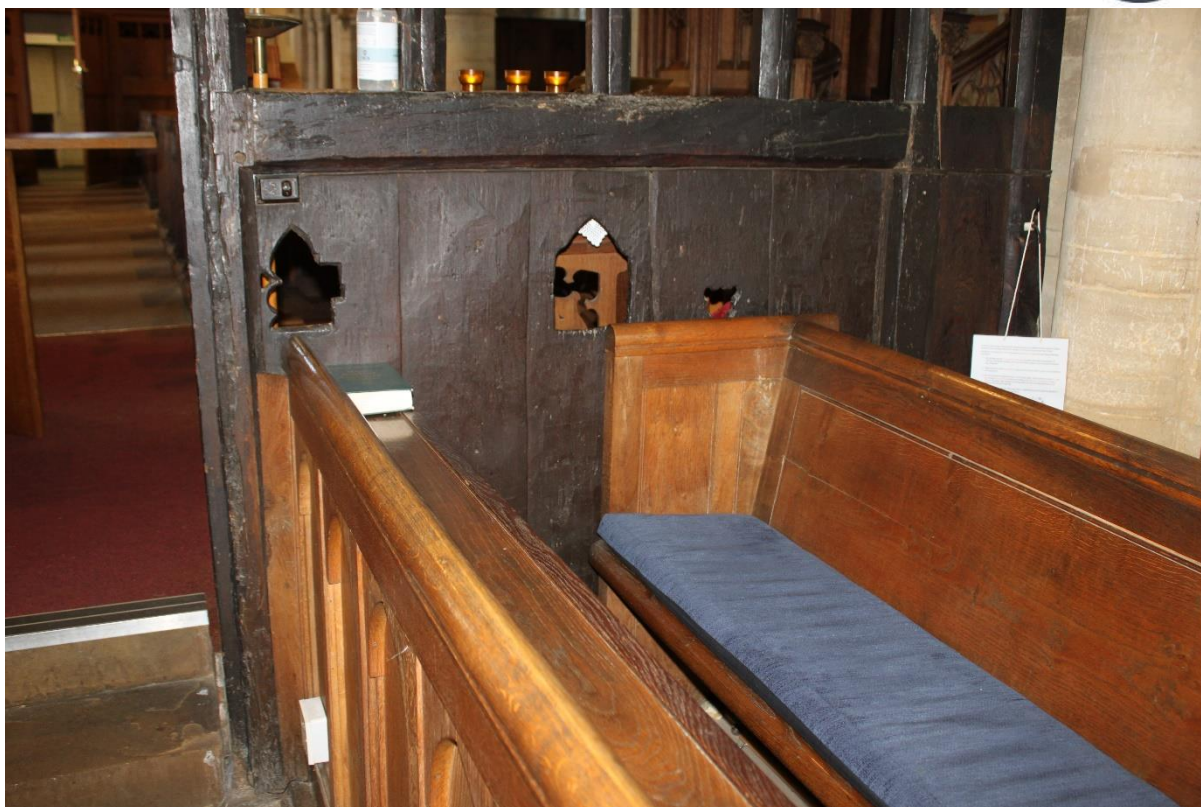
Plate 20: View to the dado on the chancel of the north side of the screen from the chancel, looking northwest (Credit: Esther Robinson Wild)

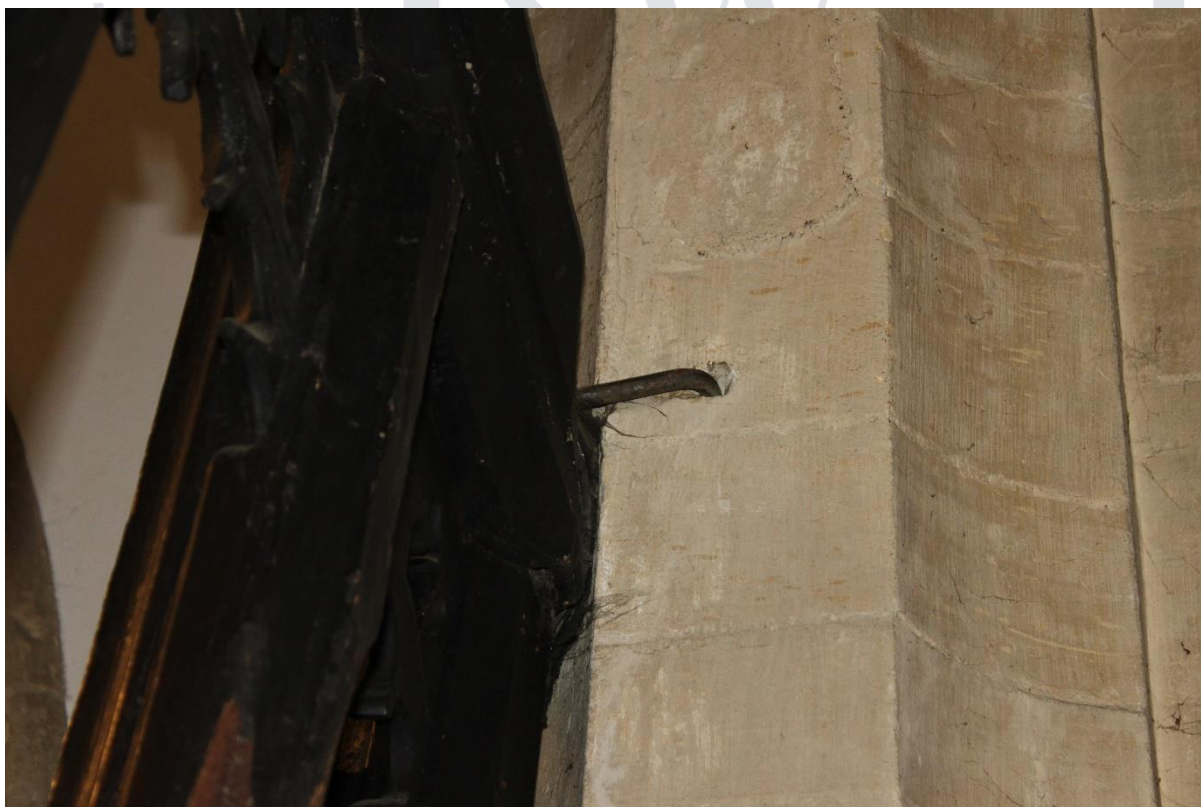
Plate 21: View to the iron fixing on the chancel facing side of the north side of the screen from the chancel, looking northwest (Credit: Esther Robinson Wild)

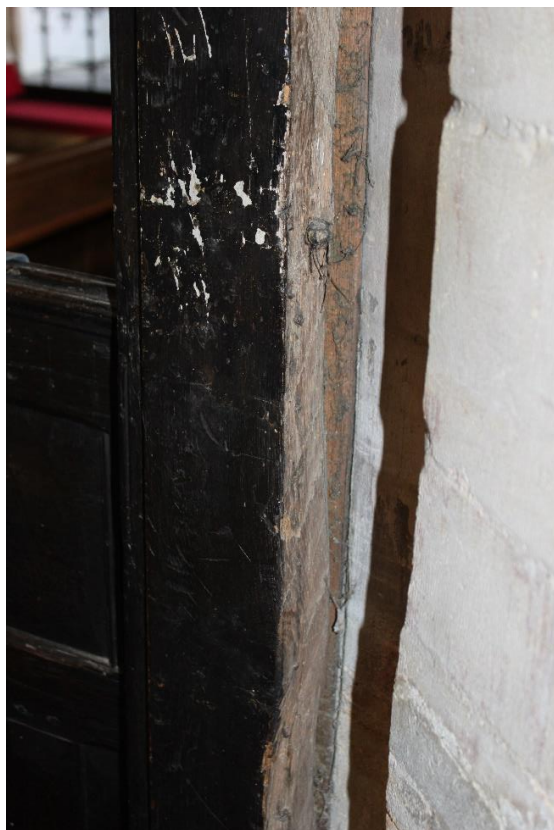
Plate 22: View to a section of post on the chancel facing side of the north side of the screen from the chancel, looking northwest (Credit: Esther Robinson Wild)

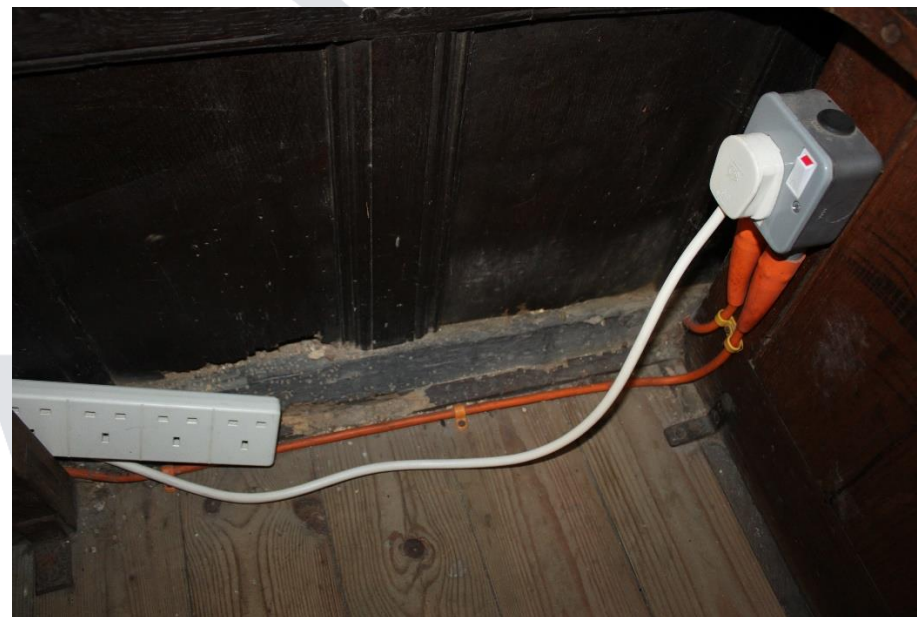
Plate 23: View to a section of sill on the chancel facing side of the north side of the screen from the chancel, looking northwest (Credit: Esther Robinson Wil)

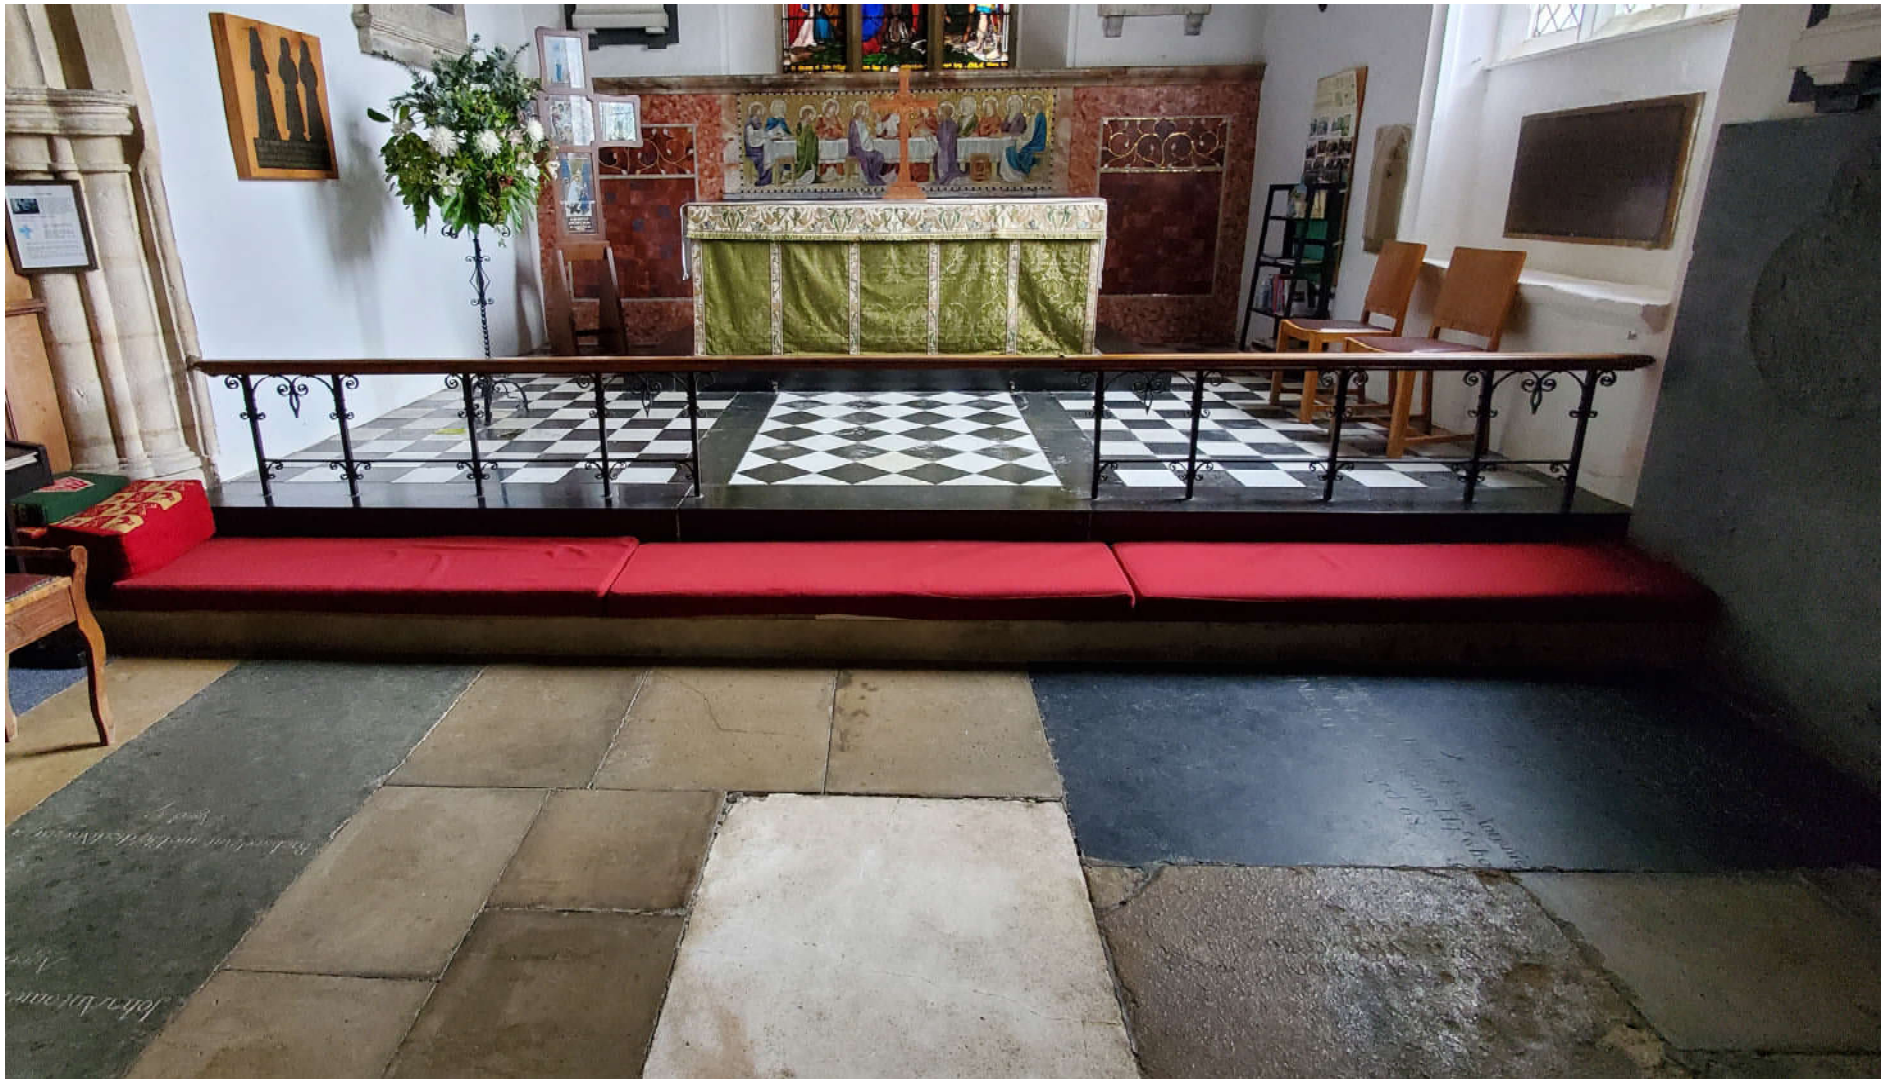
Existing Altar Rail.
