## **Draft Statement of Needs Revision B**

# St Peter's Sharnbrook – Draft Statement of Significance

Proj: 24-20: Assessment of Significance – Chancel Screen

Sharnbrook Church - Internal Access Improvements

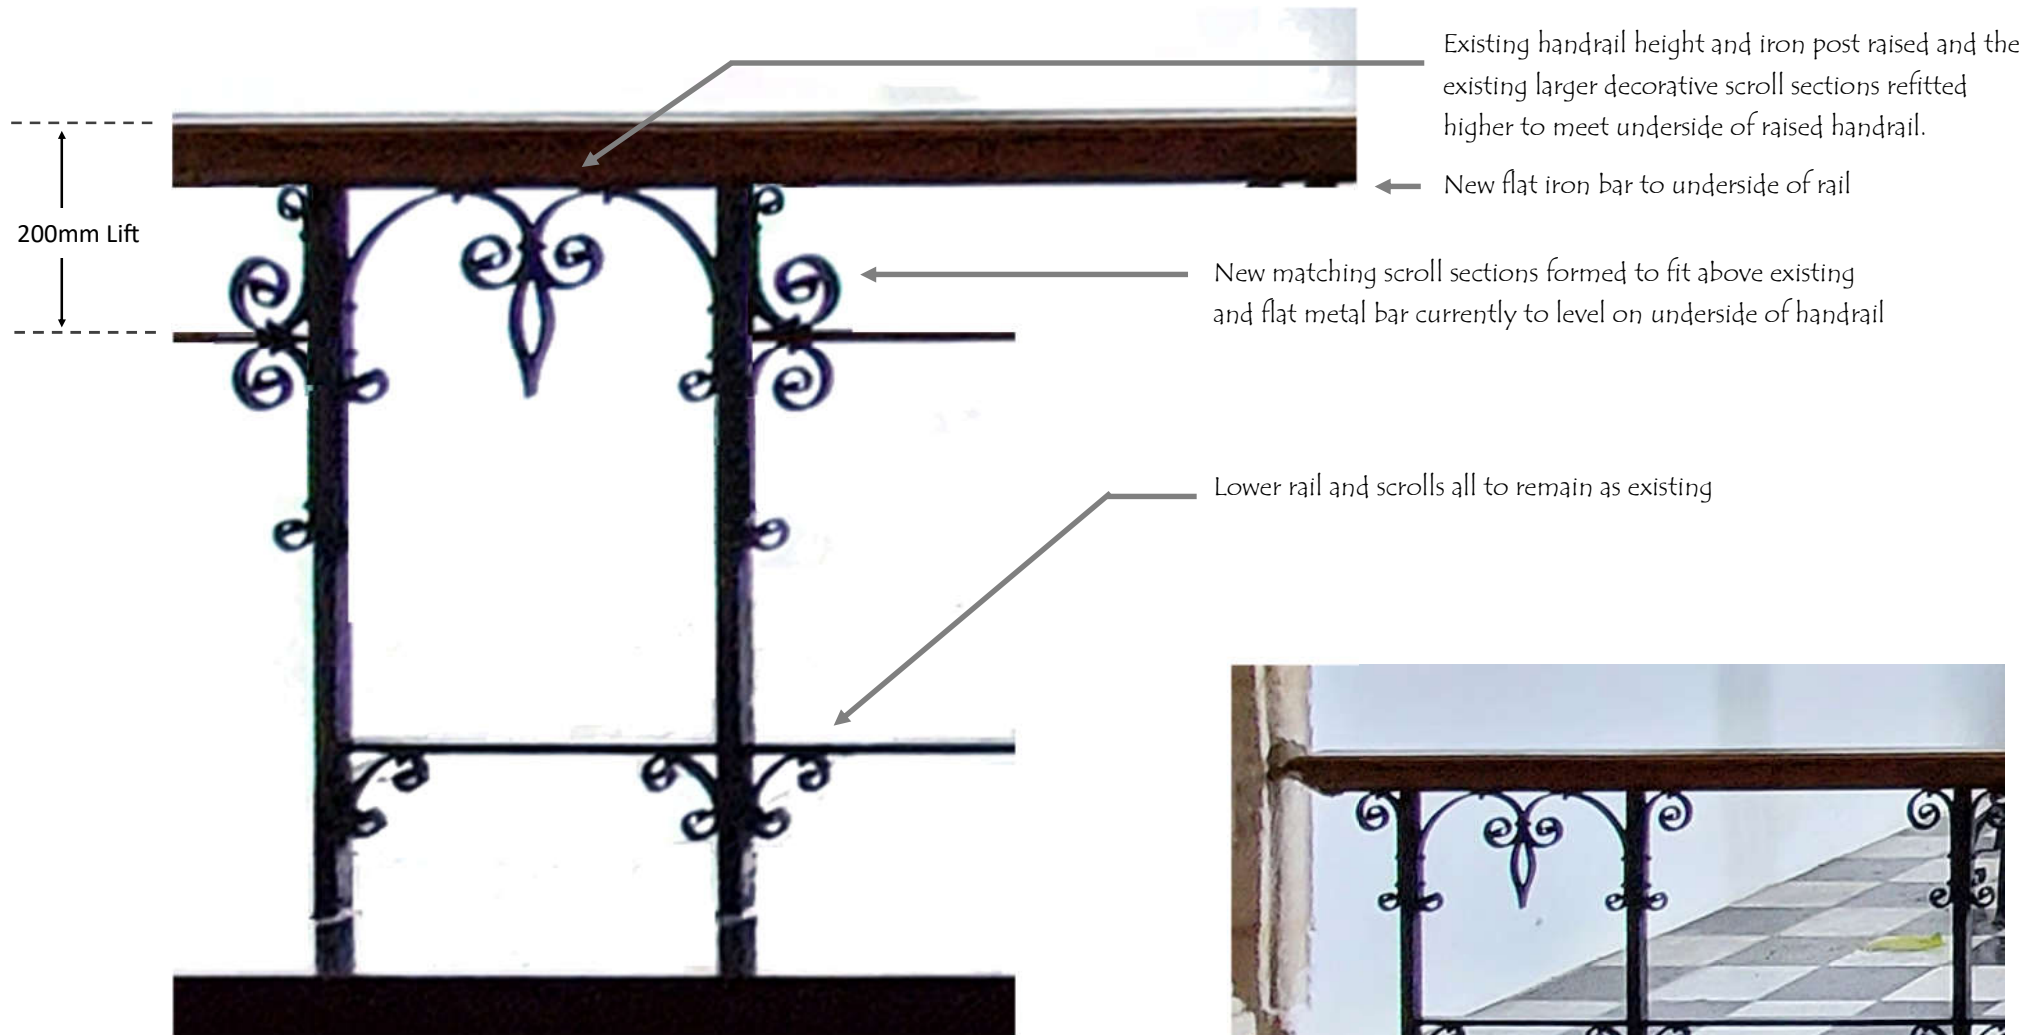
Proposed raised altar rail to enable proper use when floor level increased for level / step free access throughout.

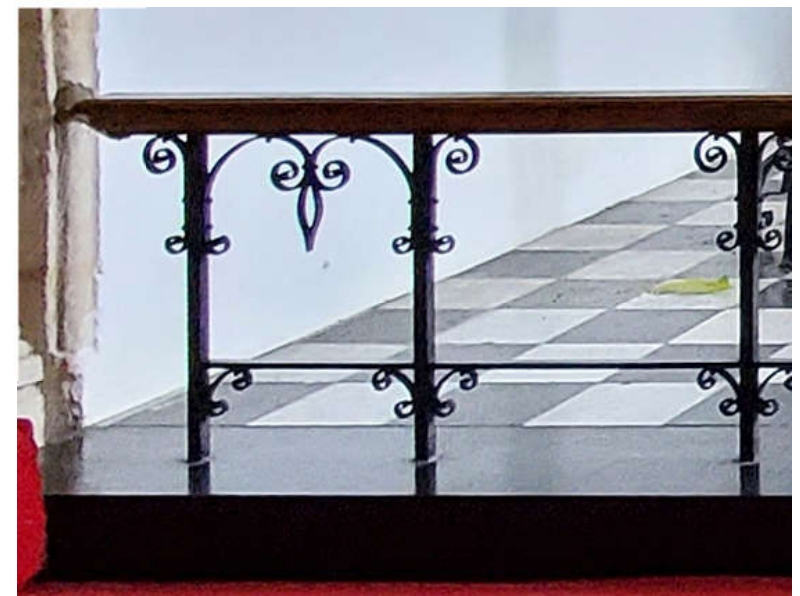
Existing Altar Rail

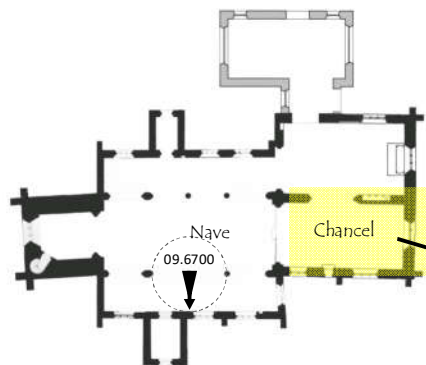
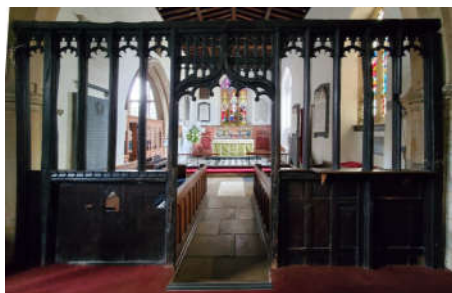
Existing chancel arch screen

If the screen was to be left where it is, the top of the arch would only be 1800mm above the nave floor when the chancel floor is raised to the same level. This would cause anyone 6ft (1800mm) tall and over to duck their head when passing through and the width of the arch opening would be too restricting especially for two wheelchairs to pass. As it is now the steps down from the nave to the lower level of the chancel obviate the need to duck. If the screen was to be raised in its present position it would expose the bottom part which will have decayed where it has been buried in concrete.

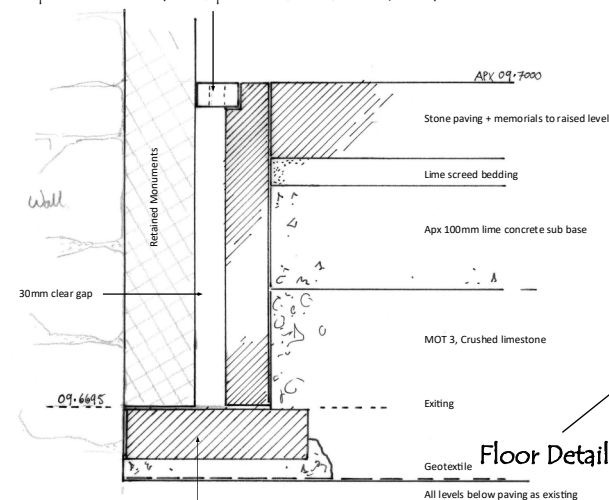
Floor Detail B

Rebed new section stone slab at original level to support monument and form base of vent gap structure

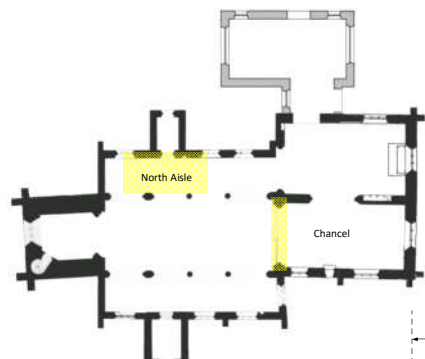
North wall

Stainless steel clip fixings to provide spacers and concurrently restrain screen against north wall

Allow to purpose fabricate and fix nominal 12N° black painted stainless steel fixing brackets to secure screen against wall. The exact location + detail for each fixing to be agreed with C.A. on site to ensure they remain as unobtrusive behind the historic timbers. The vertical load (weight) of the screen is to be supported directly to the floor as existing configuration.

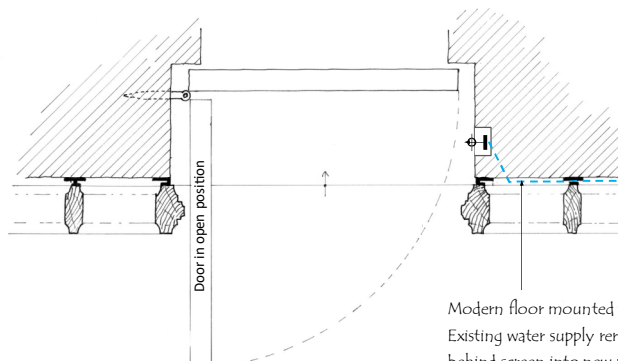
North Door - screen detail

Modern floor mounted tap removed, Existing water supply rerouted in gap behind screen into new recess formed on door reveal

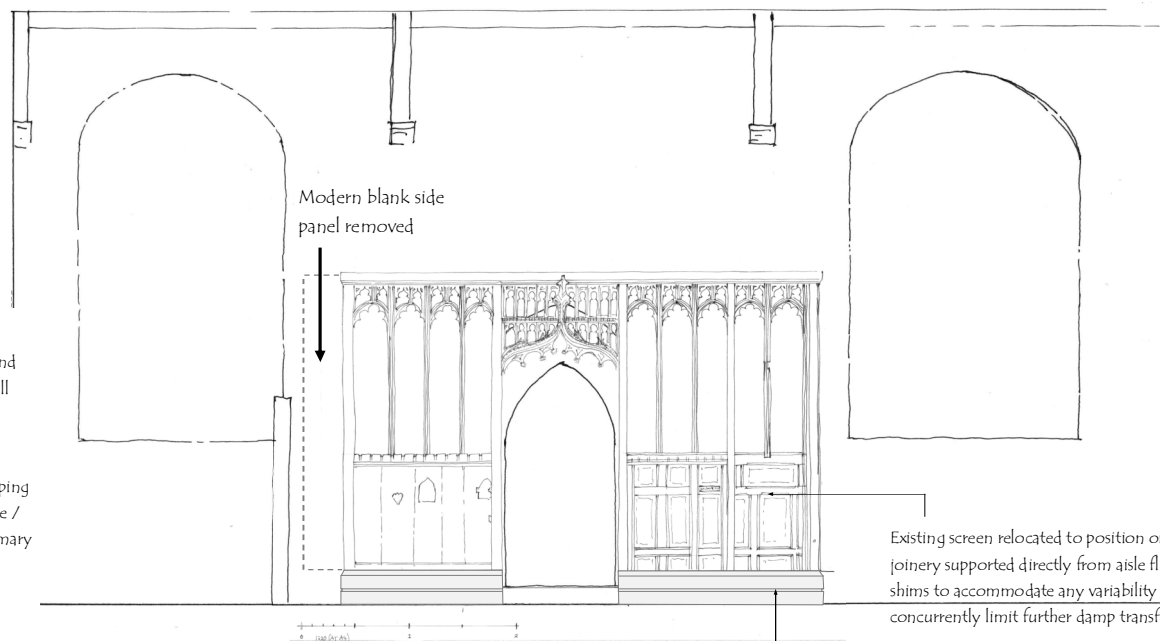
North Aisle Elevation

Existing screen relocated to position on north wall. Historic joinery supported directly from aisle floor with slate / lead shims to accommodate any variability of surface level and concurrently limit further damp transfer into timbers.

Oak plinth facing fitted to cover outer face where decayed / damaged to extent previously buried into concrete to Nave floor. (See detail)

- m) On completion of repairs lever into final position set on lead spacers to isolate timber and level up for any sundry deviation of existing floor surface. Remove remaining temporary support framing and fix securely against wall.

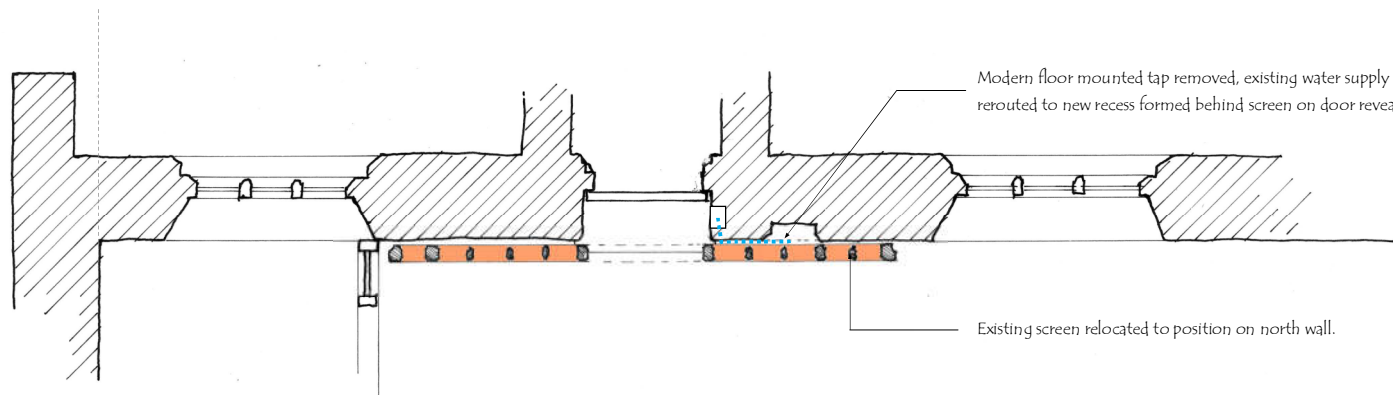
North Aisle Plan

Modern floor mounted tap removed, existing water supply rerouted to new recess formed behind screen on door reveal

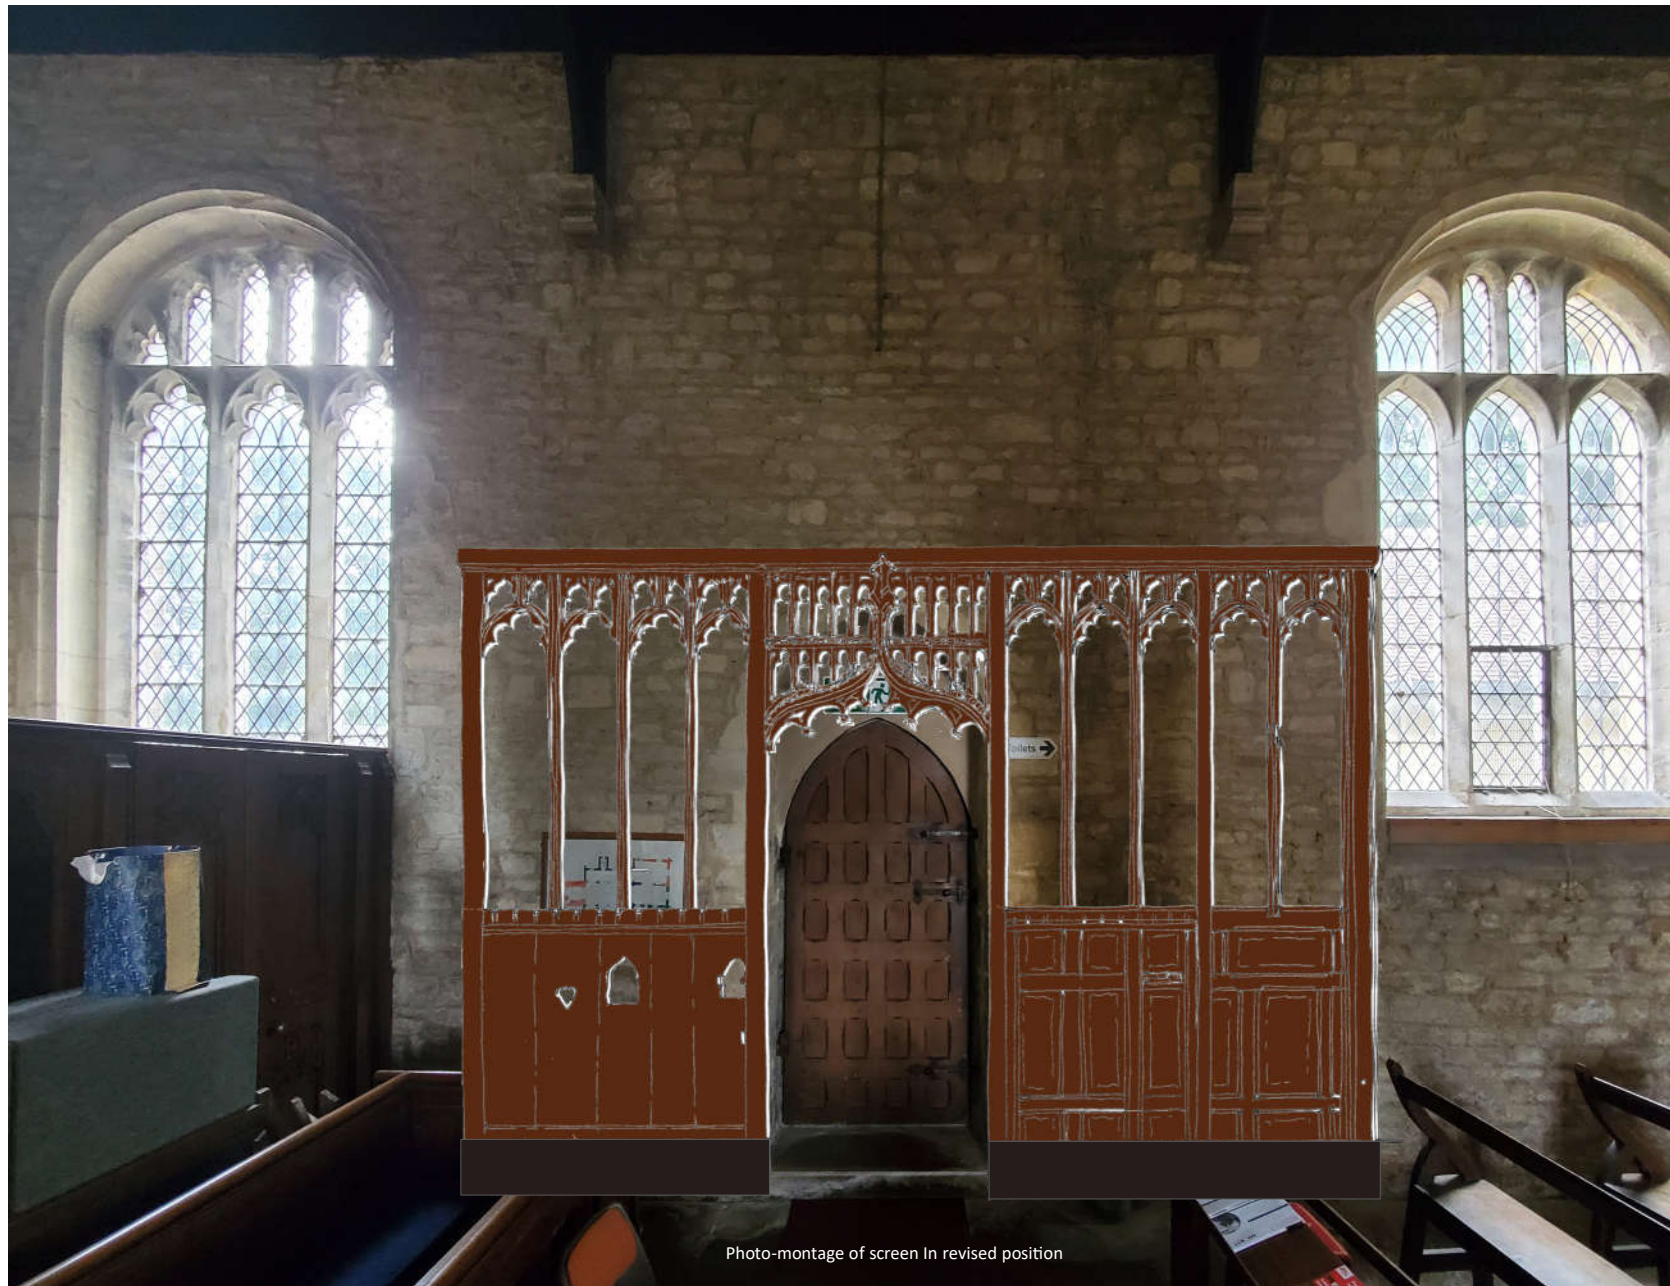
DRG-2416-P2-4a

Photo-montage of screen in revised position

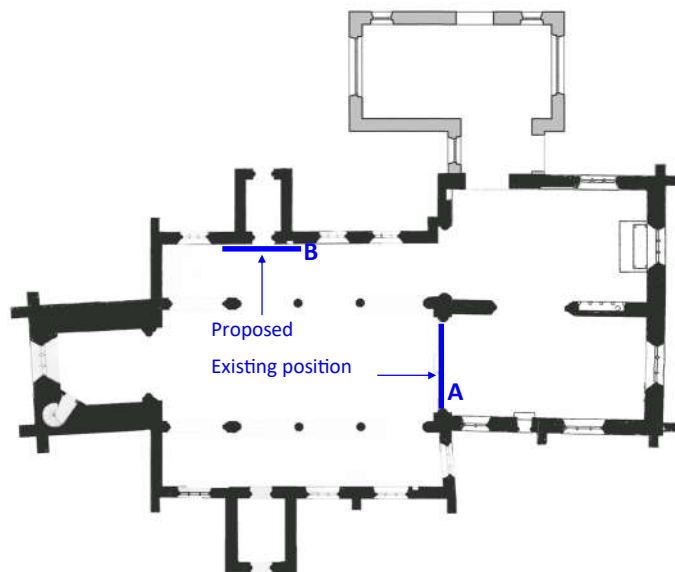
The proposal requires removal of the timber screen currently in position (A) Chancel arch, and relocation to position (B) Aisle north wall.

The existing screen can be accommodated in the new position. It allows the north door to open without need for modification other than removal of the modern end panel which currently exists against the north side of the arch.

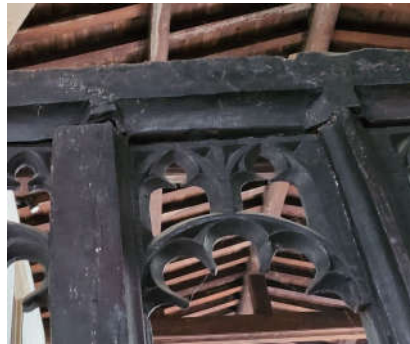
Mismatched assembly of historic headrail to lower mullion sections

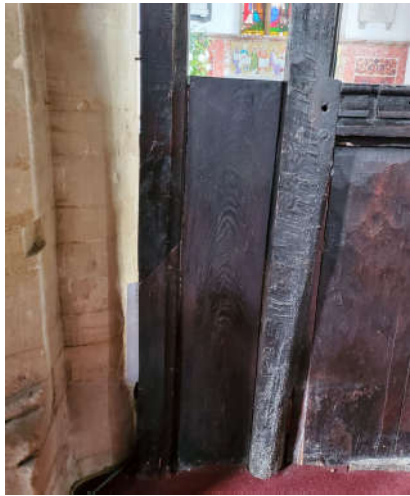
Extended screen width with extra frame section fitted with a modern infill board.

Below, original infill planking to lower screen

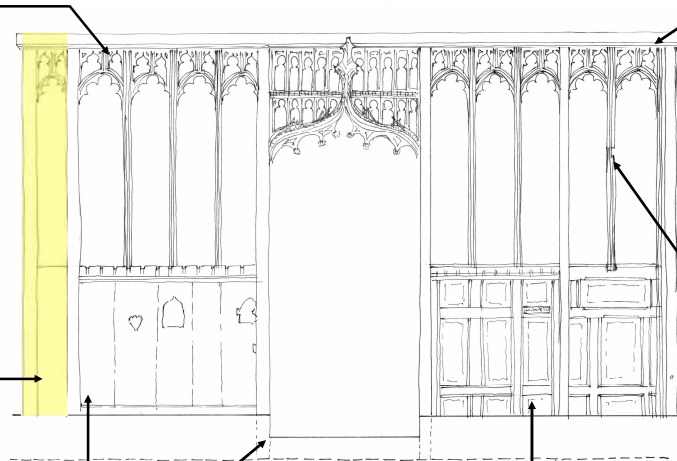
Side frame and tracery sections mis-matched to adjacent joinery and currently loose.

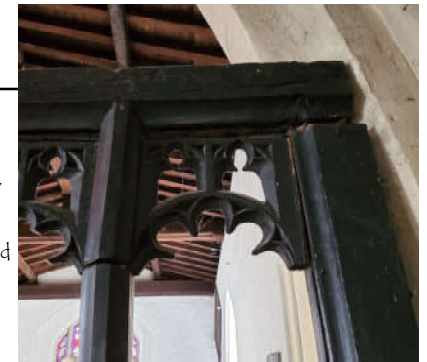
Cut out / damage for former pulpit location

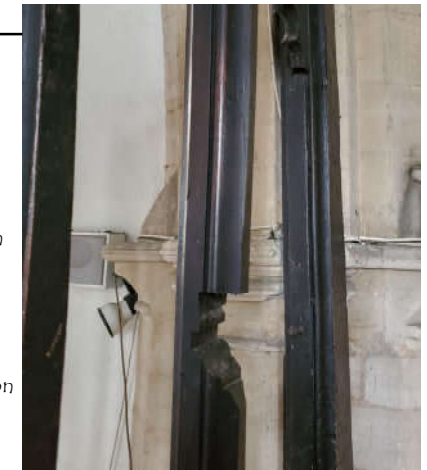
Lower Chancel floor level with base of screen partially buried against raised floor / concrete

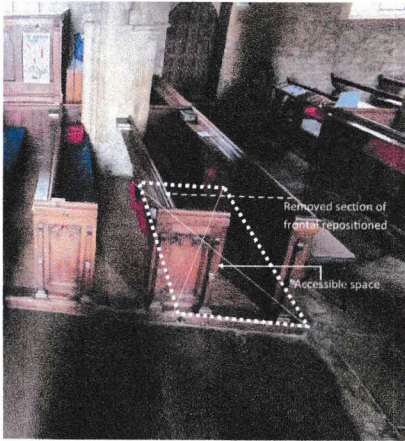
Loose, non original, pews removed and replaced with choir stall pews relocated from Chancel

- 12.01. Choir stalls** To the choir pews removed from the chancel under item 11.01 above allow to reposition 3N° into the area indicated on plan 2416-P2-7. This area already has a temporary timber pew platform which is currently populated with three loose non matching pews.

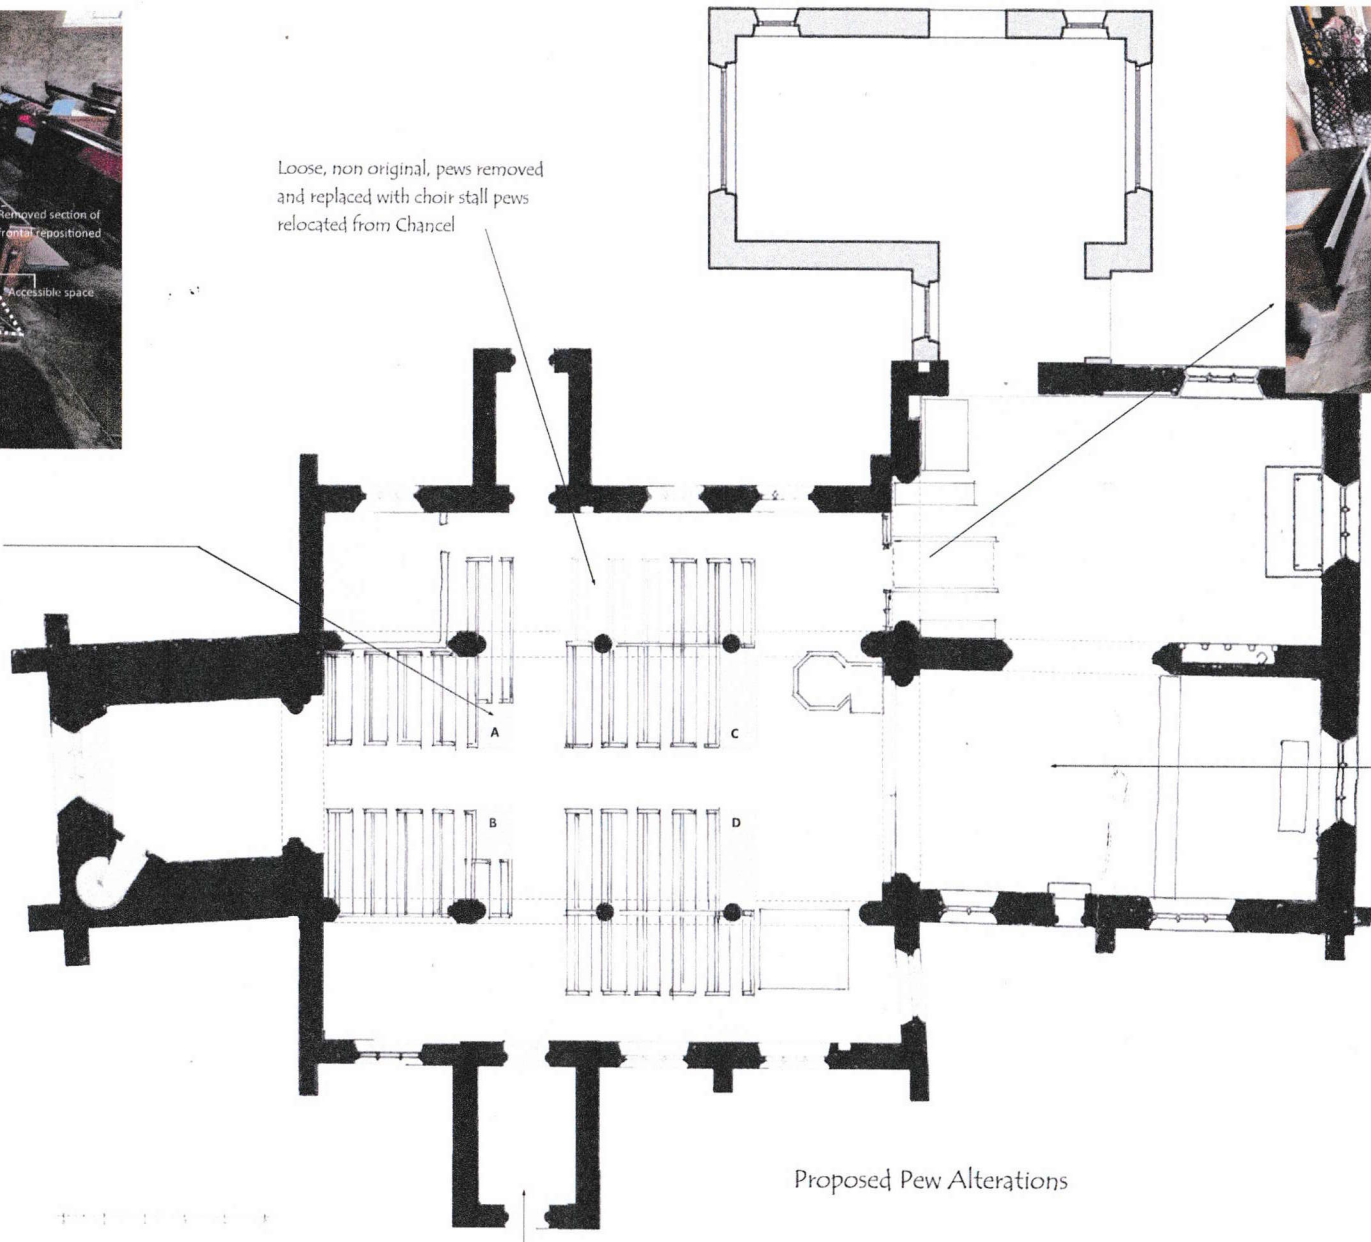
Proposed Pew Alterations

Areas A, B, C, D to have 1 No pew removed and frontals relocated to provide space suitable for wheelchair or pram use during services.

Pew base reduced in height. Timber kerbs repositioned around edge of retained plinth and clear area made flush with Nave floor using stone paving to match.

NB, When required loose chairs will be positioned to permit able bodied people to sit alongside those using spaces C + D.

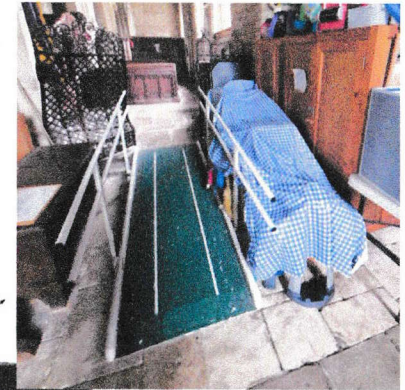
Existing temporary metal ramp replaced with fixed York stone paved ramp constructed over exiting retained floor slabs to apx 3050mm length reducing gradient of current ramp.

New ramp fitted blacksmith made black wrought iron handrail both sides.
