## **SCHEDULE OF DOCUMENTS**

## **Draft Statement of Needs Revision B**

# St Peter's Sharnbrook – Draft Statement of Significance

Sharnbrook Church - Internal Access Improvements

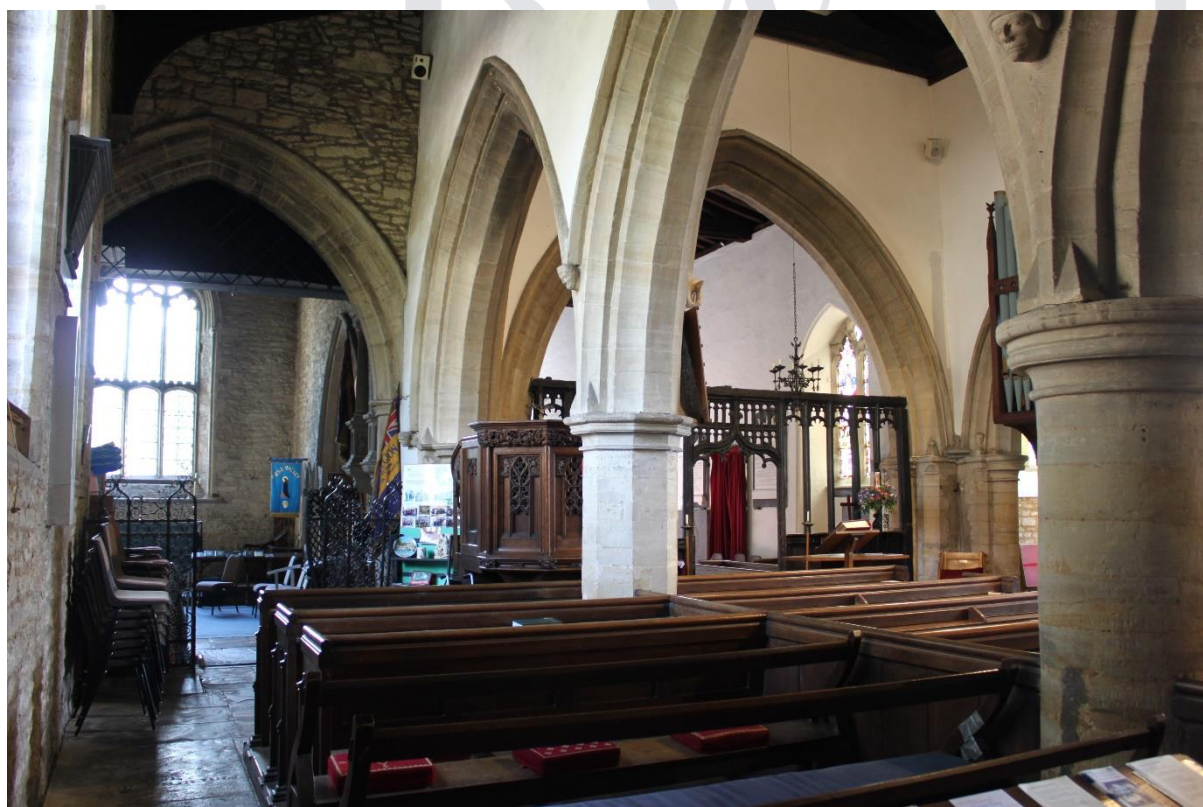
Plate 4: View to the Tofte Chapel, pulpit, nave facing side of the screen and the chancel from the north aisle, looking southeast (Credit: Esther Robinson Wild)

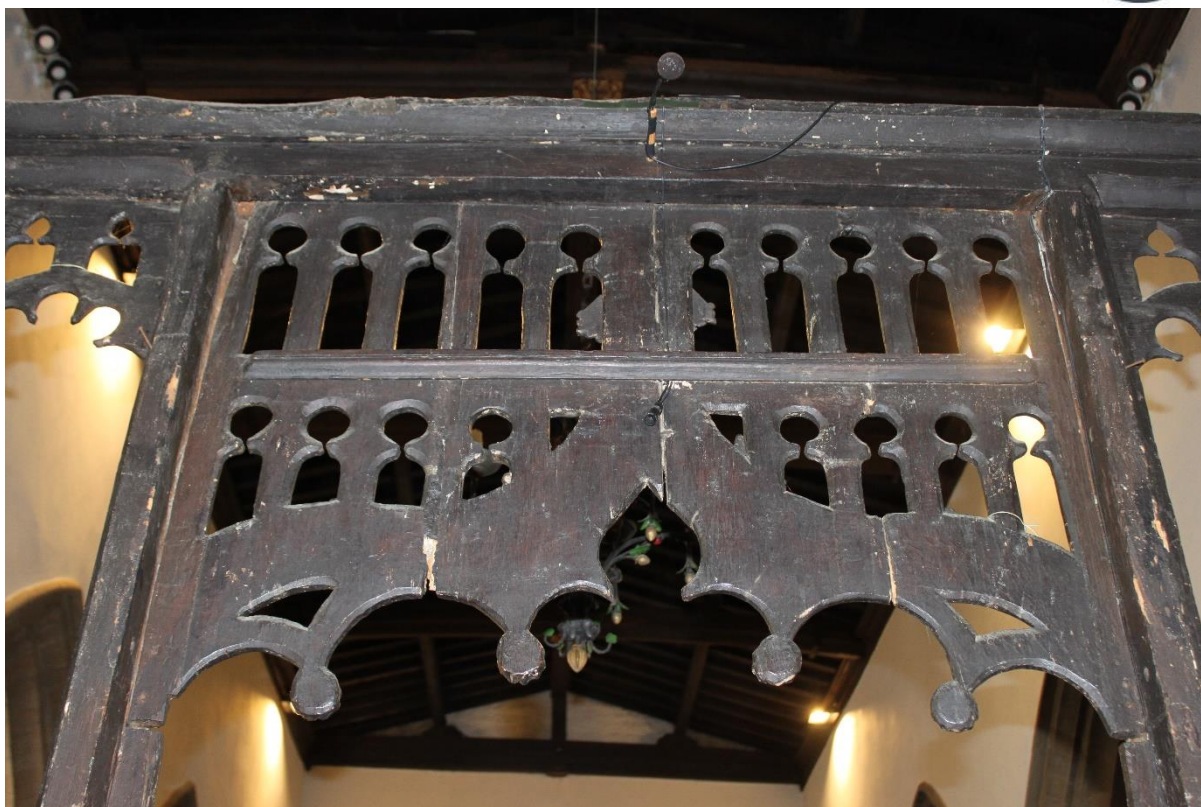
Plate 7: View to the chancel facing side of the decorative central arch of the screen from the chancel, looking west (Credit: Esther Robinson Wild)

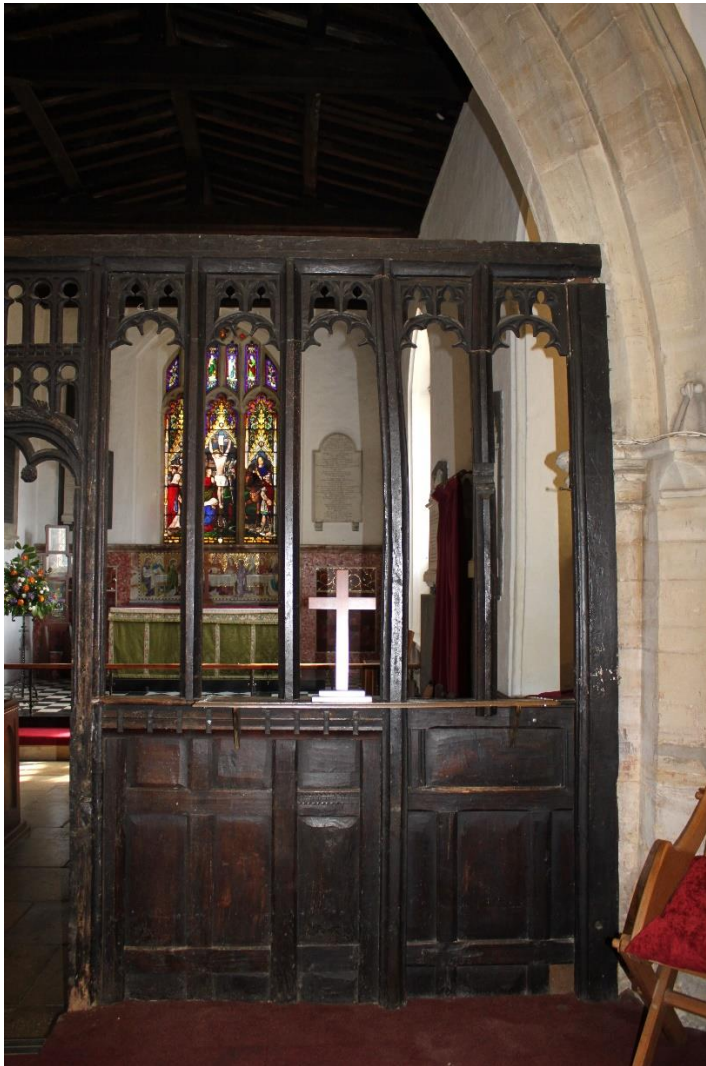
Plate 8: View to the south side of the nave facing side of the screen and the chancel from the nave, looking east (Credit: Esther Robinson Wild)

25. The History, which is based on contextual research, states that the extant chancel screen is partly of sixteenth century date with re-used panelling of the seventeenth century on the south side (Plates 8 – 15). The panelling is likely to have come from a pulpit which was inserted into the church in 1636. An inspection of the chancel screen indicates that it has been materially altered,

29. There is no uniformity to the dado. On the south side (Plates 8; 10 – 11) it is comprised of raised panelling with boards of varied sizes and differing sections of limited decoration. As noted above, some of this panelling was taken from the 1636 pulpit. The dado on the north side (Plate 16; 20) is uniform and comprises five plain boards with squint holes of varying size within three of them. In the History, the north side dado is attributed to the sixteenth century.

31. The stanchions to the window lights (fenestration) have moulding profiles with some variety displayed on the south side (Plate 8). These evidence repair and the reuse of timbers. The stanchions on the north side (Plate 19) have a consistent moulding profile. An analysis of woodworking technique can assist in dating chancel screens. Specifically, an analysis of the jointing of the junction between the transom rail and the stanchion. Research (Wrapson, 2020,

32. Each window light is headed by open tracery (Plates 8 – 9; 12 – 13; 15; 19) with two forms of trefoil arches. The central ogee arch decorated with a vine trail has drop tracery and openwork tracery in the spandrels (Plate 6). Overall, the design of the chancel screen is rather simple with the decoration restricted to the nave facing side (Plate 7 shows the plain chancel facing side of the central ogee arch). The restriction of the decoration to the nave facing side of the chancel screen is seen elsewhere and has been considered by some to indicate that because the parishioners paid for the work in many cases, and these same parishioners were not allowed into the chancel, then they were not especially concerned – if at all – with the eastern face of the screen in all its elements (Williams, 2008, pp. 148 – 149).

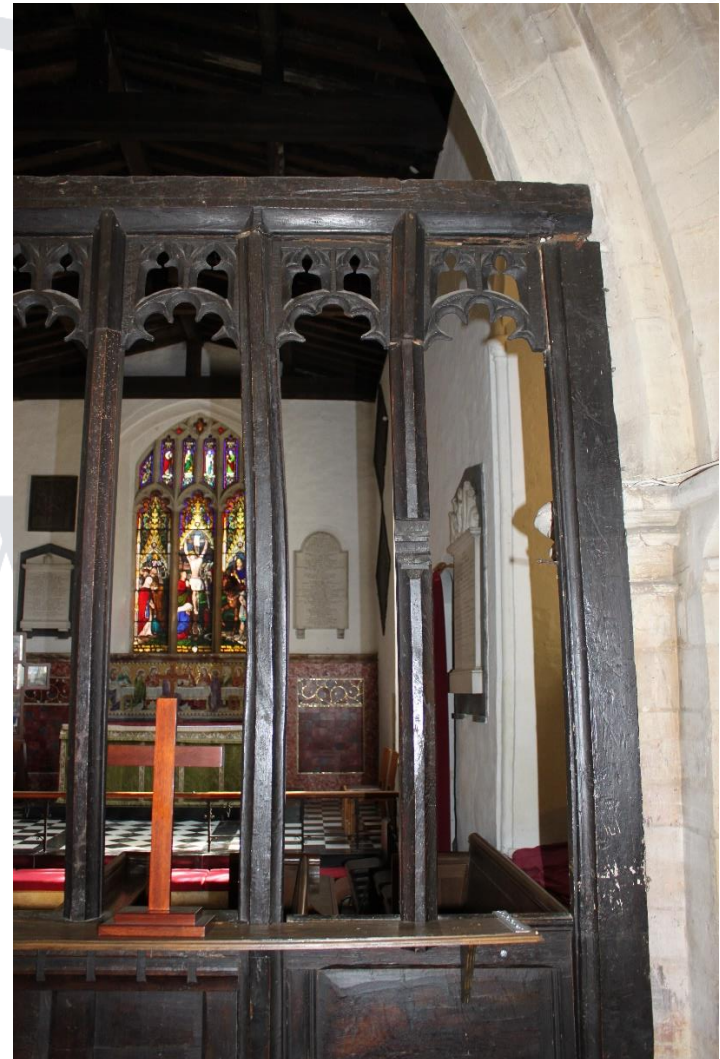
Plate 9: View to the window lights of the nave facing side of the south side of the screen and the chancel from the nave, looking east (Credit: Esther Robinson Wild)

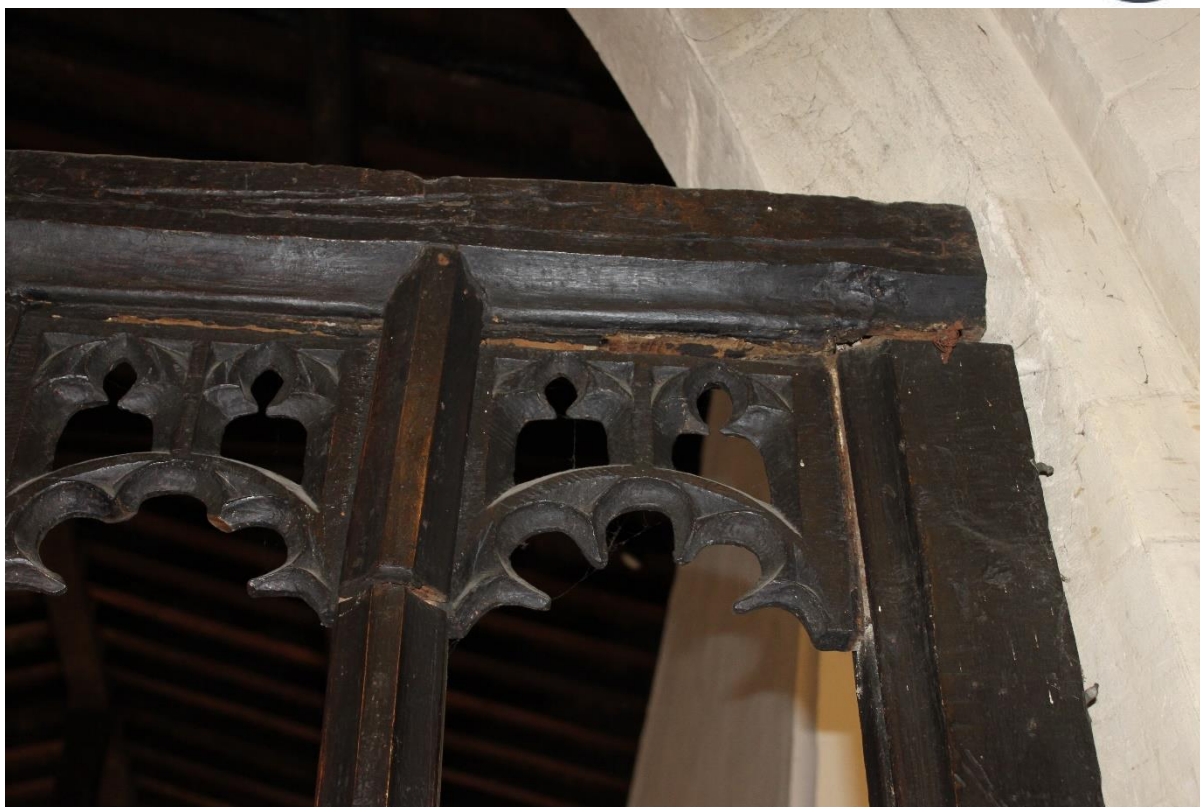
Plate 12: View to top of the window lights of the south side of the screen from the nave, looking east (Credit: Esther Robinson Wild)

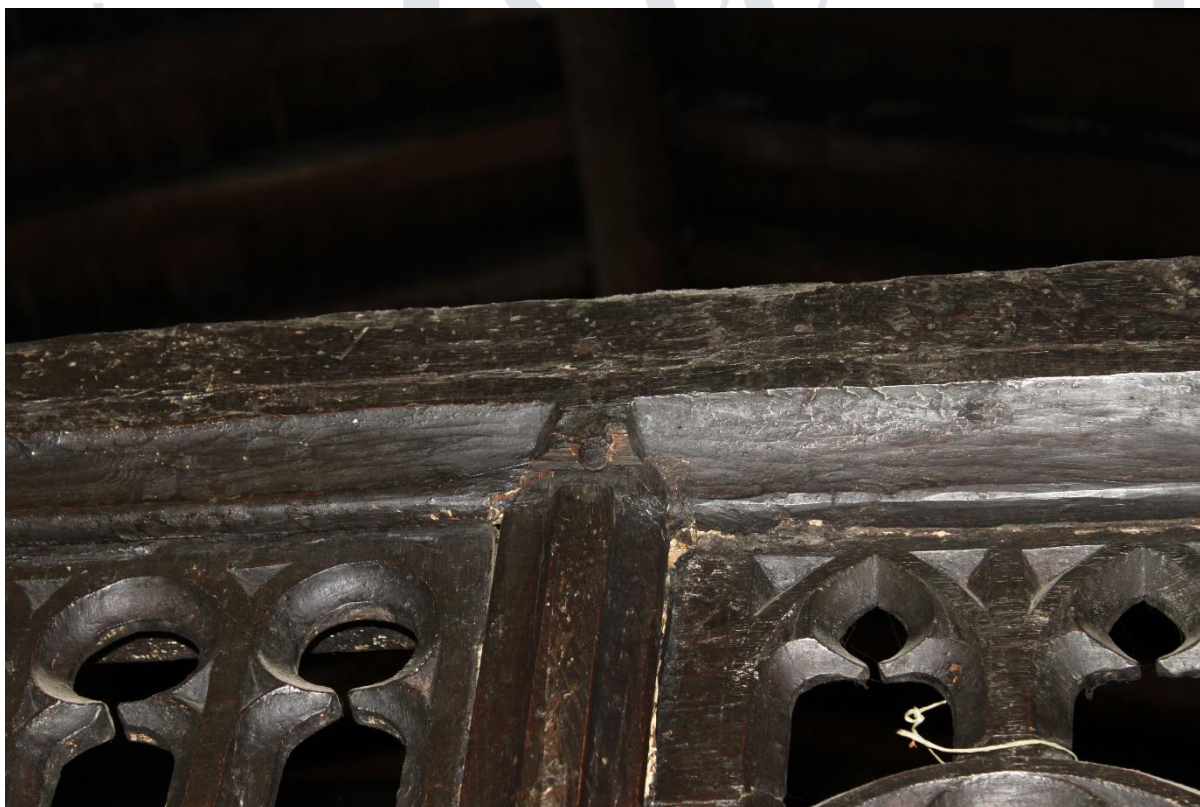
Plate 13: View to the top of the window lights (and metal nail) of the south side of the screen from the nave, looking east (Credit: Esther Robinson Wild)

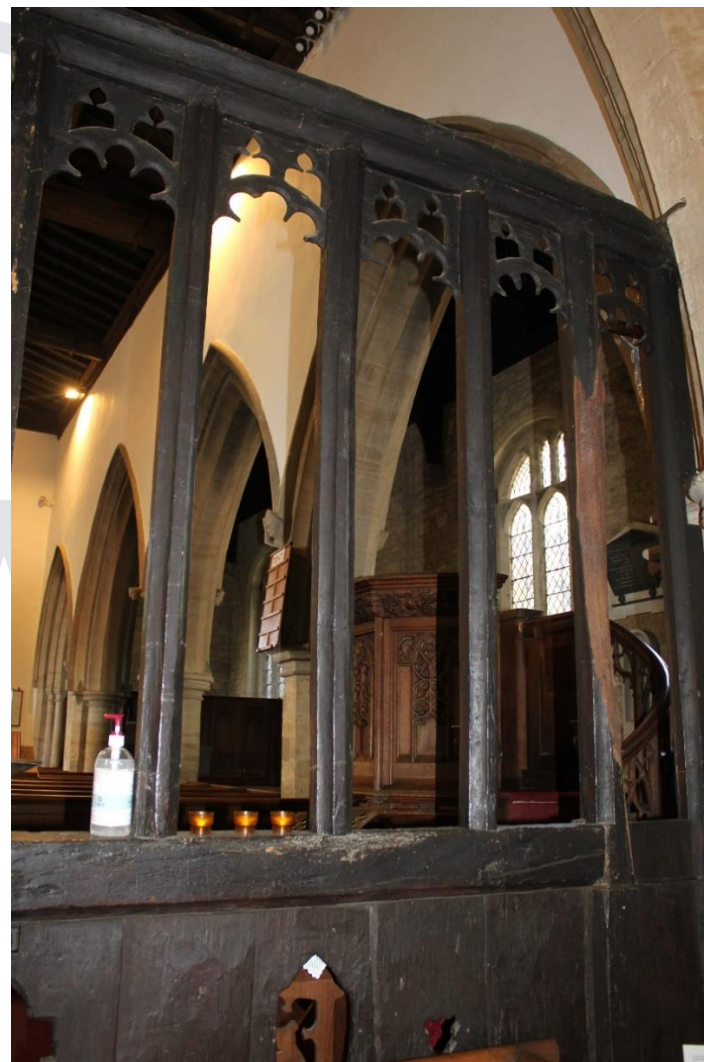
Plate 19: View to the window lights on the chancel facing side of the north side of the screen from the chancel, looking northwest (Credit: Esther Robinson Wild)

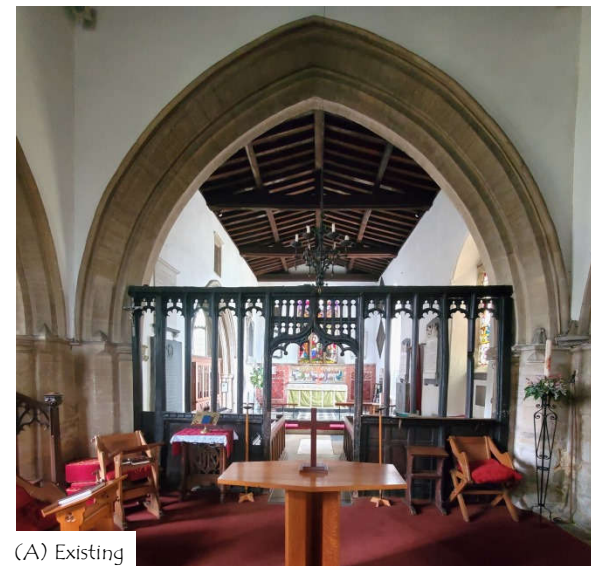
(A) Existing

The proposal requires removal of the timber screen currently in position (A) Chancel arch, and relocation to position (B) Aisle north wall.

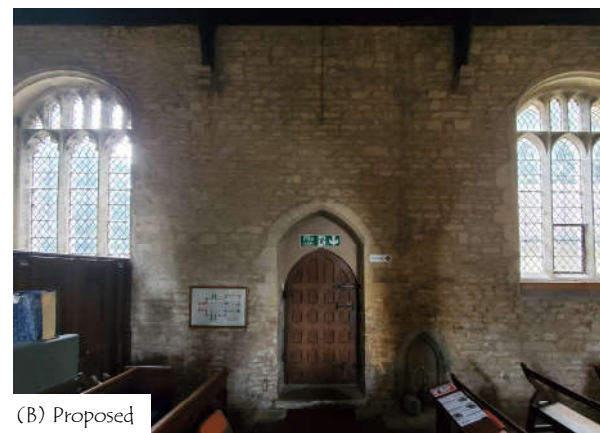
(B) Proposed

The existing screen can be accommodated in the new position. It allows the north door to open without need for modification other than removal of the modern end panel which currently exists against the north side of the arch.

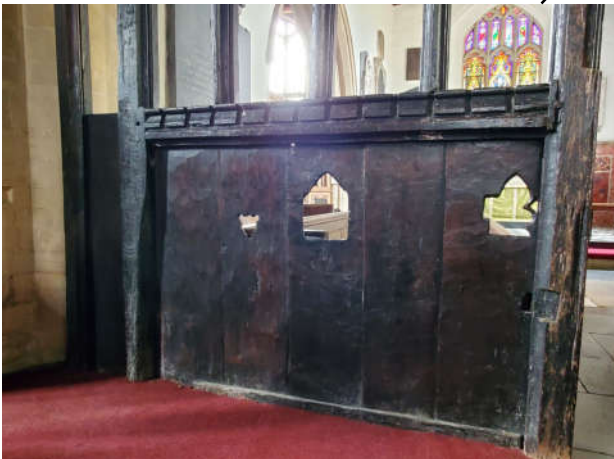
Lower Chancel floor level with base of screen partially buried against raised floor / concrete
